## Field Report #5

**No. 3917**

**Project:** Gateway PG – Forest Ave. Façade Repairs Phase 2  
**Project #:** WO 3917  
**Date/Time:** March 17, 2017, 1:30 p.m.  
**Observers** Adam Sampson, (BSE) Author

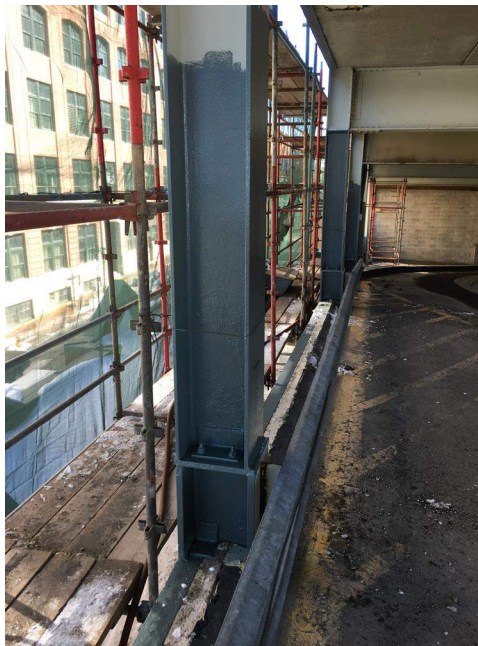
1. KISC has completed the majority of the steel beam and column painting at levels one, two and the roof level. All coats had been applied at the roof level and level two. The top coat still needed to be applied at level one. (See photos below).

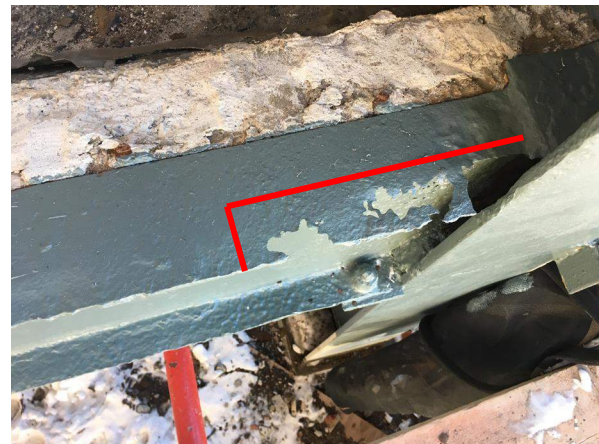
2. At level one, steel repairs have not been completed to the exterior steel beams. Where the section loss is visible to pedestrians, in the garage or from the street, the steel should be repaired according to the sketch previously submitted by BSE. At the ramp locations where the section loss is not directly visible, the areas showing section loss should be cut back according to the sketch provided but no steel plate is required to be welded to the beam flange. (See adjacent photos, area outlined in red to be removed).

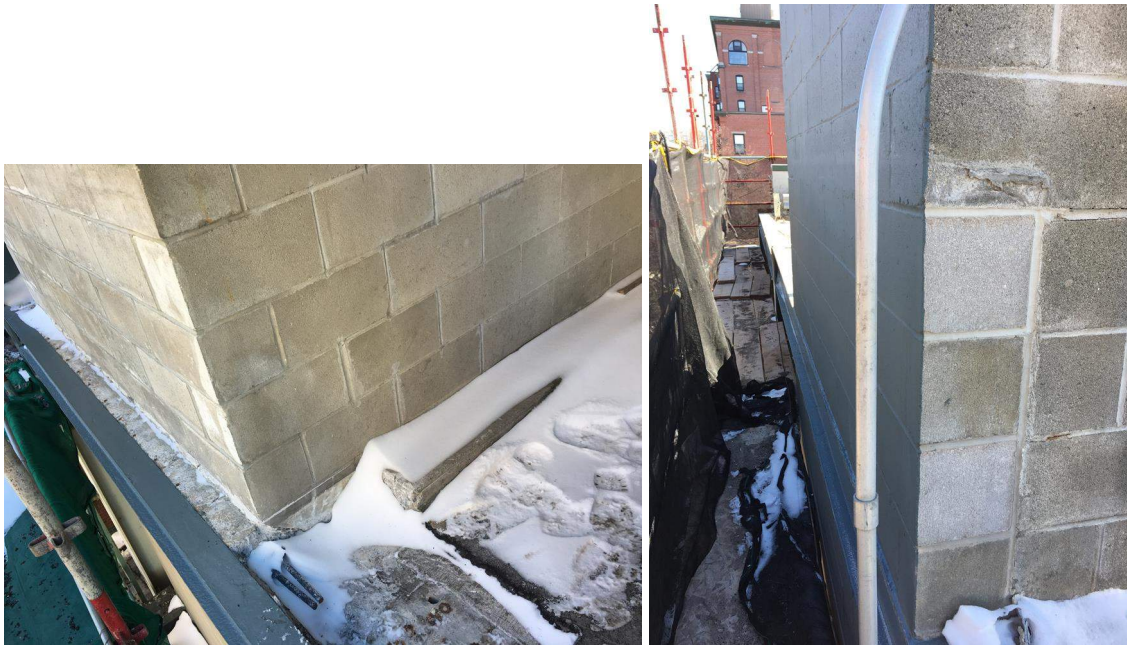
3. KISC has repaired the corners of the CMU stair tower, and repointed the cracked joints, at the roof level and level two. At the roof level KISC has painted the CMU at the Forest Ave. façade. (See photos below).

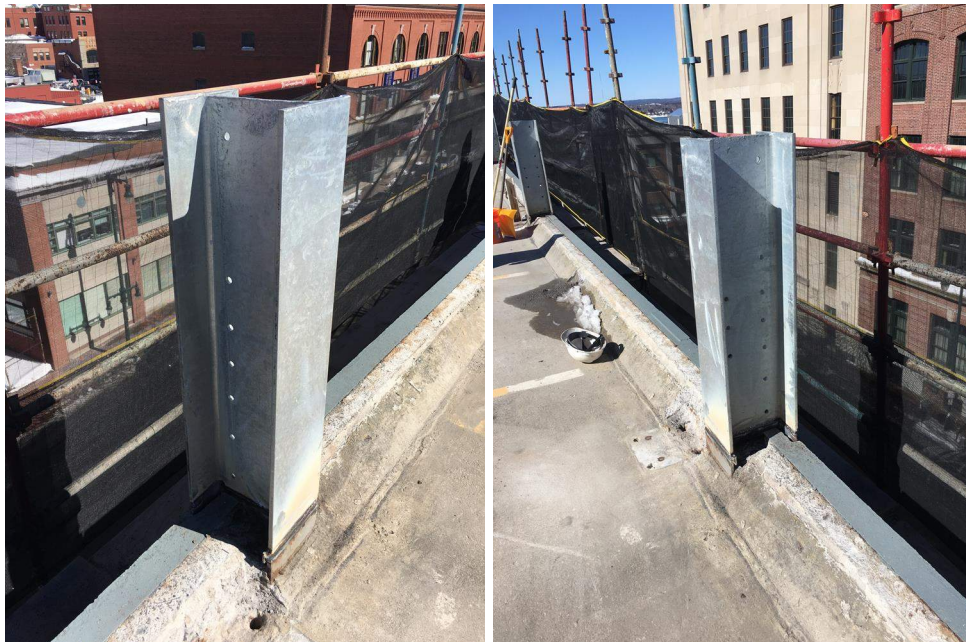
4. Smith Custom Fabrication (SCF) was on site welding the column extensions at the roof level. SCF anticipated completing the remaining column extensions the week of March 20-24. (See photos below).

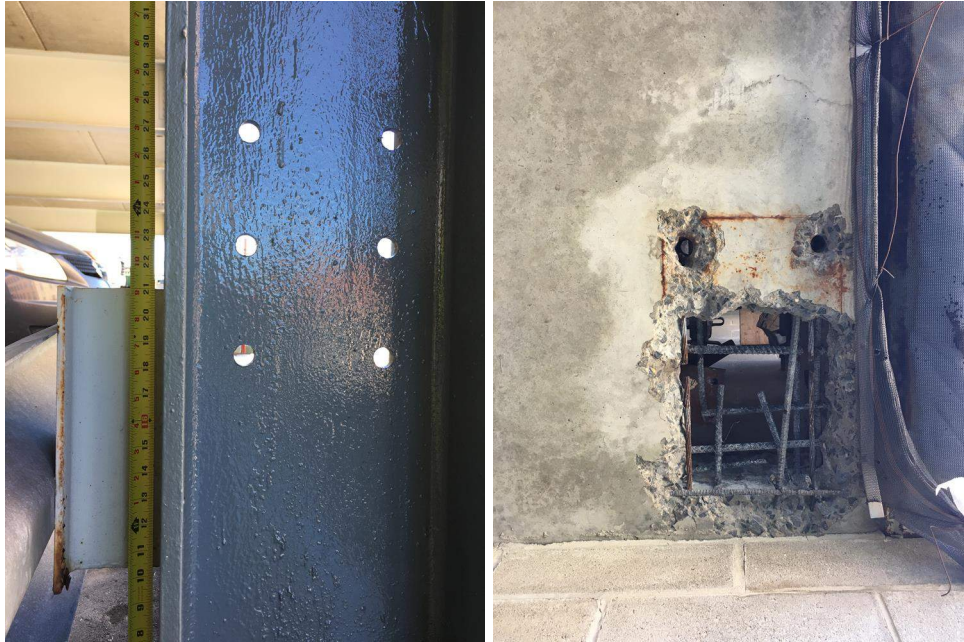
5. SCF has begun to drill holes for the HSS bumper connections at the level two columns. (See photos below).

6. KISC demoed a hole at the level three deck for the additional post supporting the HSS bumper at grid line 2.5. This location will need to be repaired to support the new post above. A hole should be demoed in the same location through roof level for the post to extend through. (See photo above.)
