OWNER:
53 DANFORTH STREET, LP
C/O THE SZANTON COMPANY
ONE CITY CENTER - 4TH FLOOR
PORTLAND, ME 04101

53 DANFORTH
53 DANFORTH STREET
PORTLAND, MAINE

Date: 28 May 2008
Scale: 1/8" = 1'-0"
POST-TENSIONING
SECTIONS & DETAILS

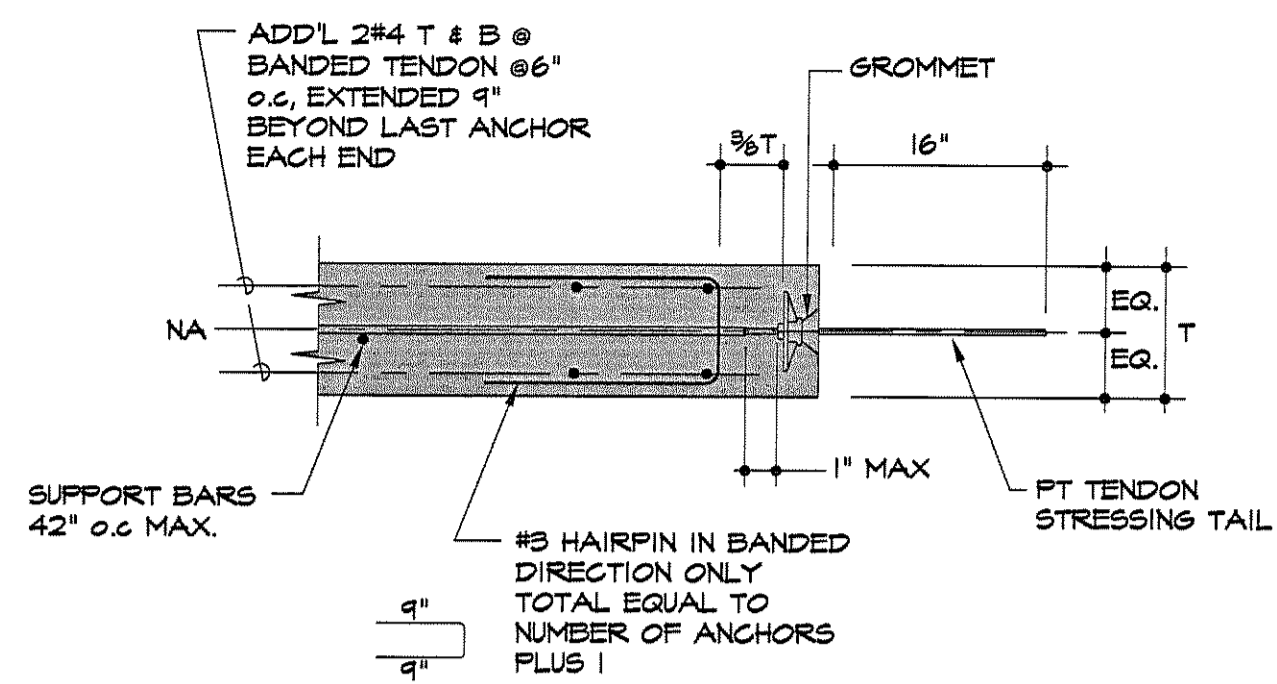
STRESSING END ANCHORS SHOWING THE HAIRPIN

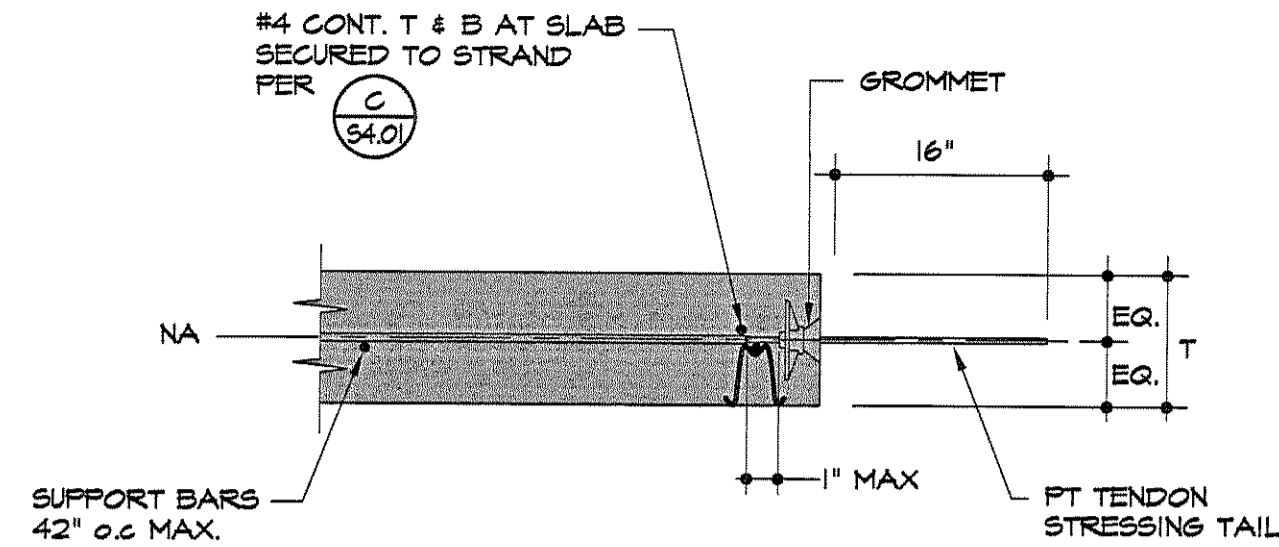
STRESSING END ANCHOR SHOWING

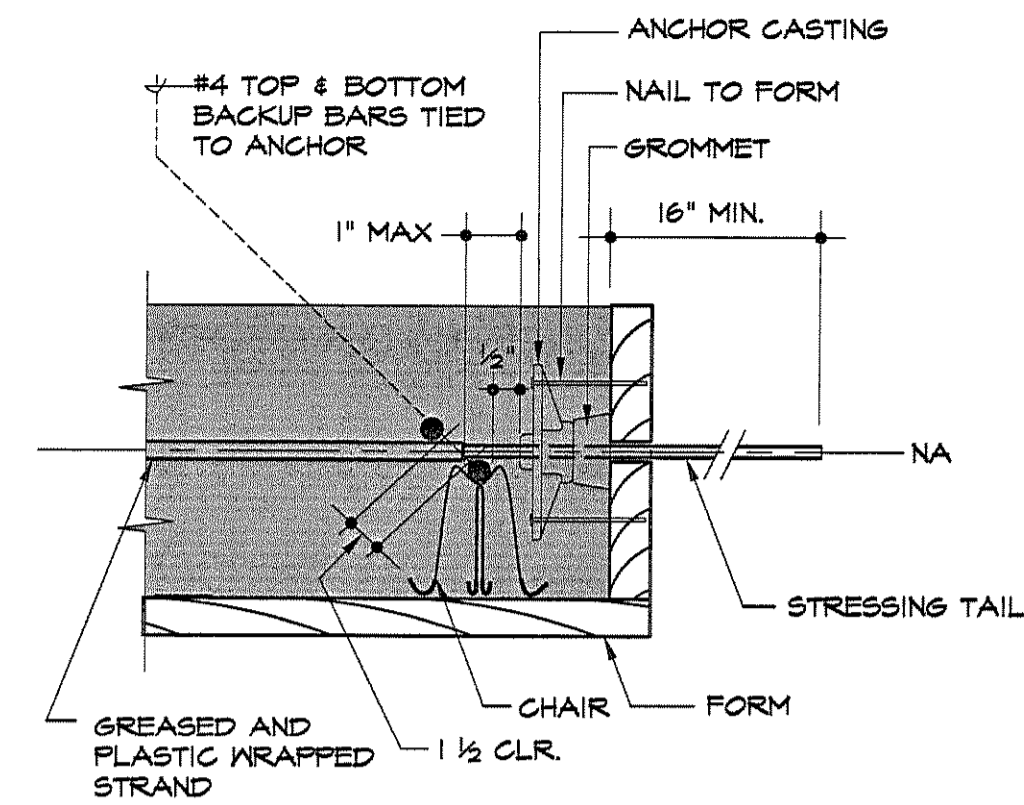
STRESSING END ANCHOR FOR

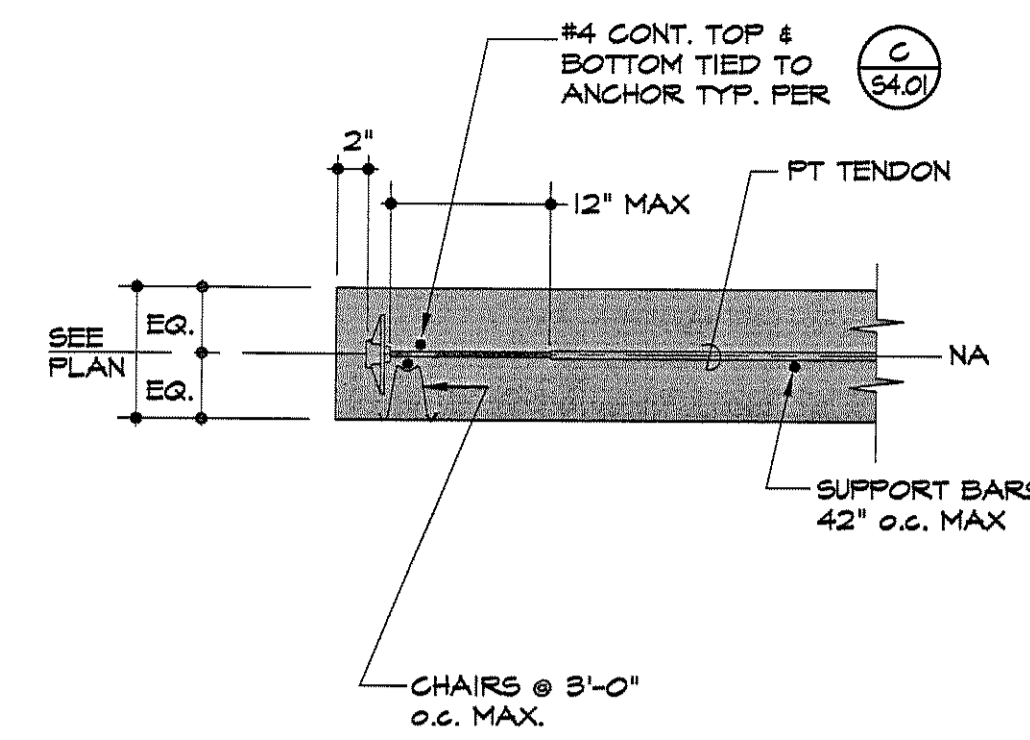
DEAD END AT DISTRIBUTED TENDONS

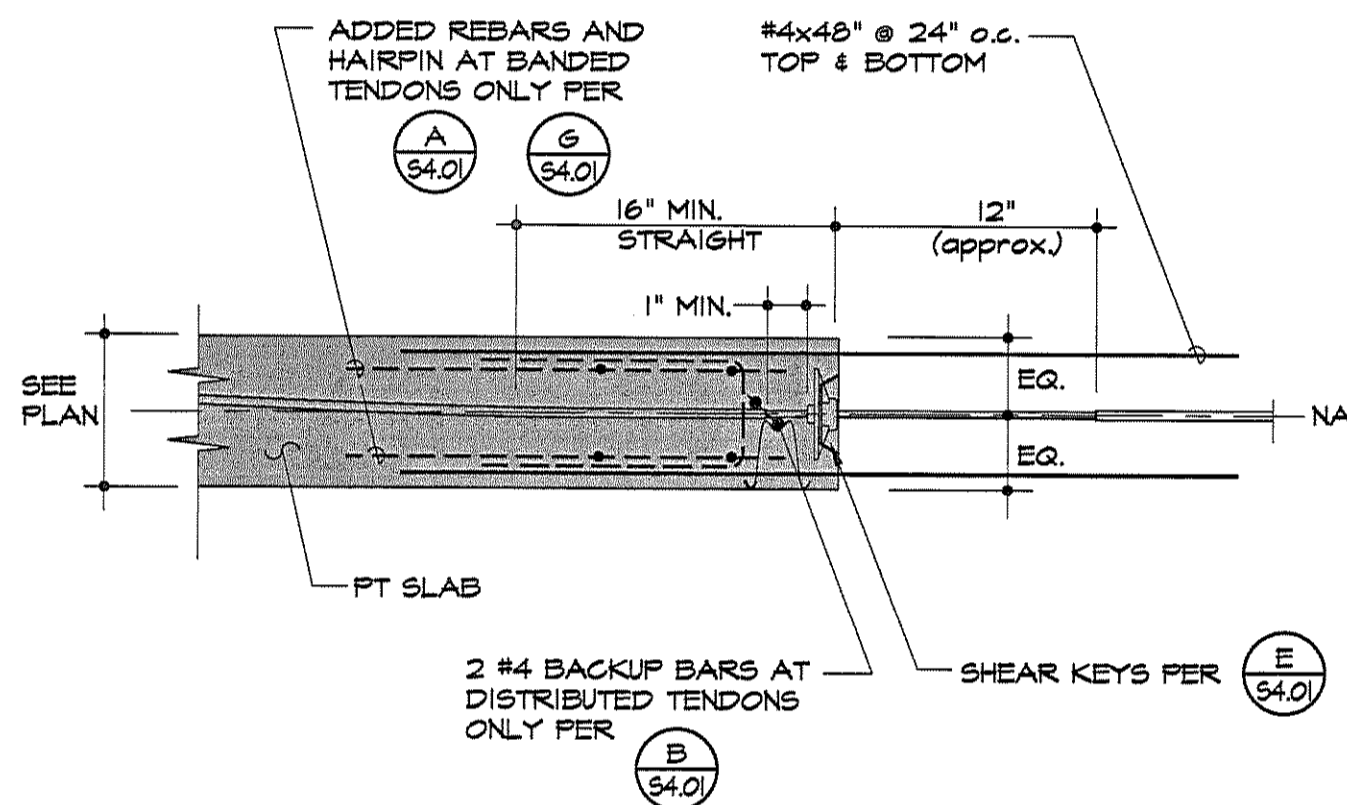
CONSTRUCTION JOINT WITH INTERMEDIATE STRESSING

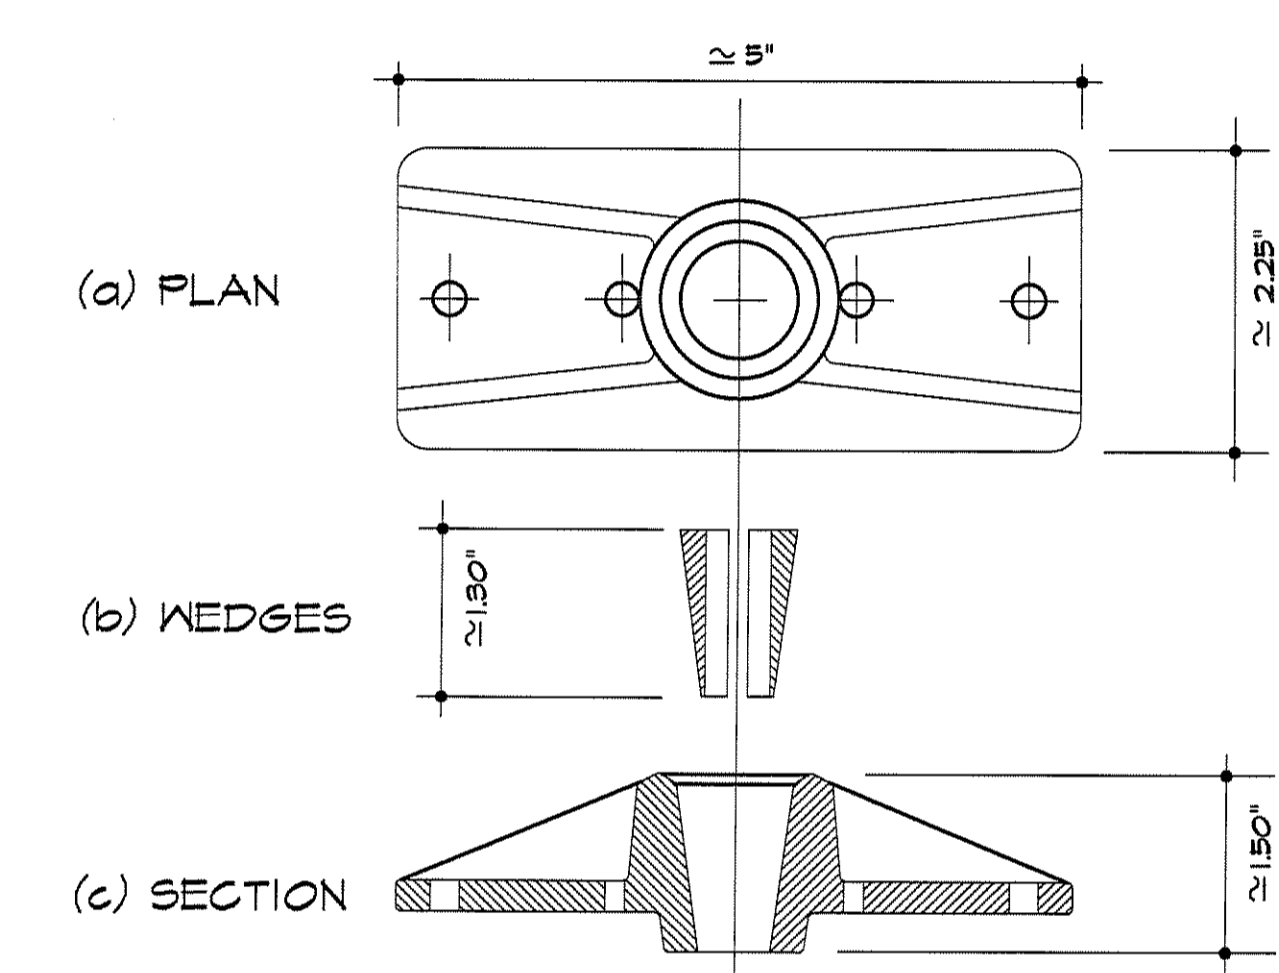
(H) S4.01 GENERIC MONOSTRAND ANCHORAGE

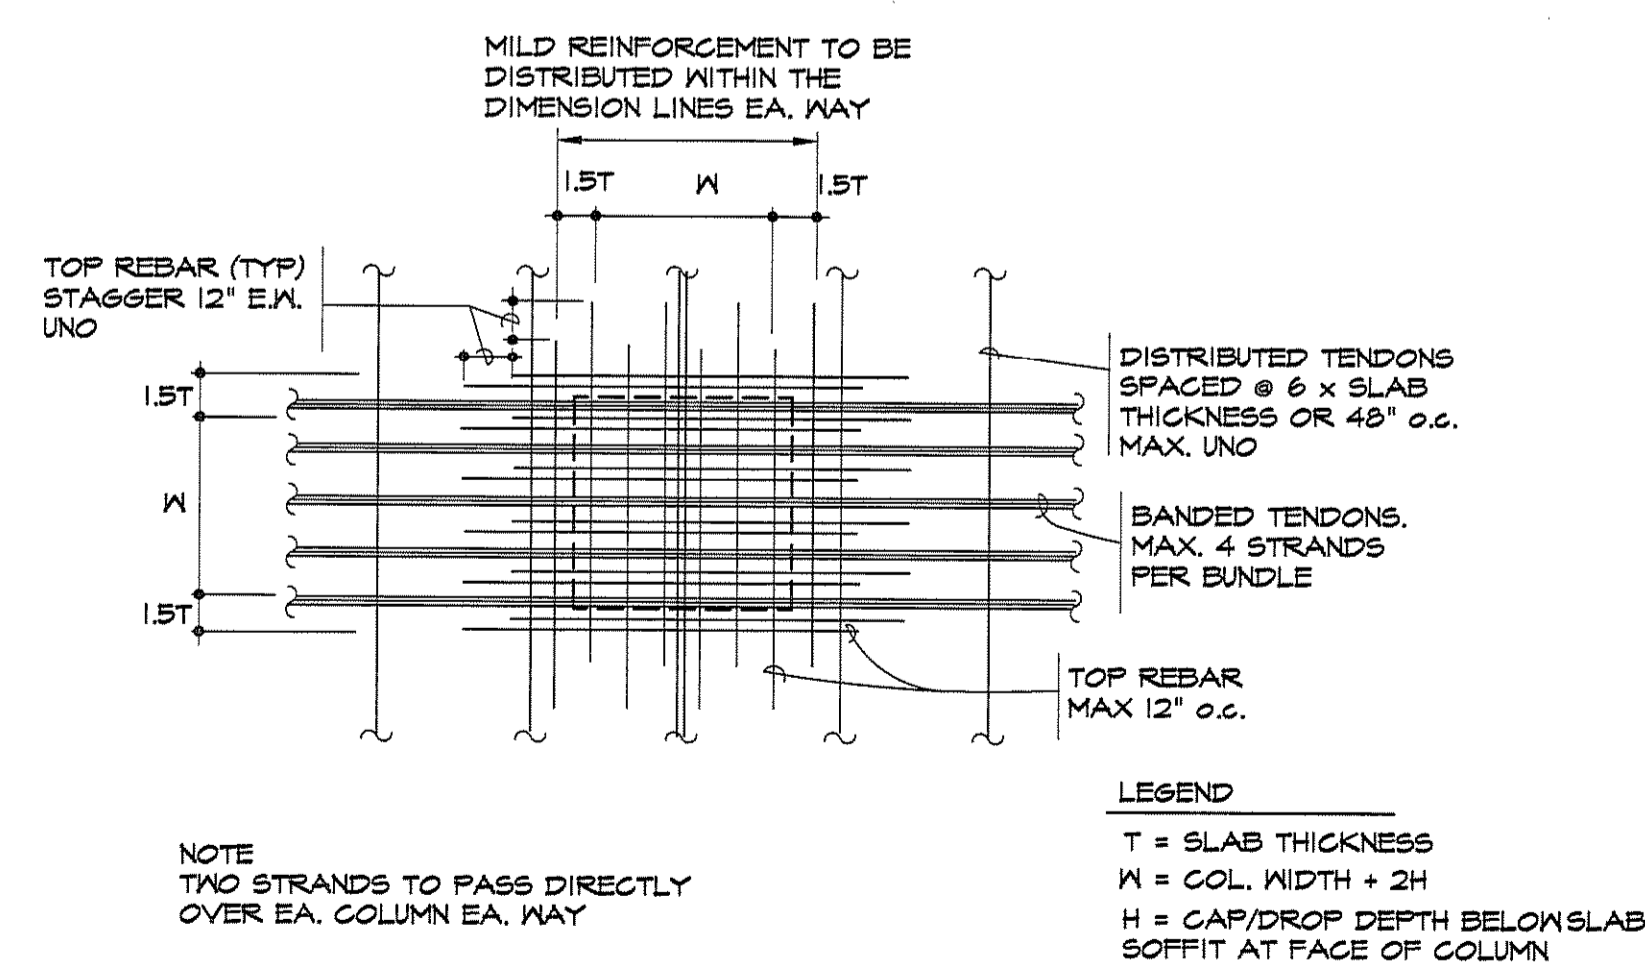
TOP REINFORCEMENT AT INTERIOR COLUMNS
