REHABILITATION OF FRONT ENTRY  
126 & 128 DANFORTH STREET  
PORTLAND, MAINE  
PLAN AND DANFORTH STREET PARTIAL ELEVATION

**A2**

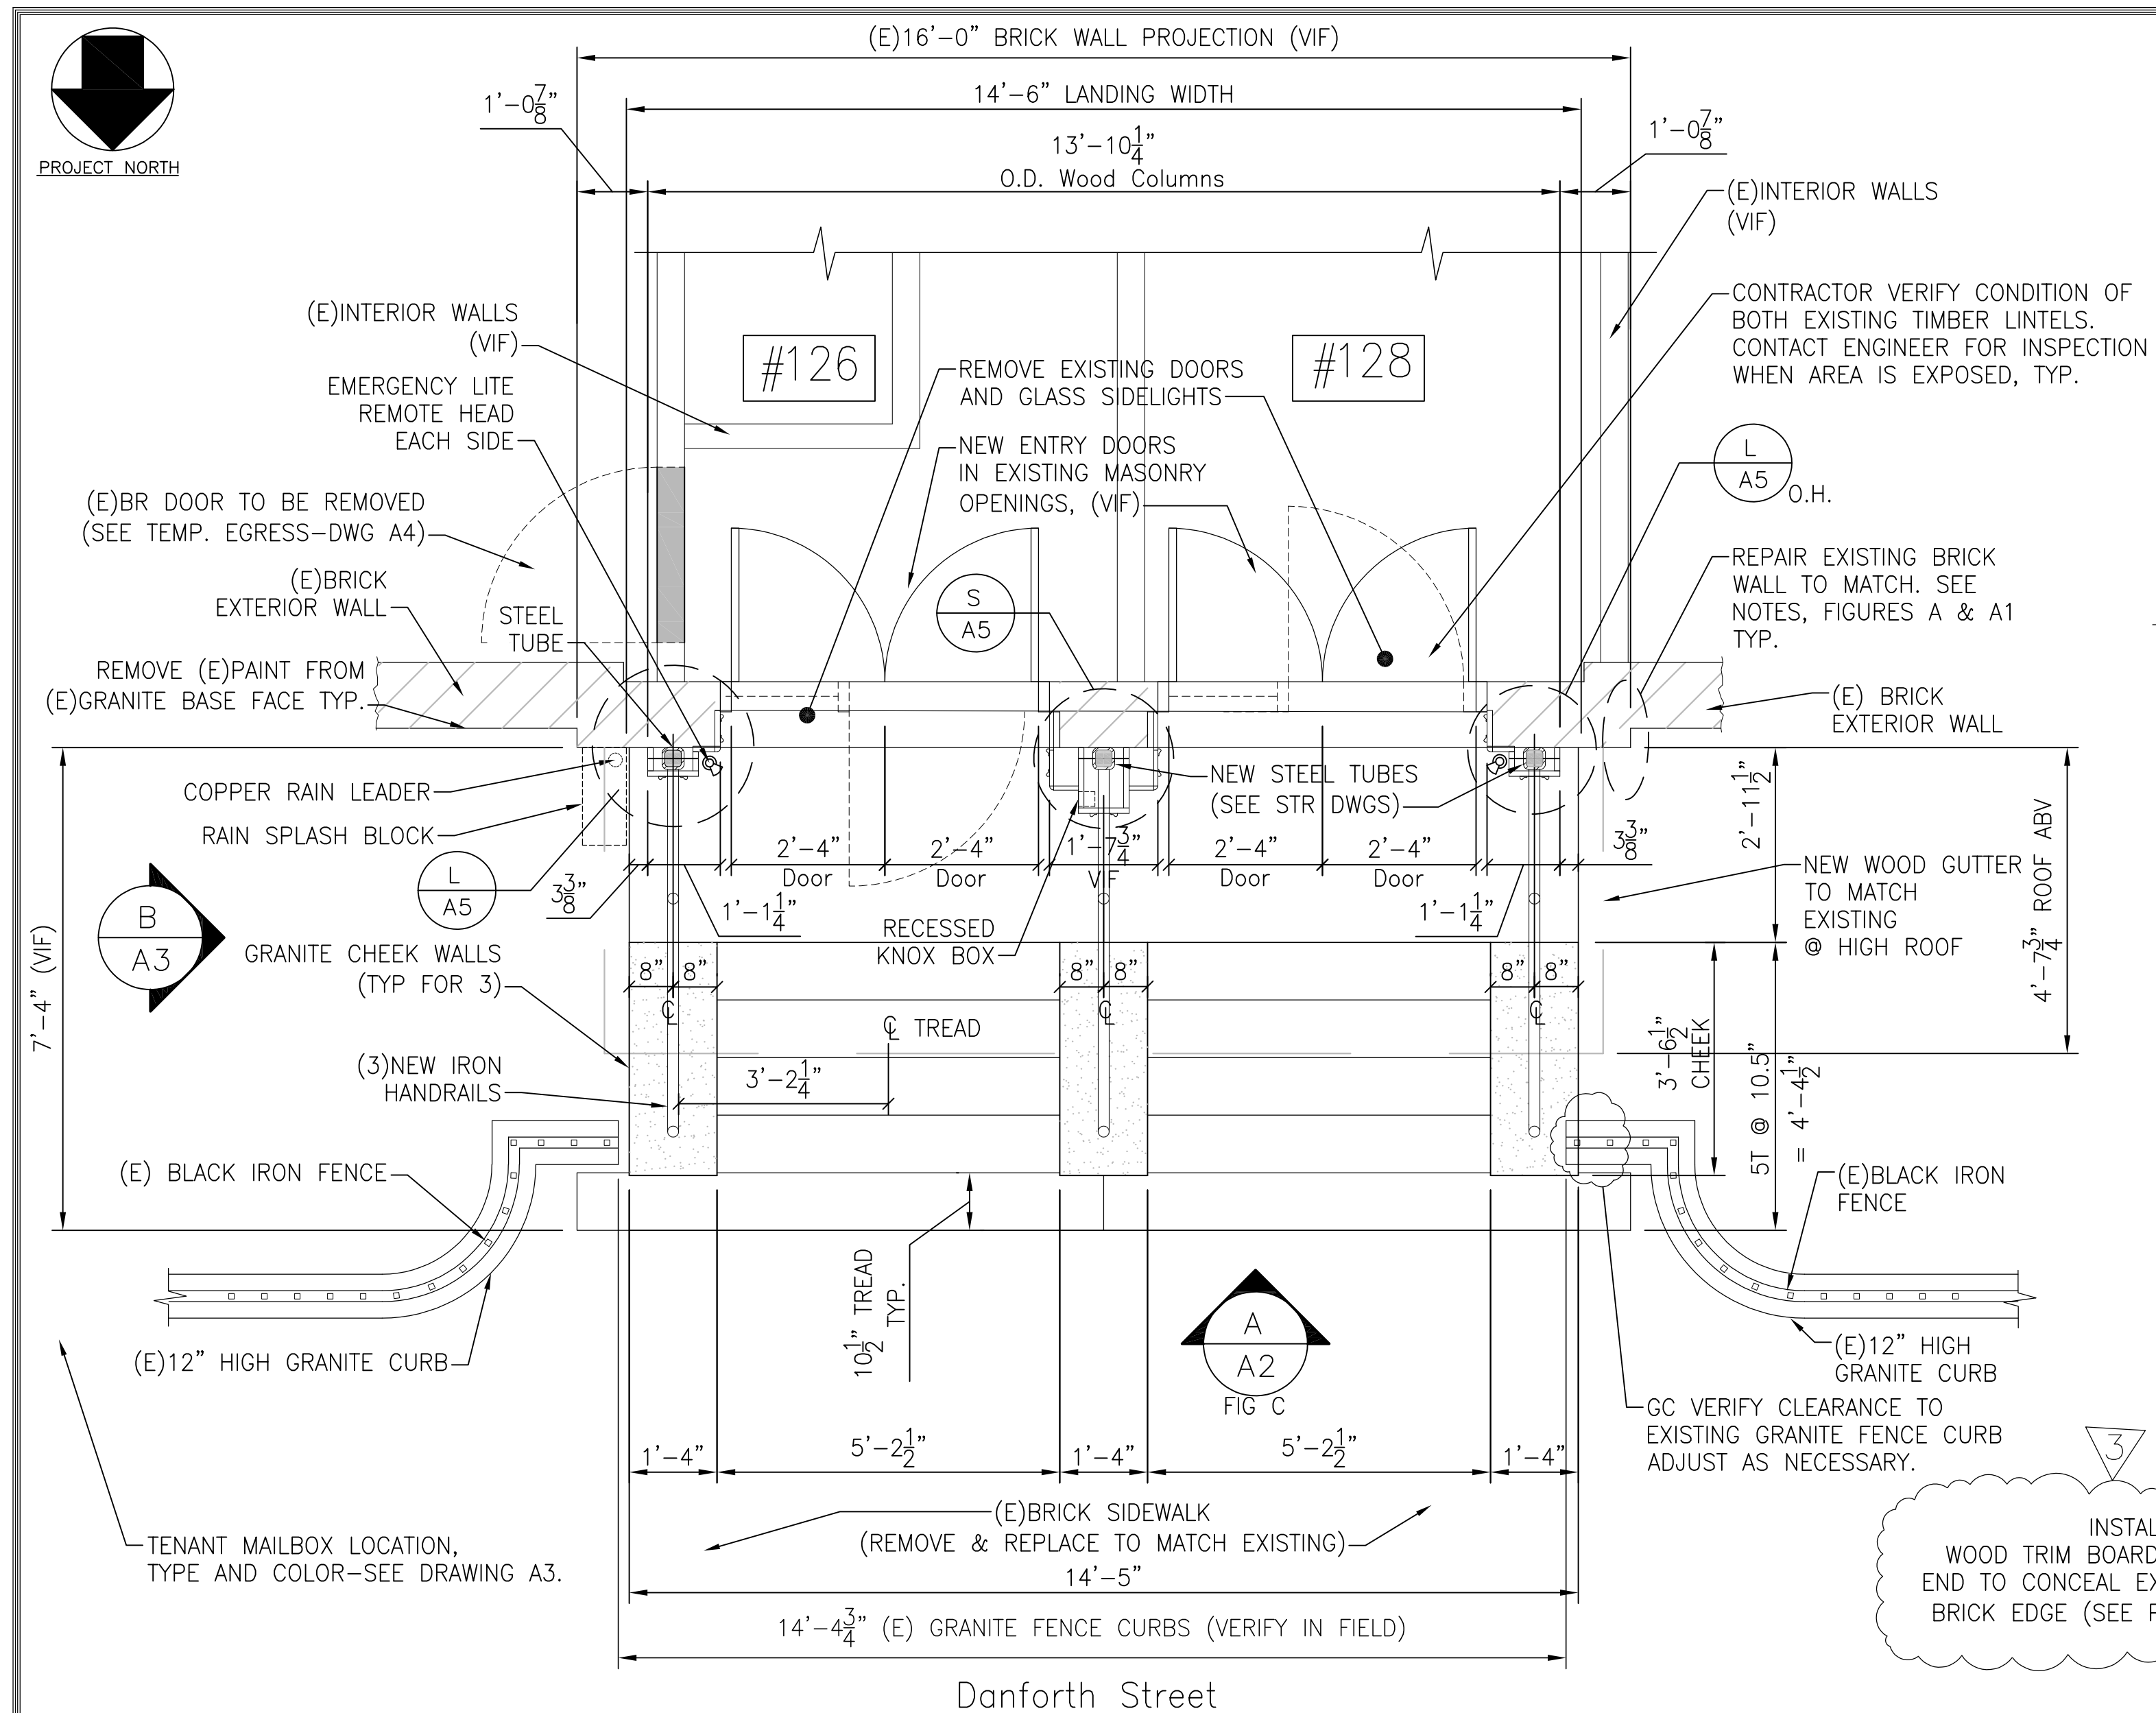
FRONT ENTRY PLAN  
SCALE: 1/2 = 1'-0"

- Existing segmental arched door surrounds relate to original bracketed door hood. No photos or evidence of original entry doors or their frames can be found other than the 1924 picture shown.

- Comparable building entries in the general area, door is typically single, solid, with sidelites; often with transoms.
- Proposal is to provide solid single entry doors slabs set back from existing arched entrance plane.

- The set back entry system is enclosed within a square headed transom and is not constrained by existing arch-topped wood trim.
- The flat painted walls just behind the original wood trim offers a transition between the rehabilitated face and new entry panel doors (Refer Section 1)

- Steps in 1924 image (Fig. 8) show treads with heavy shadow and are difficult to distinguish the material. Appears to be masonry or brownstone? The brick center divider may be a remnant of that stair system. We propose to remove the brick center divider at the landing level only. We proposed to construct granite center wall between the steps and up to the granite slab landing. (See drawings)

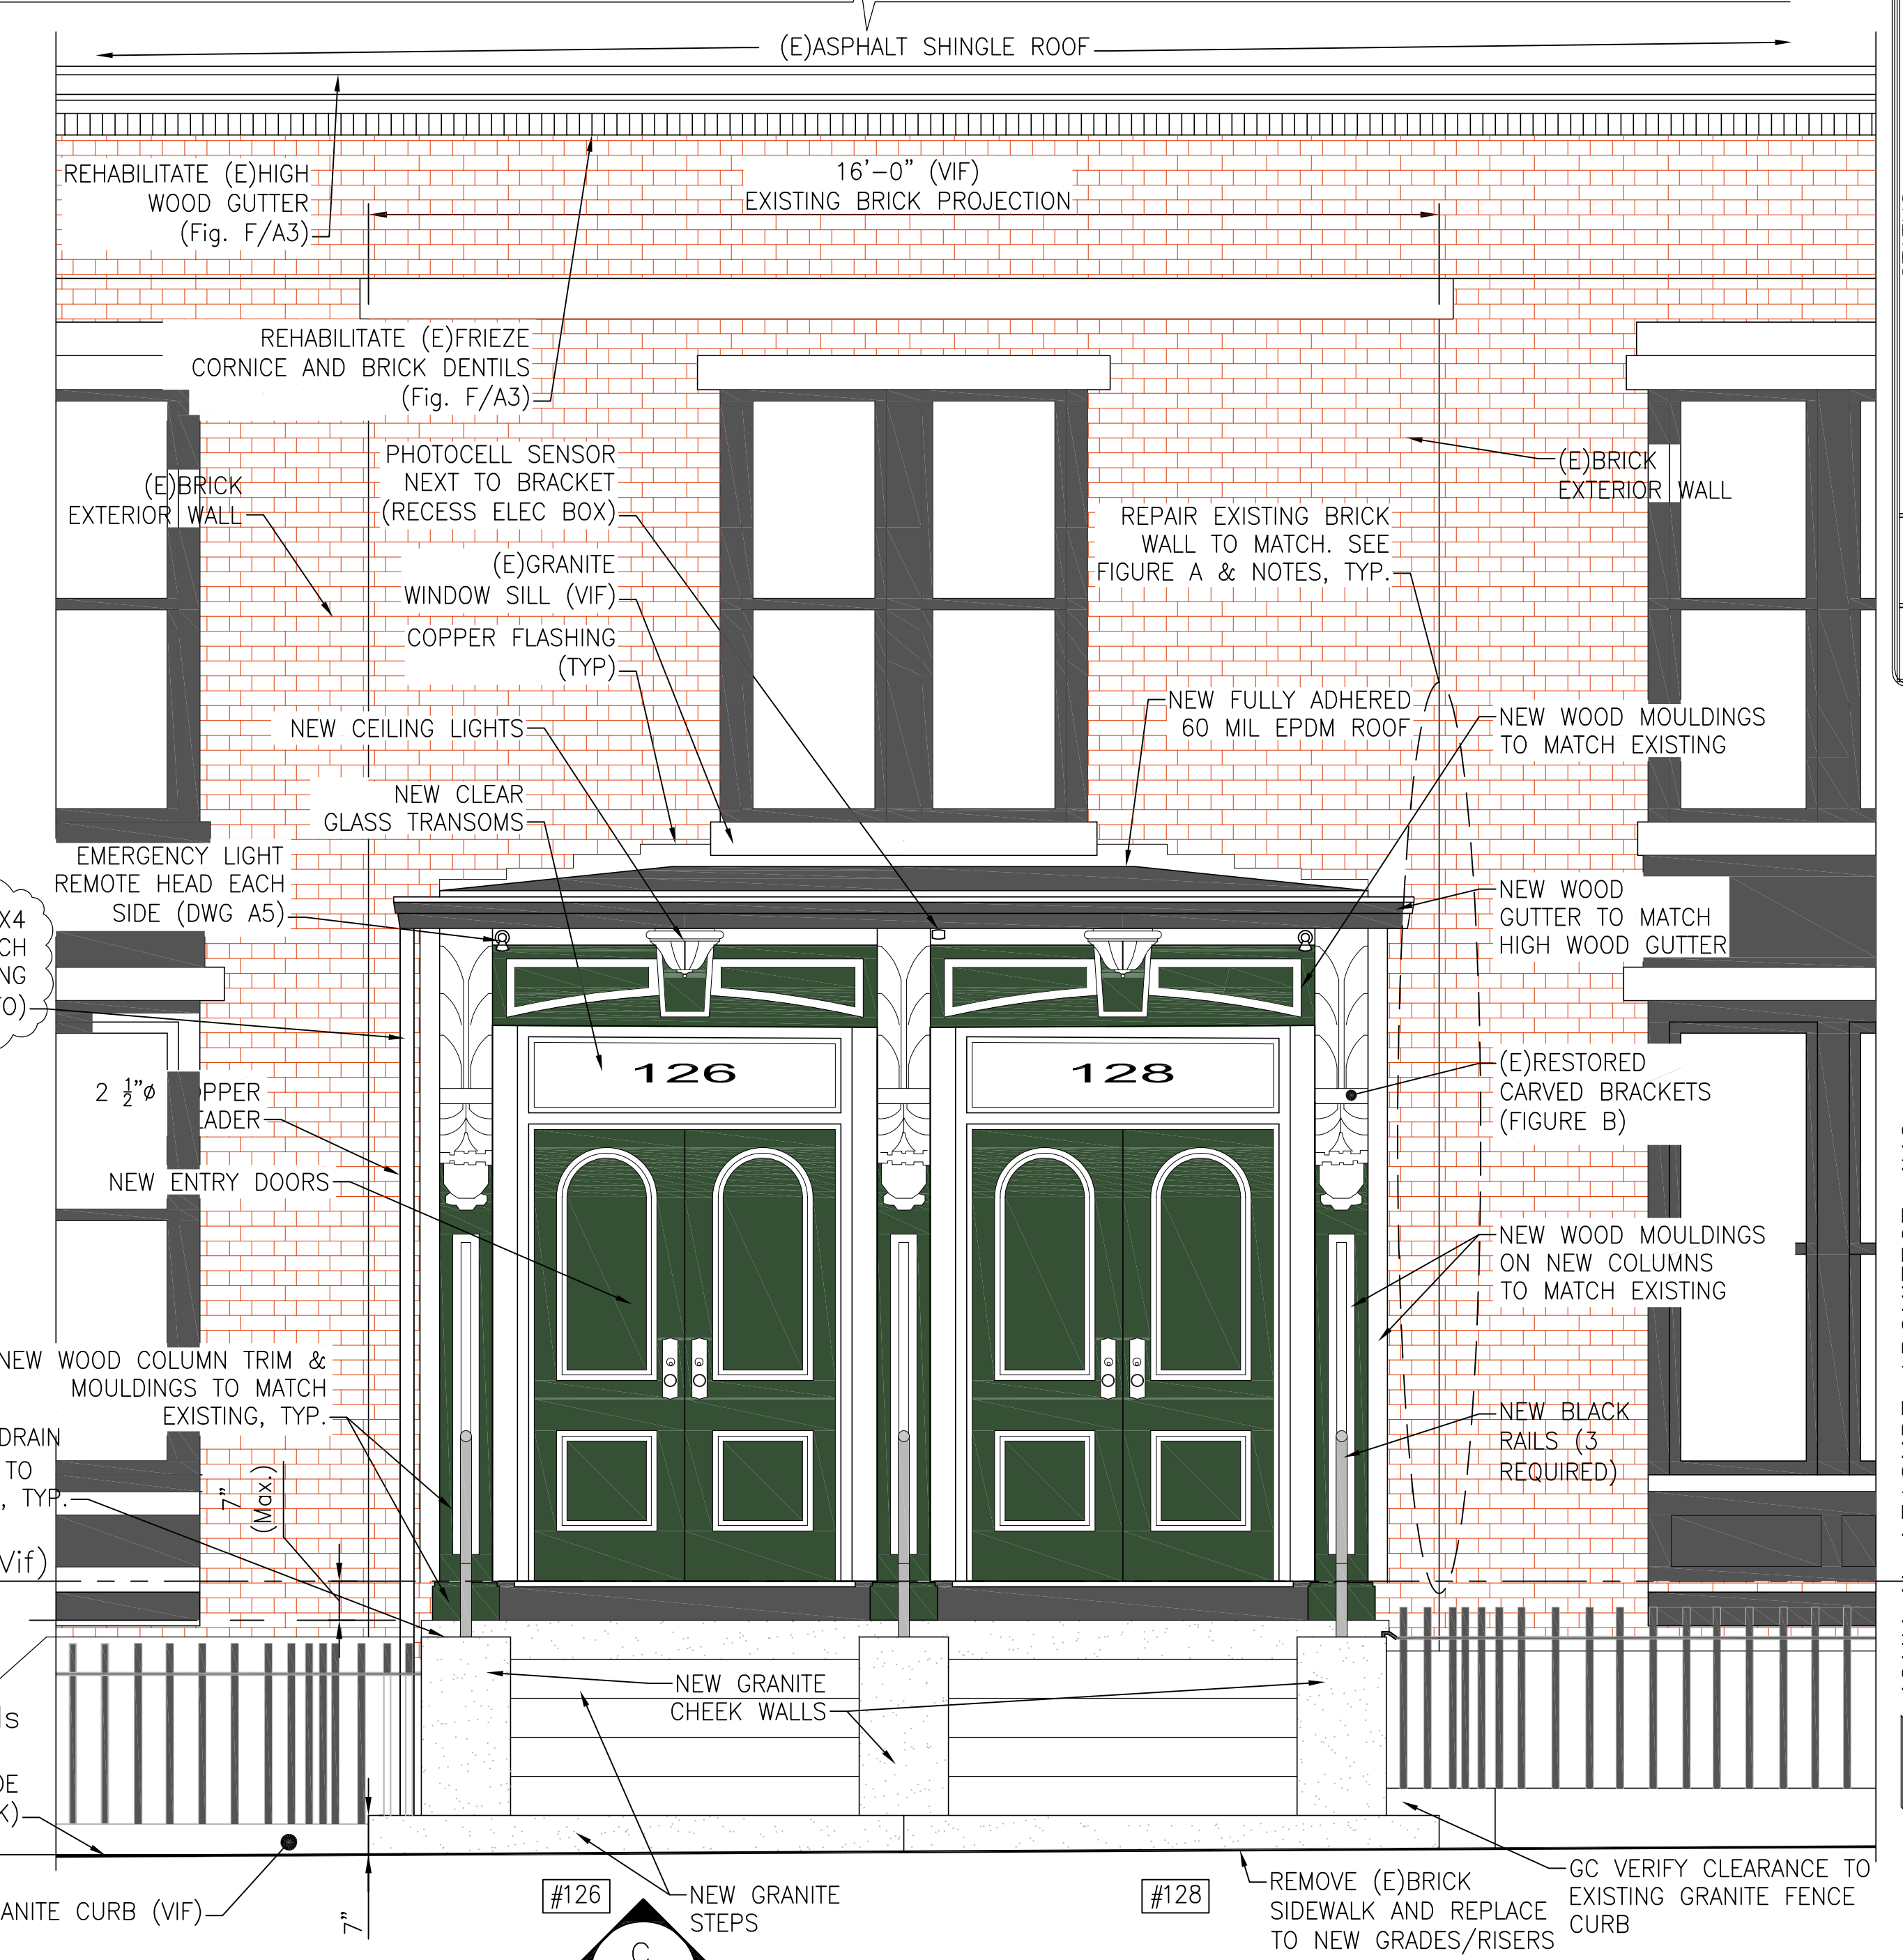
DANFORTH STREET ELEVATION  
SCALE: 1/2 = 1'-0"

- Existing Window wood trim - Painted Black (Fig. C / A3)
- Restored Wood Carved Brackets (3) - Painted Black to match
- Wood Fascia - Painted Black to match
- Wood Gutter - Painted Creme color to match high gutter color
- Entry Doors and wood panel field - Painted Dark Green
- Door Mouldings - Painted Black to match
- Pipe Handrails (3) - Painted Black to match
