Structural Special Inspections Report

Elm Terrace

Portland, ME
October 15, 2012

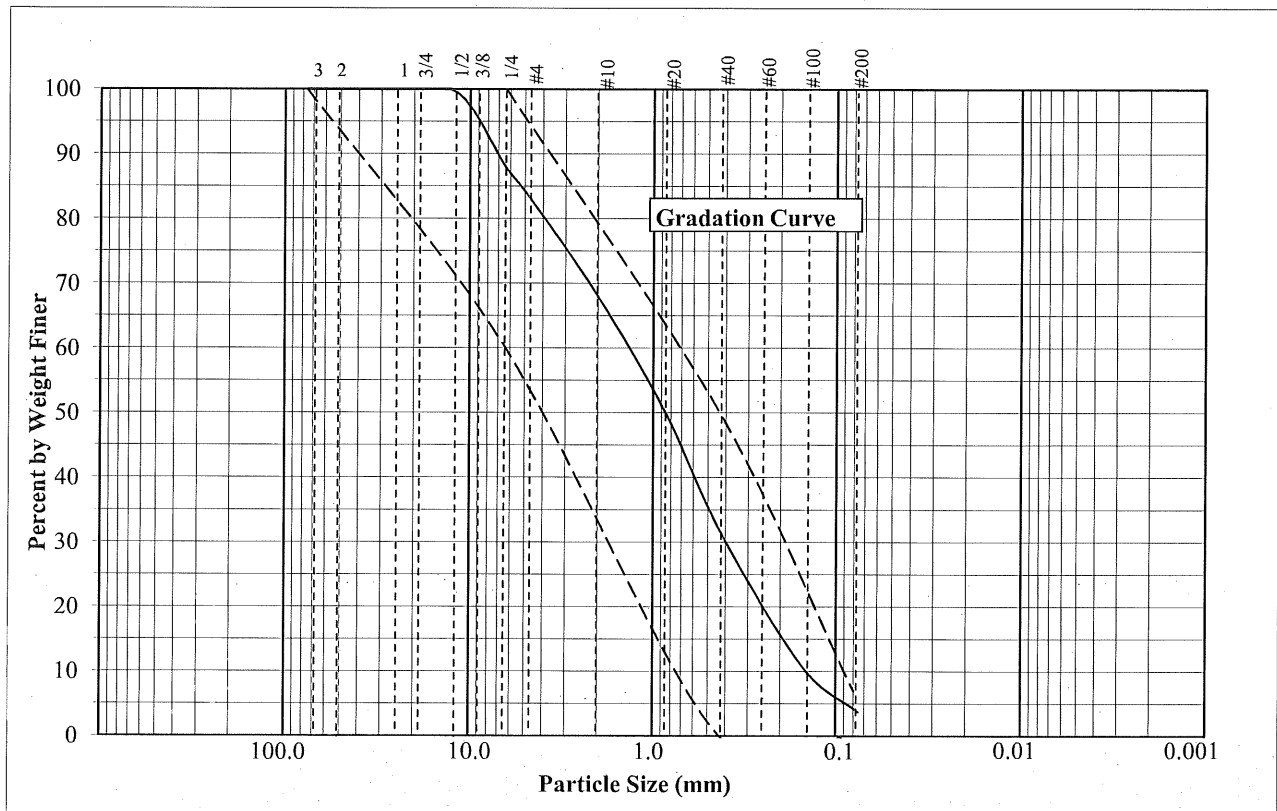
MDOT 703.06 Type "F"
 Foundation Backfill

PARTICLE SIZE mm	% BY WT FINER	SPECIFICATION
76.20 (3 in)	100.0	100
50.80 (2 in)	100.0	
38.10 (1-1/2 in)	100.0	
25.40 (1 in)	100.0	
19.05 (3/4 in)	100.0	
12.70 (1/2 in)	99.9	
9.53 (3/8 in)	96.6	
6.35 (1/4 in)	88.0	60 to 100
4.75 (No. 4)	83.5	
2.00 (No. 10)	68.1	
0.85 (No. 20)	50.0	
0.43 (No. 40)	31.7	0 to 50
0.15 (No. 100)	10.7	
0.08 (No. 200)	3.7	0 to 7

REMARKS: Moisture Content: 1.9%

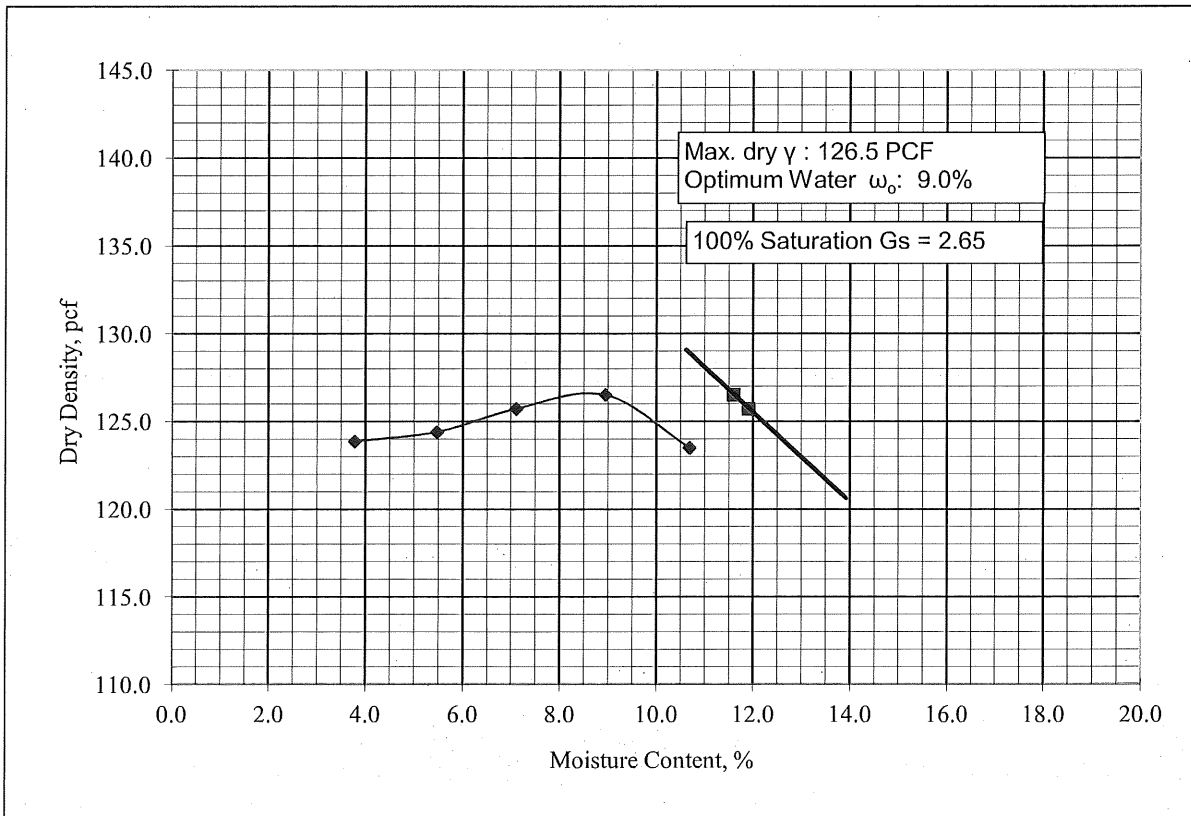
MOISTURE DENSITY TEST - ASTM D1557

Method: A
 Max. Particle Size (in): #4
 Oversize Correction (%): 17

Moisture Content %	Dry Density, pcf
3.8	123.9
5.5	124.4
7.1	125.7
9.0	126.5
10.7	123.5

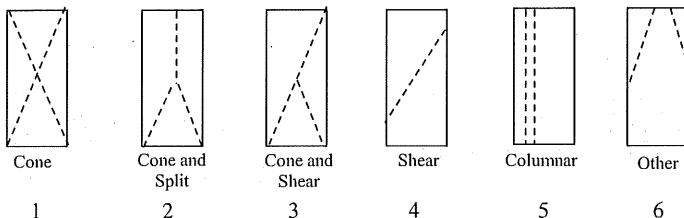
Sample No.	Test Date	Age	Type	Unit Wt.	Area (in ²)	Load (K)	Strength (psi)
C1a	16-Mar-12	7	6	144.4	28.27	73.3	2590
C1b	6-Apr-12	28	4	145.3	28.27	86.2	3050
C1c	6-Apr-12	28	4	145.7	28.27	89.8	3180
C1d

Average 28 Day (psi): 3115

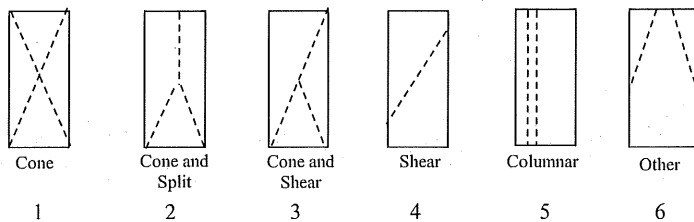
Sample No.	Test Date	Age	Type	Unit Wt.	Area (in ²)	Load (K)	Strength (psi)
C2a	23-Mar-12	7	4	144.3	28.27	97.6	3450
C2b	13-Apr-12	28	2	145.7	28.27	113.0	4000
C2c	13-Apr-12	28	4	144.6	28.27	116.7	4130
C2d

Average 28 Day (psi): 4065

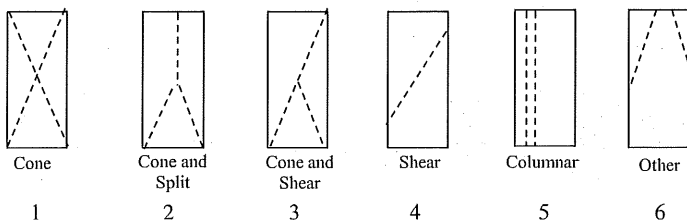
Sample No.	Test Date	Age	Type	Unit Wt.	Area (in ²)	Load (K)	Strength (psi)
C3a	29-Mar-12	7	4	144.5	28.27	98.6	3490
C3b	19-Apr-12	28	3	145.1	28.27	141.0	4990
C3c	19-Apr-12	28	6	144.4	28.27	137.4	4860
C3d

Average 28 Day (psi): 4925

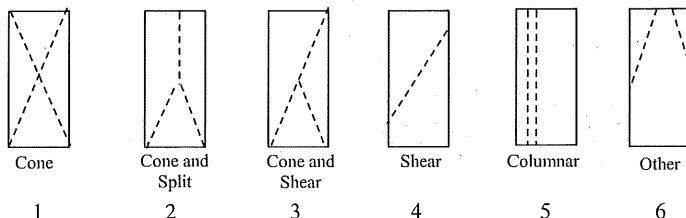
Sample No.	Test Date	Age	Type	Unit Wt.	Area (in ²)	Load (K)	Strength (psi)
C4a	9-Apr-12	7	3	142.9	28.27	105.1	3720
C4b	30-Apr-12	28	2	143.3	28.27	151.1	5340
C4c	30-Apr-12	28	2	143.3	28.27	150.1	5310
C4d

Average 28 Day (psi): 5325

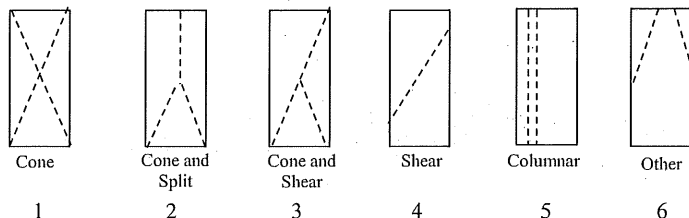
Sample No.	Test Date	Age	Type	Unit Wt.	Area (in ²)	Load (K)	Strength (psi)
C5a	11-Apr-12	7	4	147.2	28.27	119.3	4220
C5b	2-May-12	28	4	146.8	28.27	170.9	6040
C5c	2-May-12	28	4	147.0	28.27	173.2	6120
C5d

Average 28 Day (psi): 6080

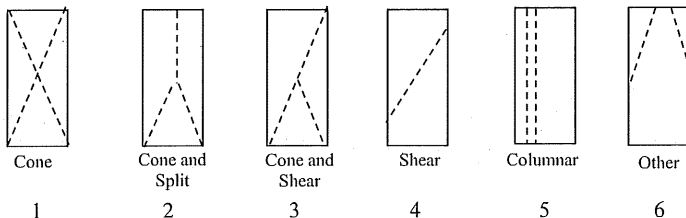
Sample No.	Test Date	Age	Type	Unit Wt.	Area (in ²)	Load (K)	Strength (psi)
C6a	18-Apr-12	7	4	137.1	28.27	82.7	2920
C6b	9-May-12	28	4	138.3	28.27	114.2	4040
C6c	9-May-12	28	4	136.6	28.27	116.4	4120
C6d

Average 28 Day (psi): 4080

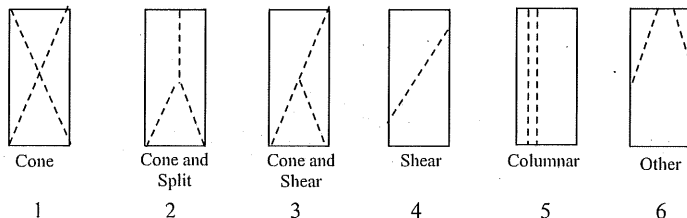
Sample No.	Test Date	Age	Type	Unit Wt.	Area (in ²)	Load (K)	Strength (psi)
C7a	18-Apr-12	7	4	146.2	28.27	104.1	3680
C7b	9-May-12	28	4	146.3	28.27	144.0	5090
C7c	9-May-12	28	4	146.1	28.27	132.4	4680
C7d

Average 28 Day (psi): 4885

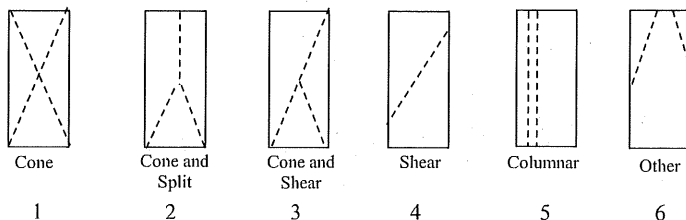
Sample No.	Test Date	Age	Type	Unit Wt.	Area (in ²)	Load (K)	Strength (psi)
9a	27-Apr-12	7	2	142.5	28.27	71.1	2510
9b	18-May-12	28	4	143.2	28.27	120.0	4250
9c	18-May-12	28	4	142.3	28.27	123.3	4360
9d

Average 28 Day (psi): 4305

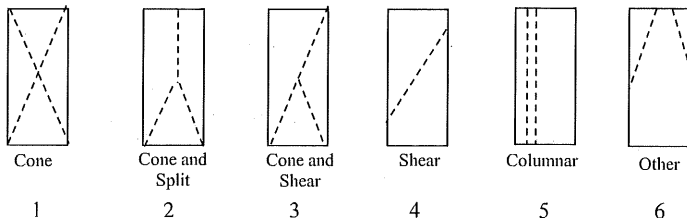
Sample No.	Test Date	Age	Type	Unit Wt.	Area (in ²)	Load (K)	Strength (psi)
14611 11A	7-May-12	7	2	142.8	28.27	94.7	3350
11B	28-May-12	28	3	144.2	28.27	149.7	5290
11C	28-May-12	28	3	142.2	28.27	144.0	5090
11D	4-May-12	4	3	143.7	28.27	70.6	2500

Average 28 Day (psi): 5190

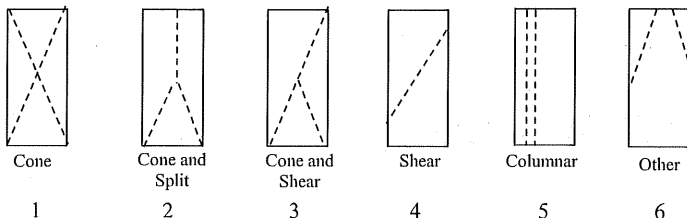
Sample No.	Test Date	Age	Type	Unit Wt.	Area (in ²)	Load (K)	Strength (psi)
C12a	10-May-12	7	4	146.6	28.27	107.2	3790
C12b	31-May-12	28	4	145.0	28.27	146.1	5170
C12c	31-May-12	28	4	146.9	28.27	148.2	5240
C12d

Average 28 Day (psi): 5205

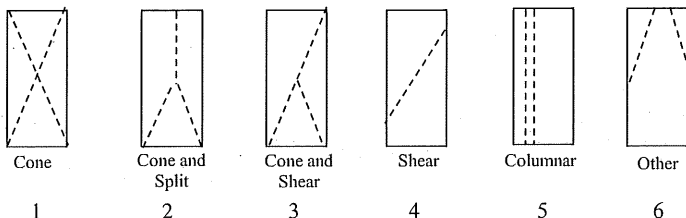
Sample No.	Test Date	Age	Type	Unit Wt.	Area (in ²)	Load (K)	Strength (psi)
C13a	10-May-12	7	6	148.7	28.27	103.7	3670
C13b	31-May-12	28	4	148.3	28.27	147.4	5210
C13c	31-May-12	28	4	148.0	28.27	145.5	5140
C13d

Average 28 Day (psi): 5175

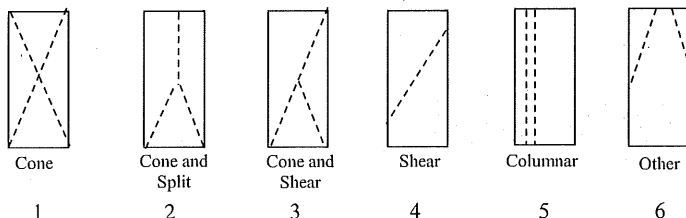
Sample No.	Test Date	Age	Type	Unit Wt.	Area (in ²)	Load (K)	Strength (psi)
C14a	22-May-12	7	6	143.1	28.27	104.0	3680
C14b	12-Jun-12	28	5	142.9	28.27	146.4	5180
C14c	12-Jun-12	28	3	142.8	28.27	144.9	5130
C14d

Average 28 Day (psi): 5155

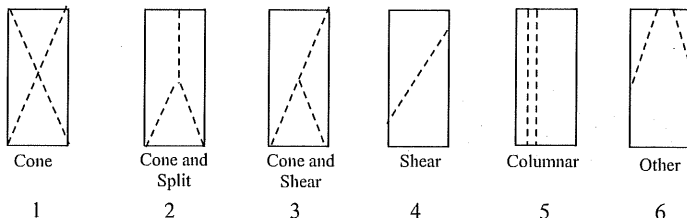
Sample No.	Test Date	Age	Type	Unit Wt.	Area (in ²)	Load (K)	Strength (psi)
C17a	29-Jun-12	7	2	141.3	28.27	147.6	5220
C17b	20-Jul-12	28	4	142.0	28.27	157.6	5580
C17c	20-Jul-12	28	4	140.5	28.27	171.3	6060
C17d

Average 28 Day (psi): 5820

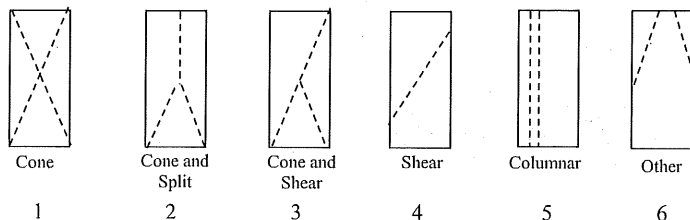
Sample No.	Test Date	Age	Type	Unit Wt.	Area (in ²)	Load (K)	Strength (psi)
C18a	15-Aug-12	7	3	140.6	28.27	96.2	3400
C18b	5-Sep-12	28	6	141.1	28.27	122.1	4320
C18c	5-Sep-12	28	5	141.1	28.27	119.8	4240
C18d

Average 28 Day (psi): 4280

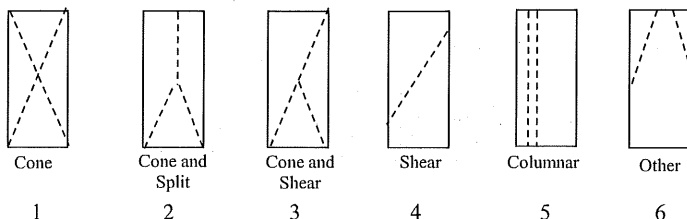
Sample No.	Test Date	Age	Type	Unit Wt.	Area (in ²)	Load (K)	Strength (psi)
C20a	14-Sep-12	7	4	145.4	28.27	126.6	4480
C20b	5-Oct-12	28					
C20c	5-Oct-12	28					
C20d

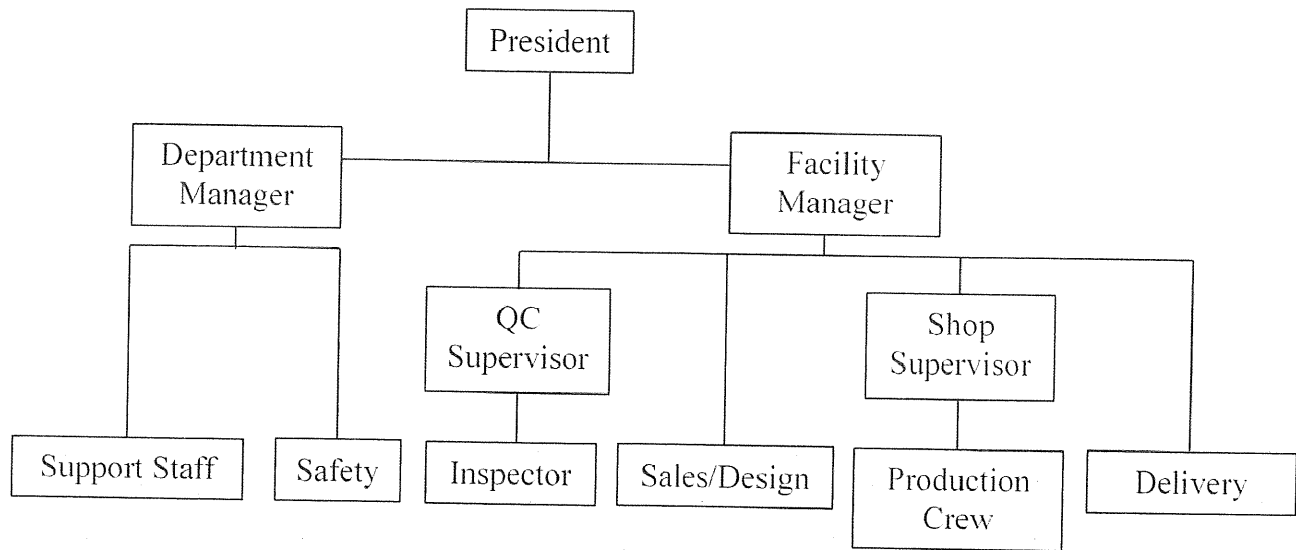
Plant organizational chart:

Quality Control Supervisor - Reports to the engineering department or management that does not have direct line production responsibilities. Has knowledge of company standards and requirements, lumber grading rules, TPI requirements and how the product is used by the customer. Records and identifies product by origin and date. Records data to identify progress of quality, either positive or negative.
