ISSUED FOR CONSTRUCTION

Episcopal Diocese of Maine
143 State Street Portland
LORING HOUSE
BUILDING ENVELOPE MASONRY REPAIR

ROOF DETAILS

A1.3

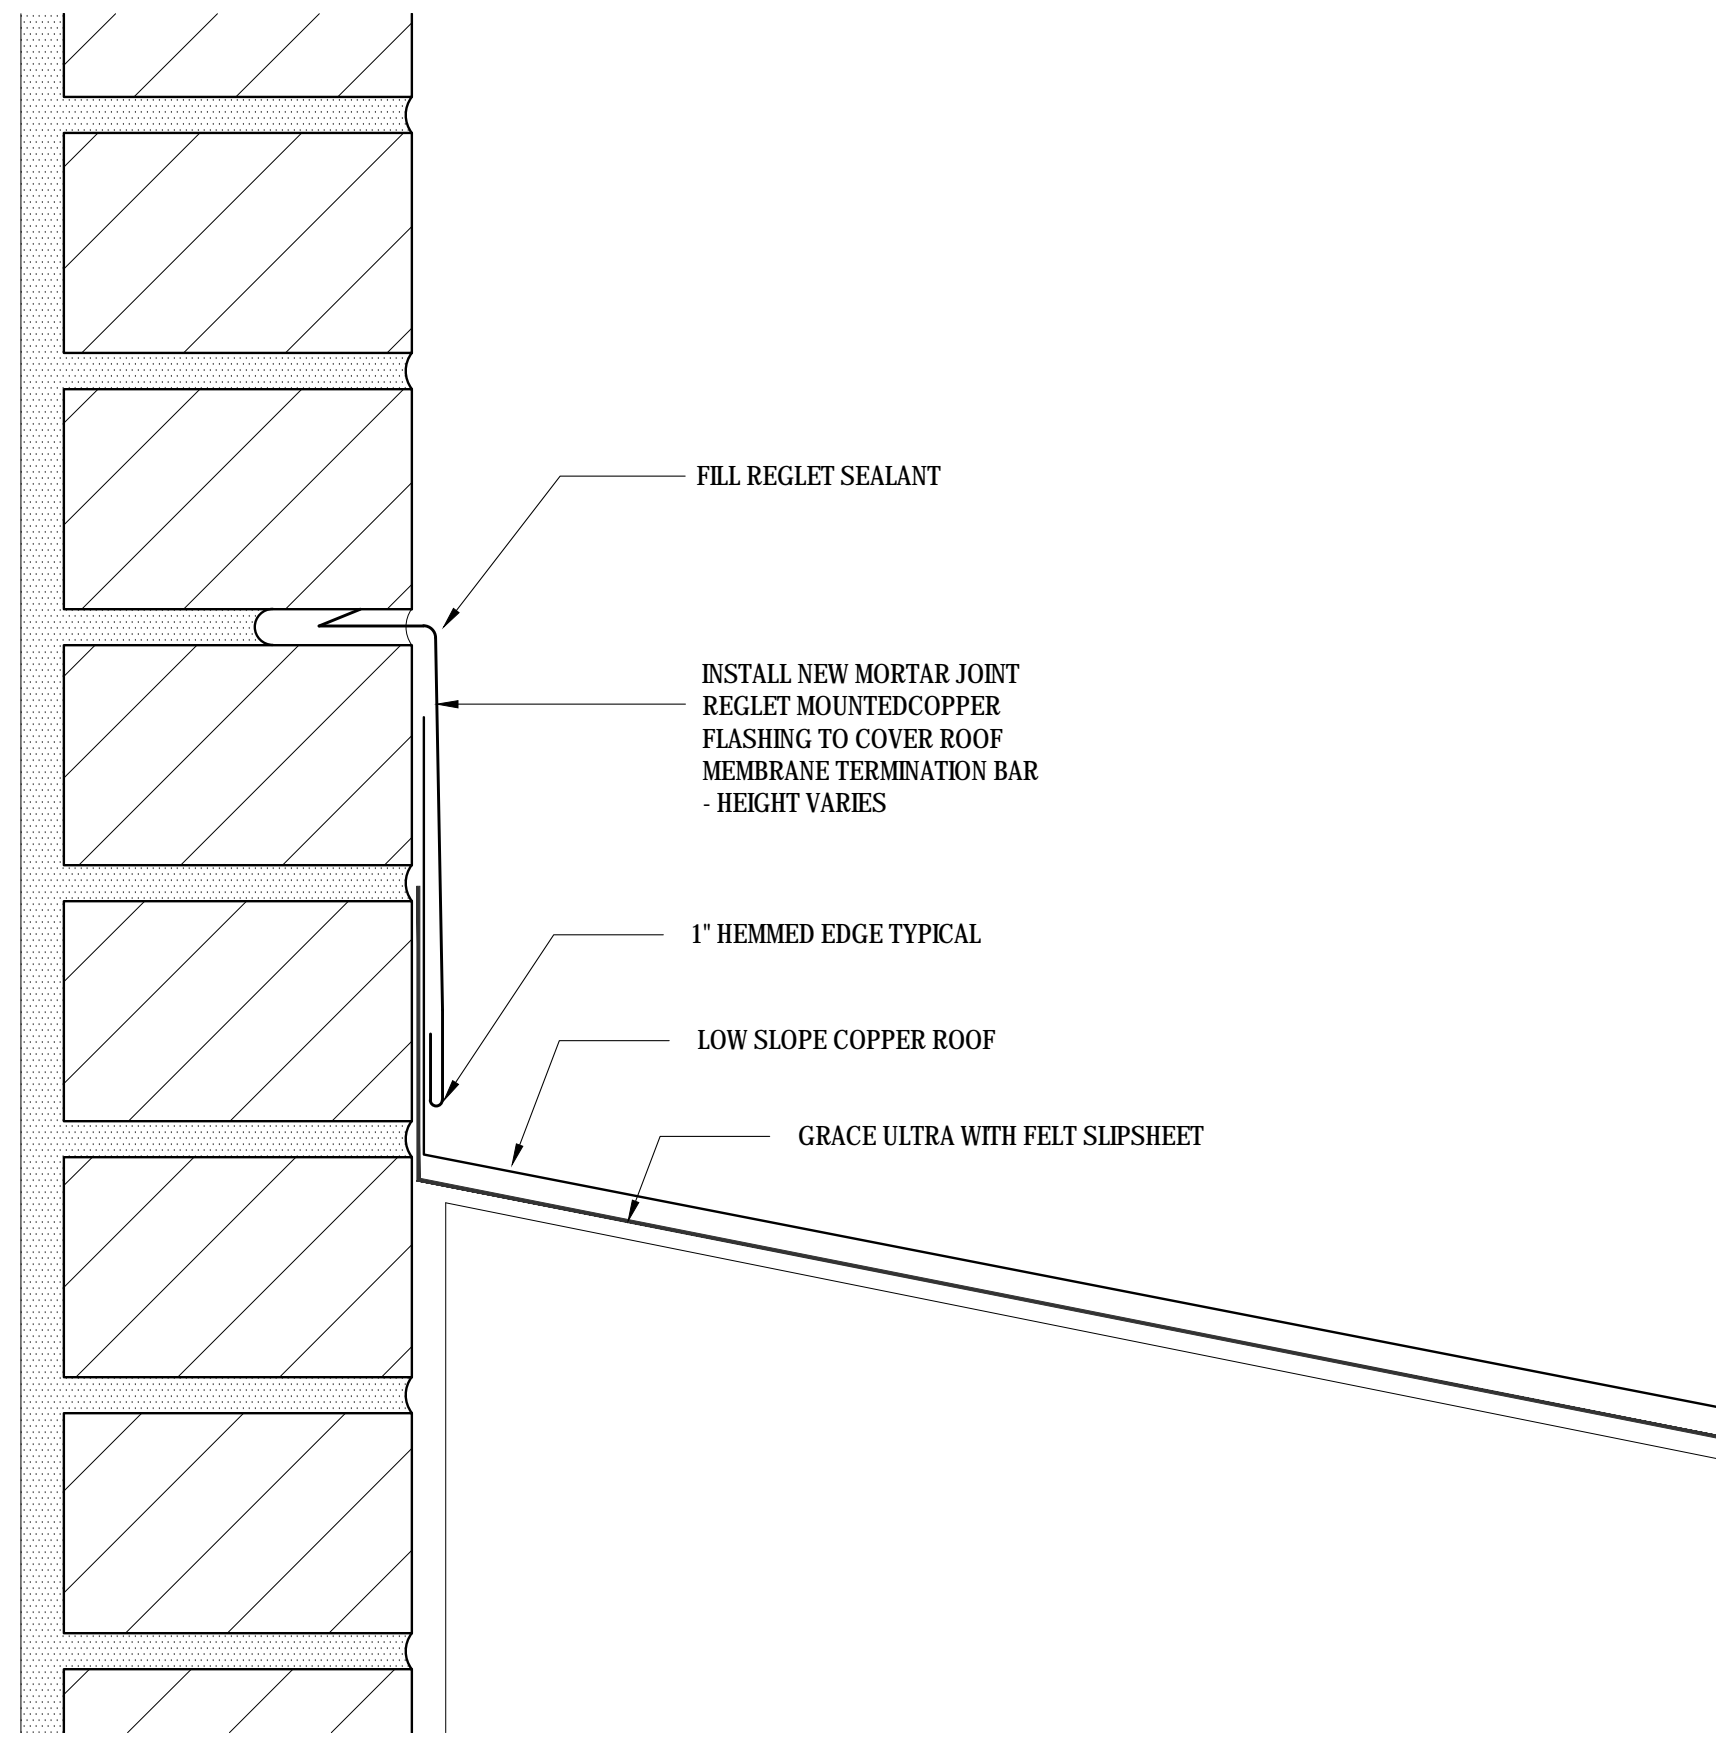
3 LOW ROOF TO BRICK FLASHING
THIS DETAIL IS TYPICAL FOR MOST AT MASONRY WALL FLASHING DETAILS

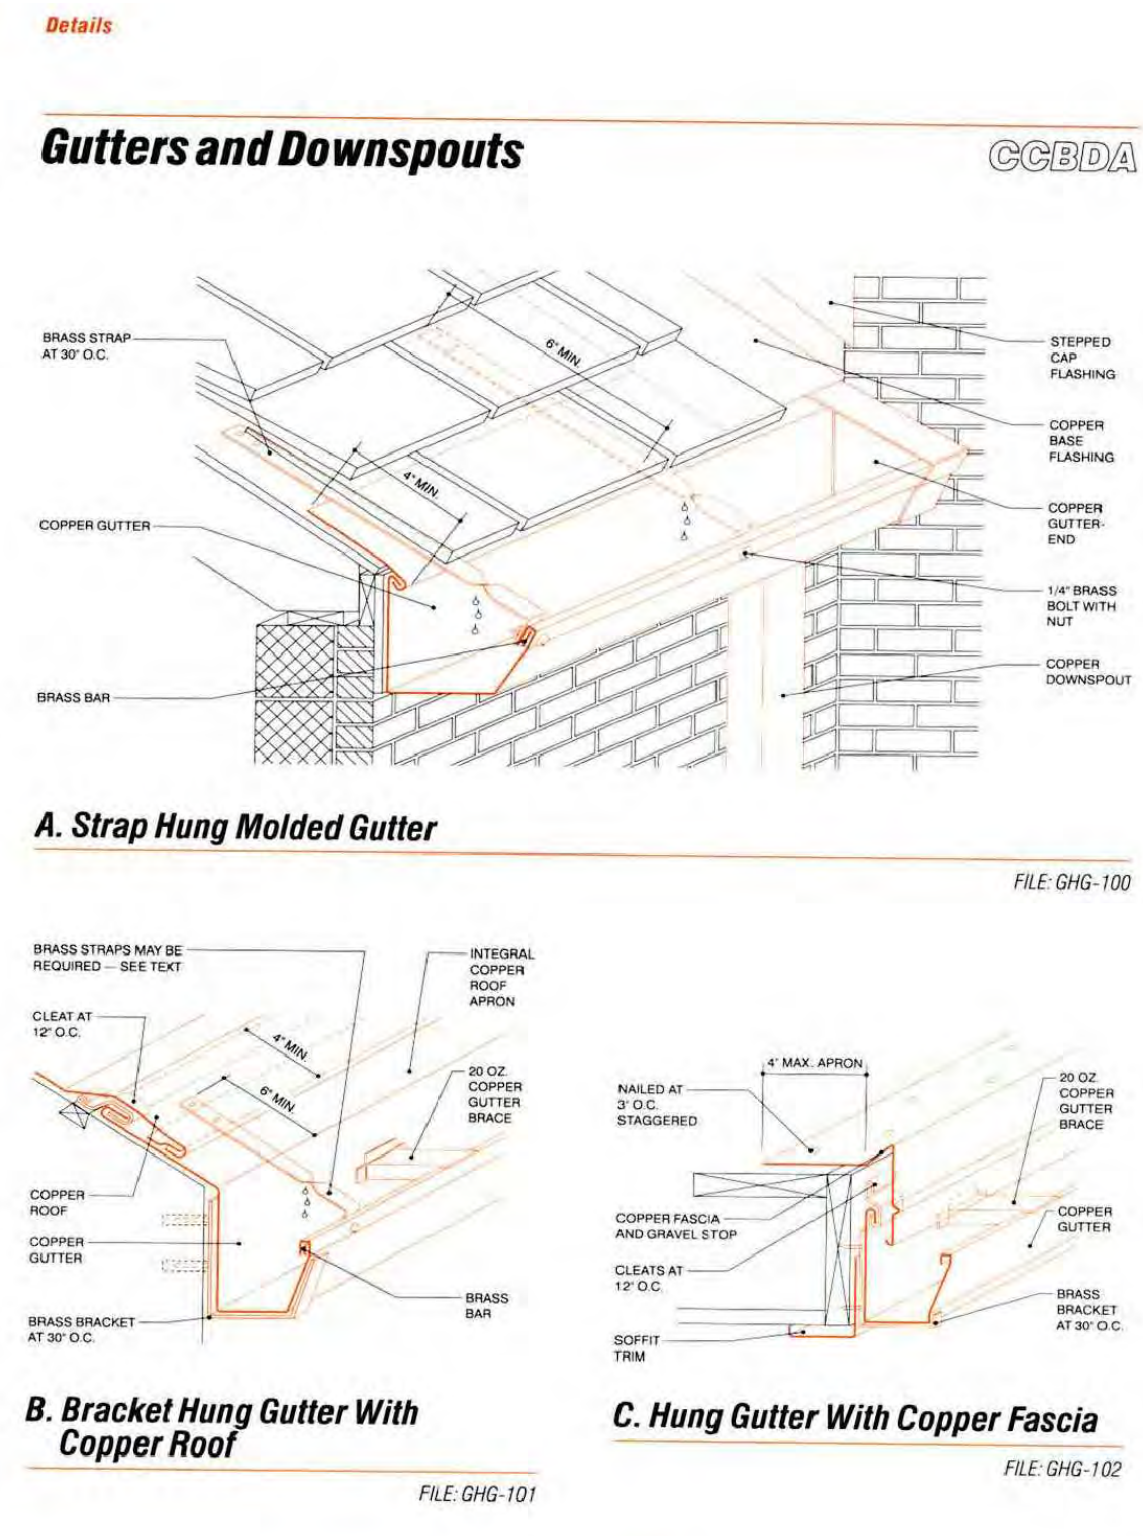
3 GUTTER DETAILS AT SLATE ROOF

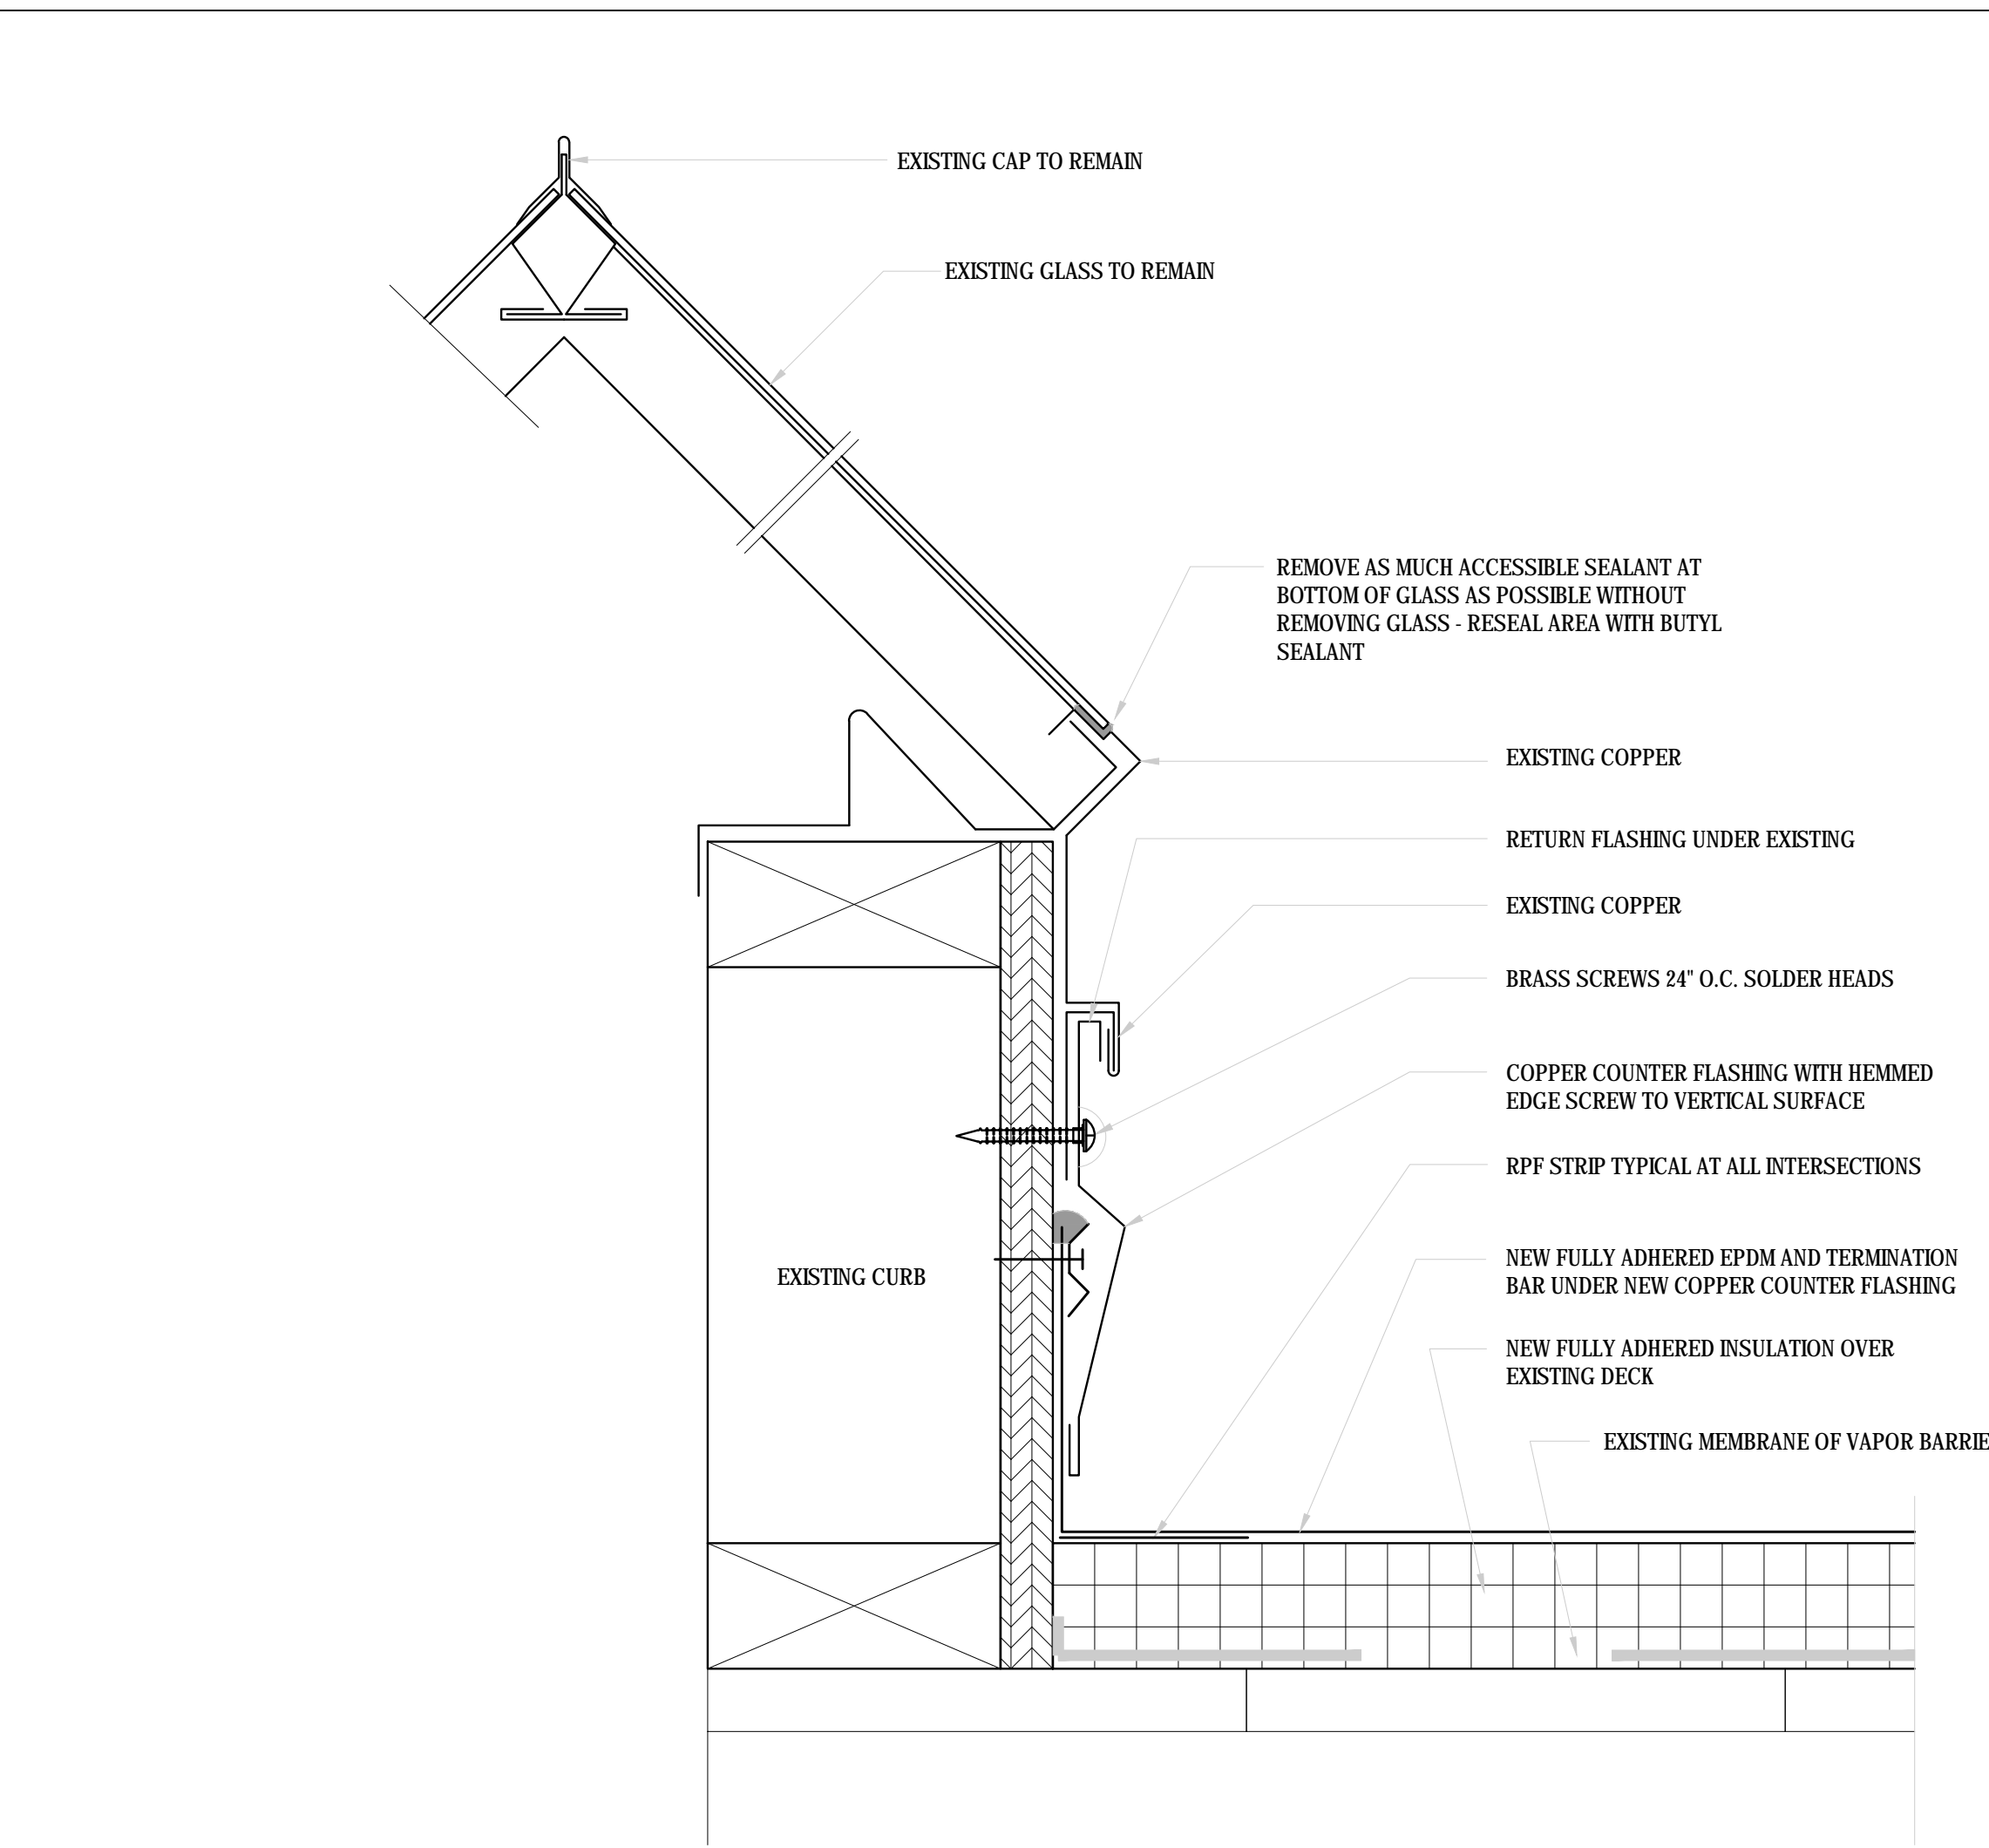
2 FLASHING DETAIL AT SKYLIGHT
