55 Sherman Street Retaining Wall, Portland, Maine

FIELD REPORT #1 of 2

Project #: **12-052.1** Date: **May 14, 2013**
Project Name: **55 Sherman Street Wall**
Project Location: **Portland, Maine**
Weather Conditions: **Mostly Sunny**
Contact Person(s): **Steven Grant-SRG**
Tom Williams-GC

FIELD REPORT #2 of 2

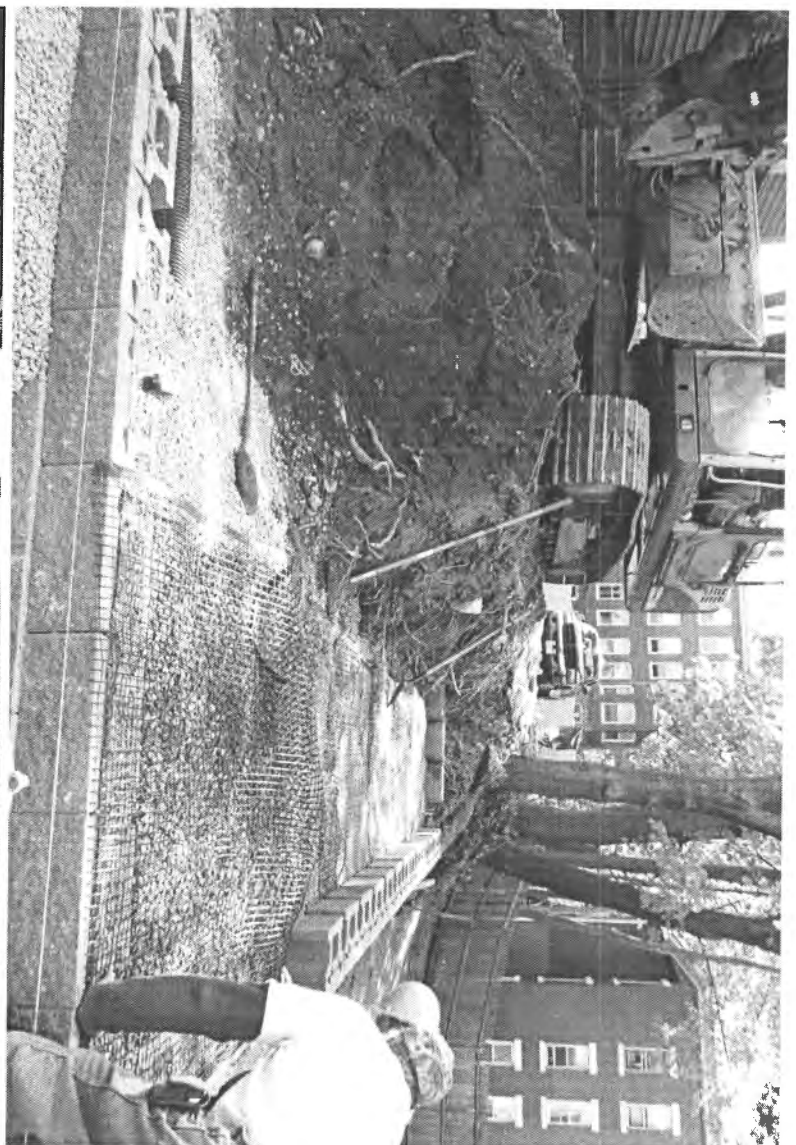
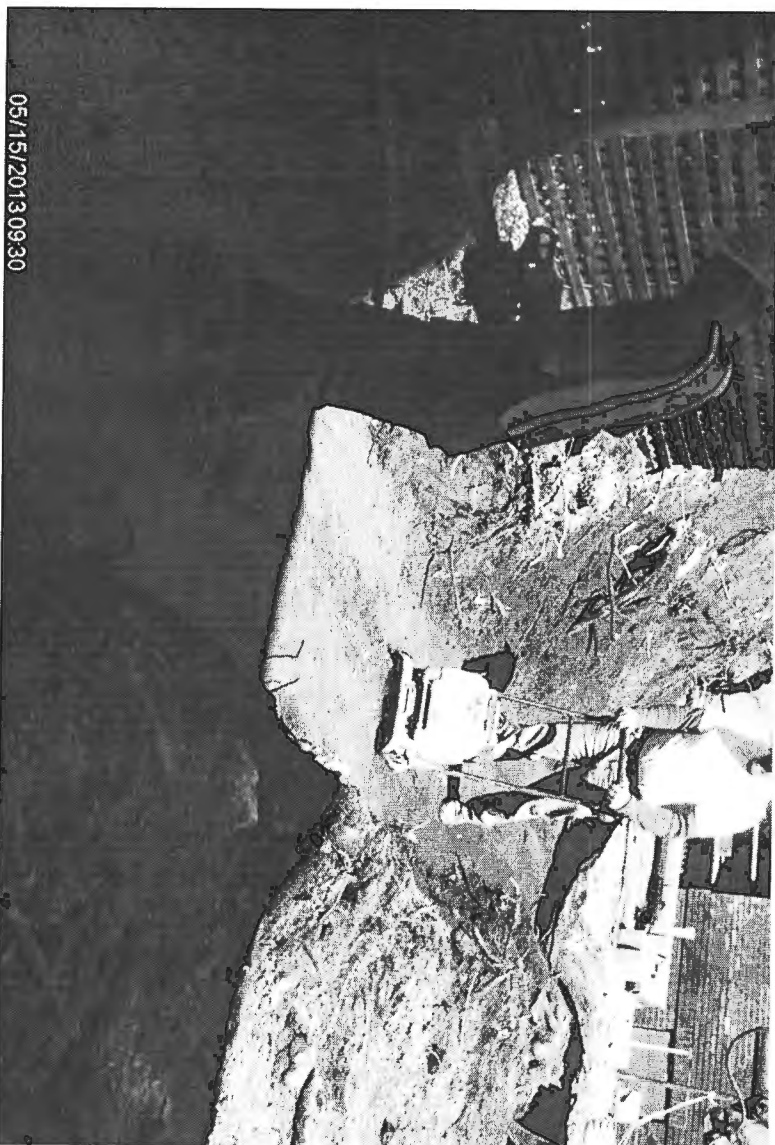
SRG#12-052.1
55 Sherman St.
15May2013
Photo Sheet 1

- A. SRG conducted an abbreviated site visit today mainly to obtain the signed contract from Tom Williams. We noted the following:
1. Contractor was on course #5.
 2. Under drain was behind the wall and had acceptable outlet locations.
 3. Crushed stone backfill was placed and compacted inside block cores and between block units.
 4. Two people from S.W. Cole were present performing construction observation. I believe P. Otto just arrived shortly before my arrival in order to relieve V. Terrell. They indicated construction has been going good.
 5. SRG reviewed the construction of the 90 degree outside corners and find them acceptable.
 6. Two (2) photos were taken for the record. Please see attached.
