NO	ISSUE	DATE
Job Number	152181.000	
Drawn	TEAM	
Checked		
Approved	JK

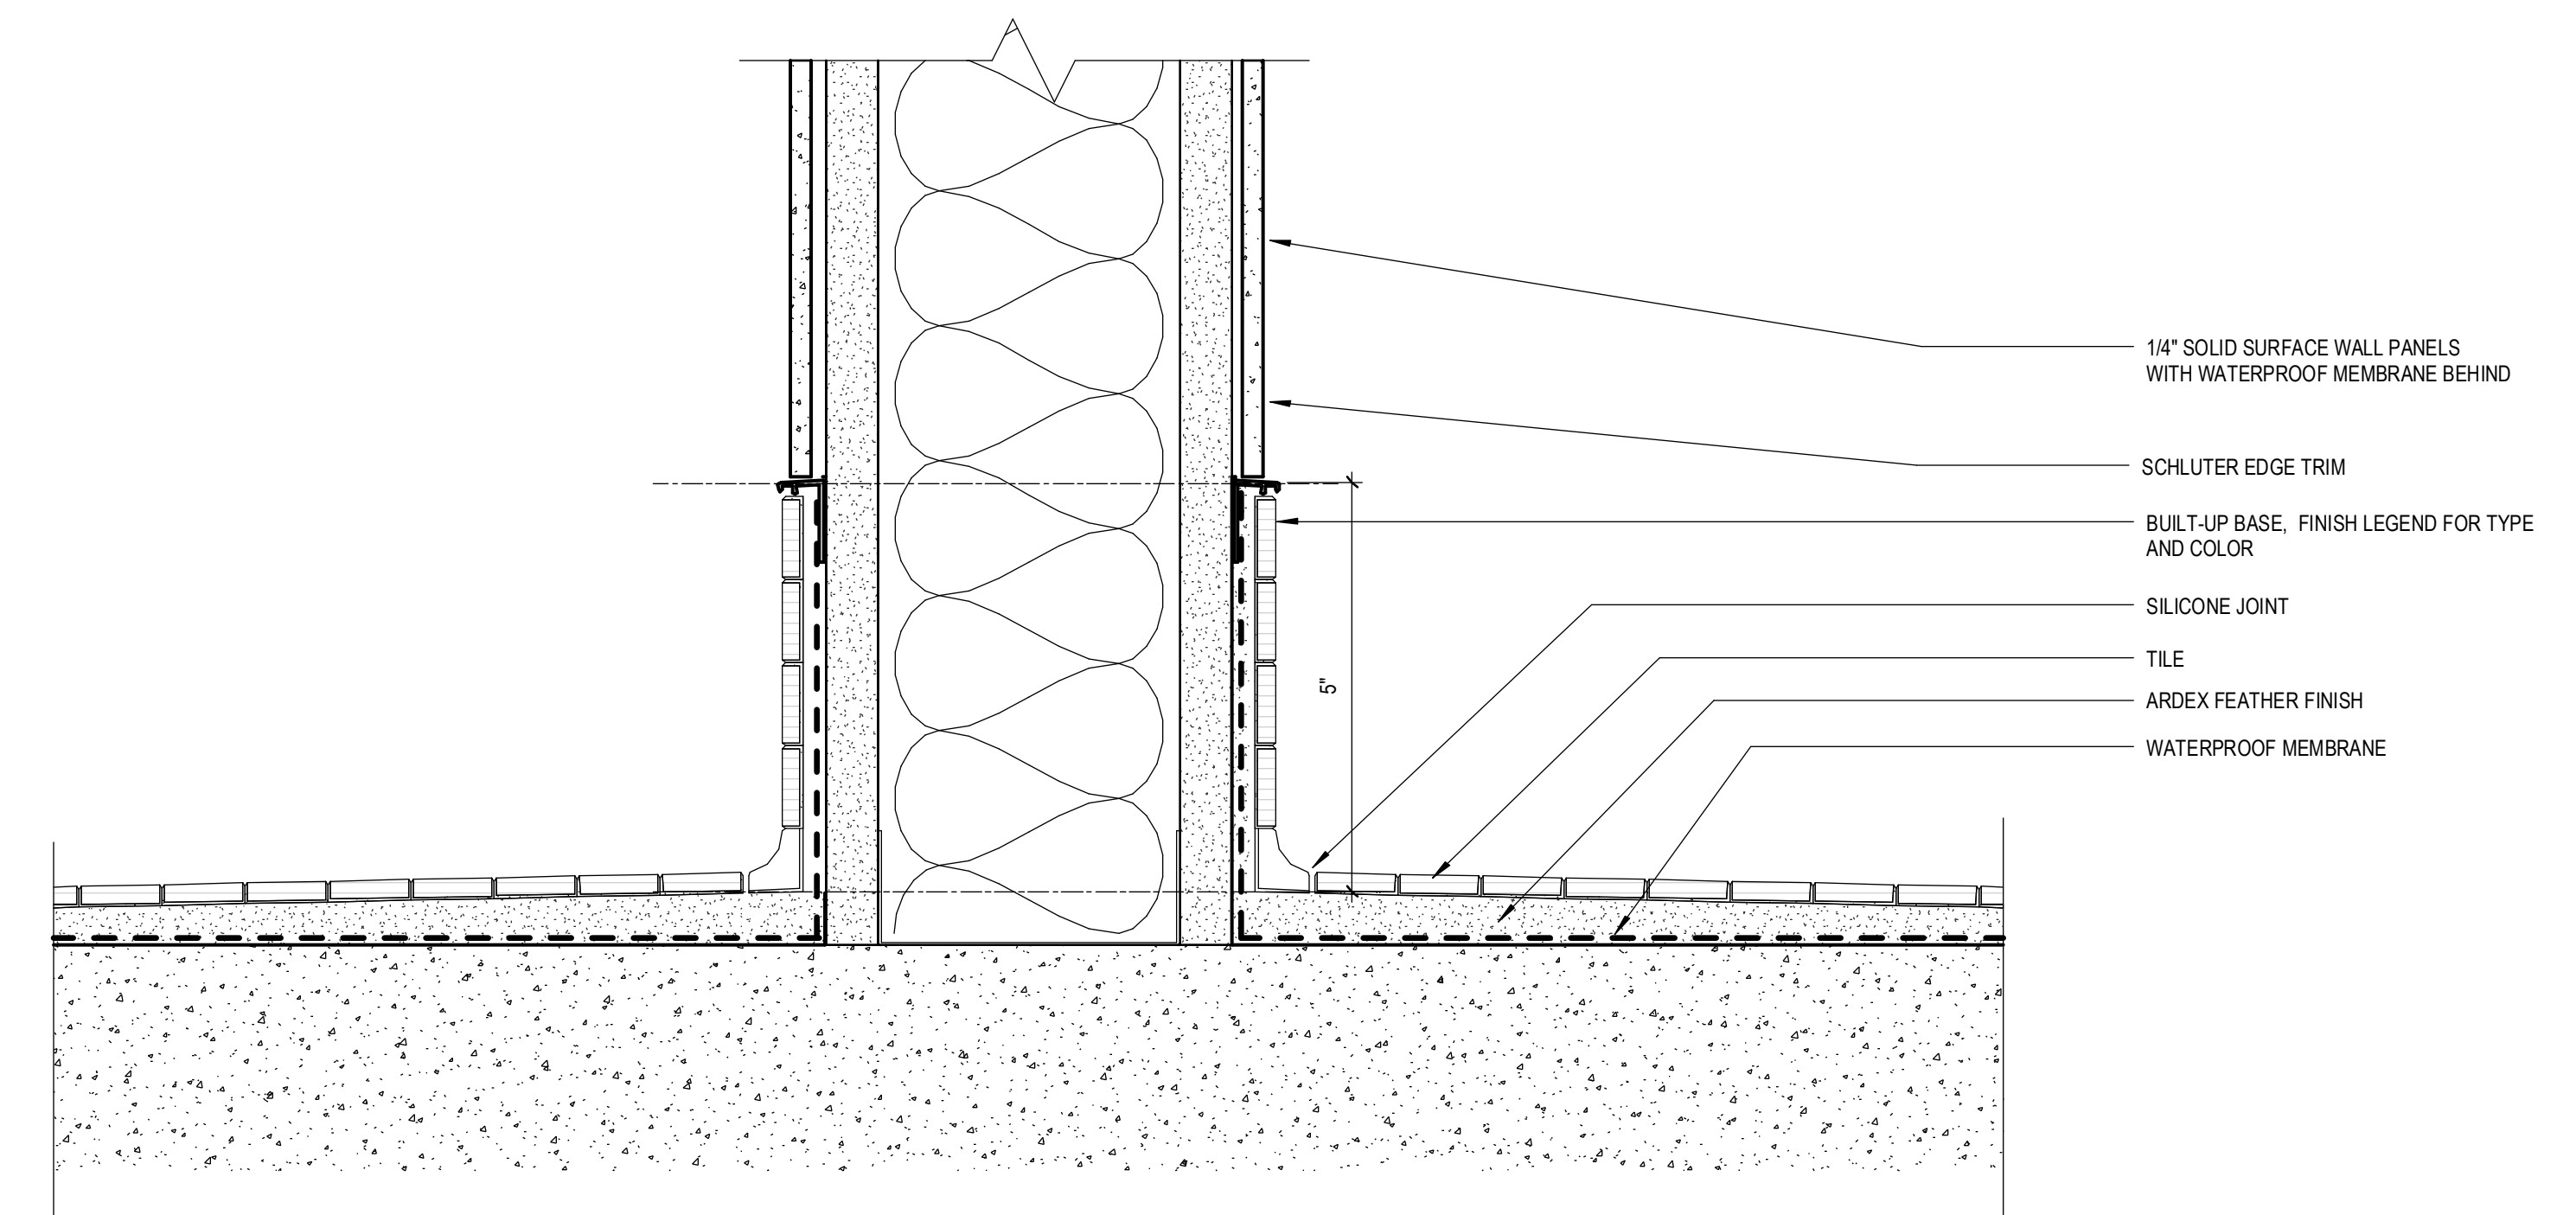
**4 TILE FLOOR TO SOLID SURFACE WALL PANEL**  
6" = 1'-0"

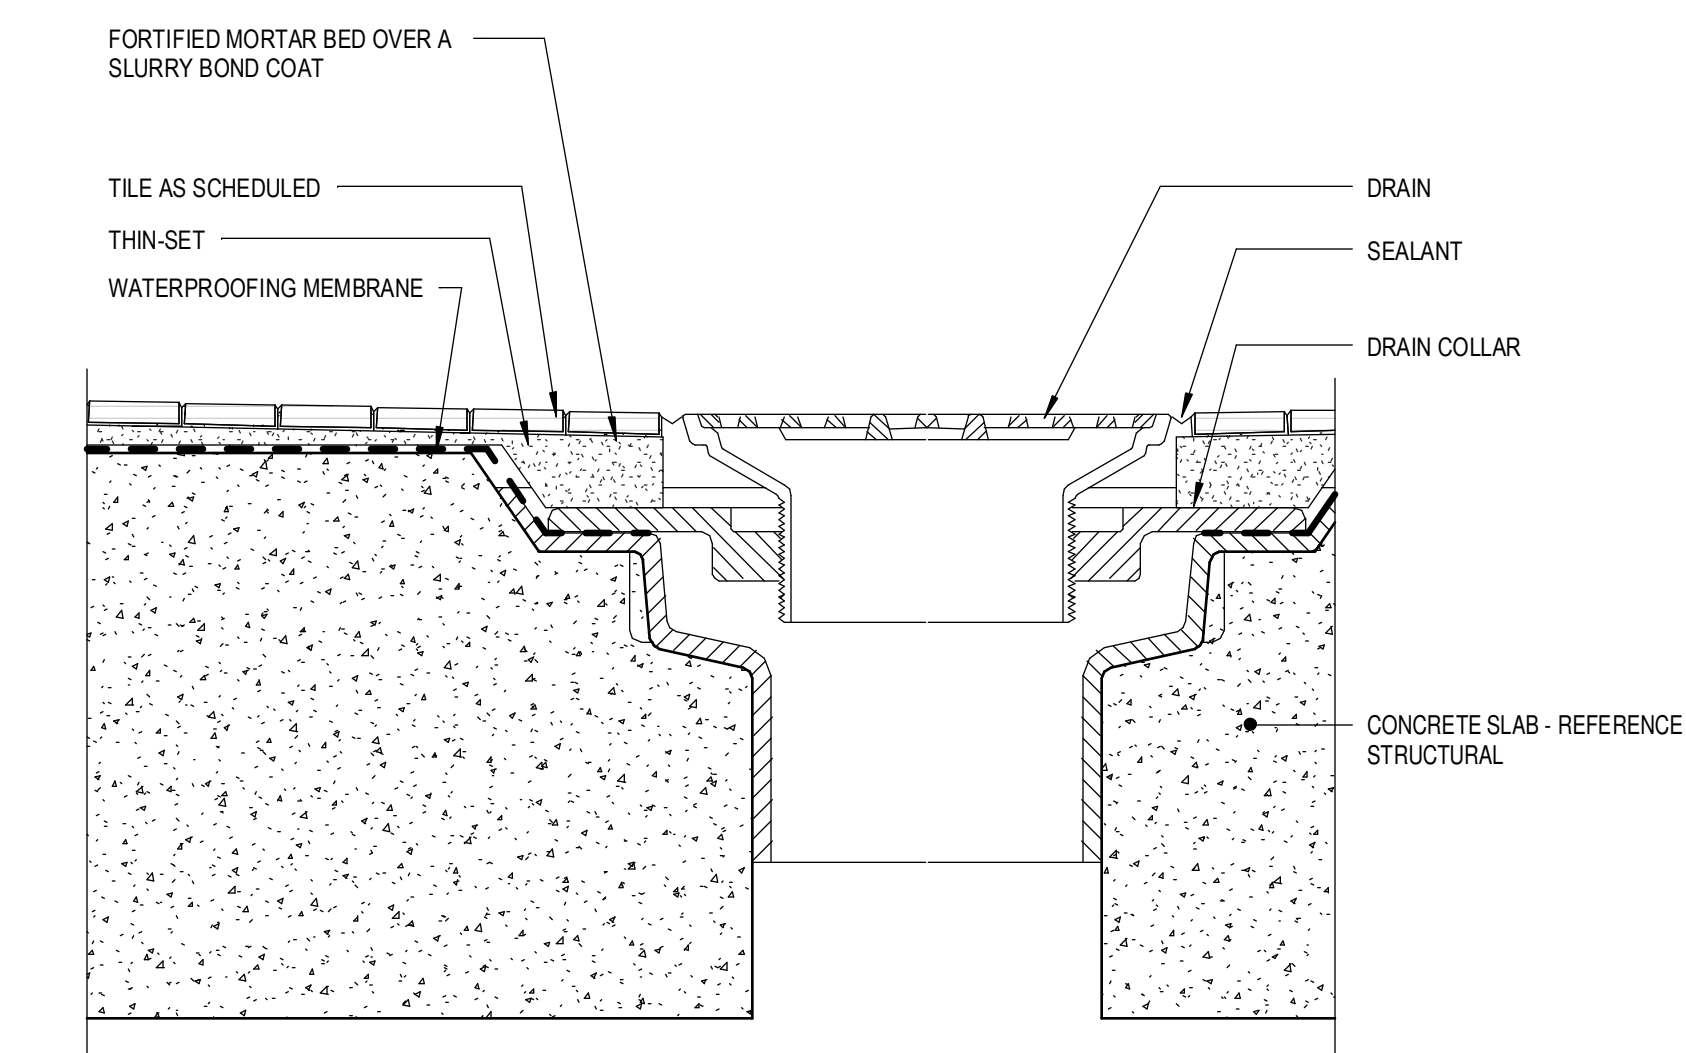
**3 DETAIL - PATIENT BATH - TYP. DRAIN**  
6" = 1'-0"

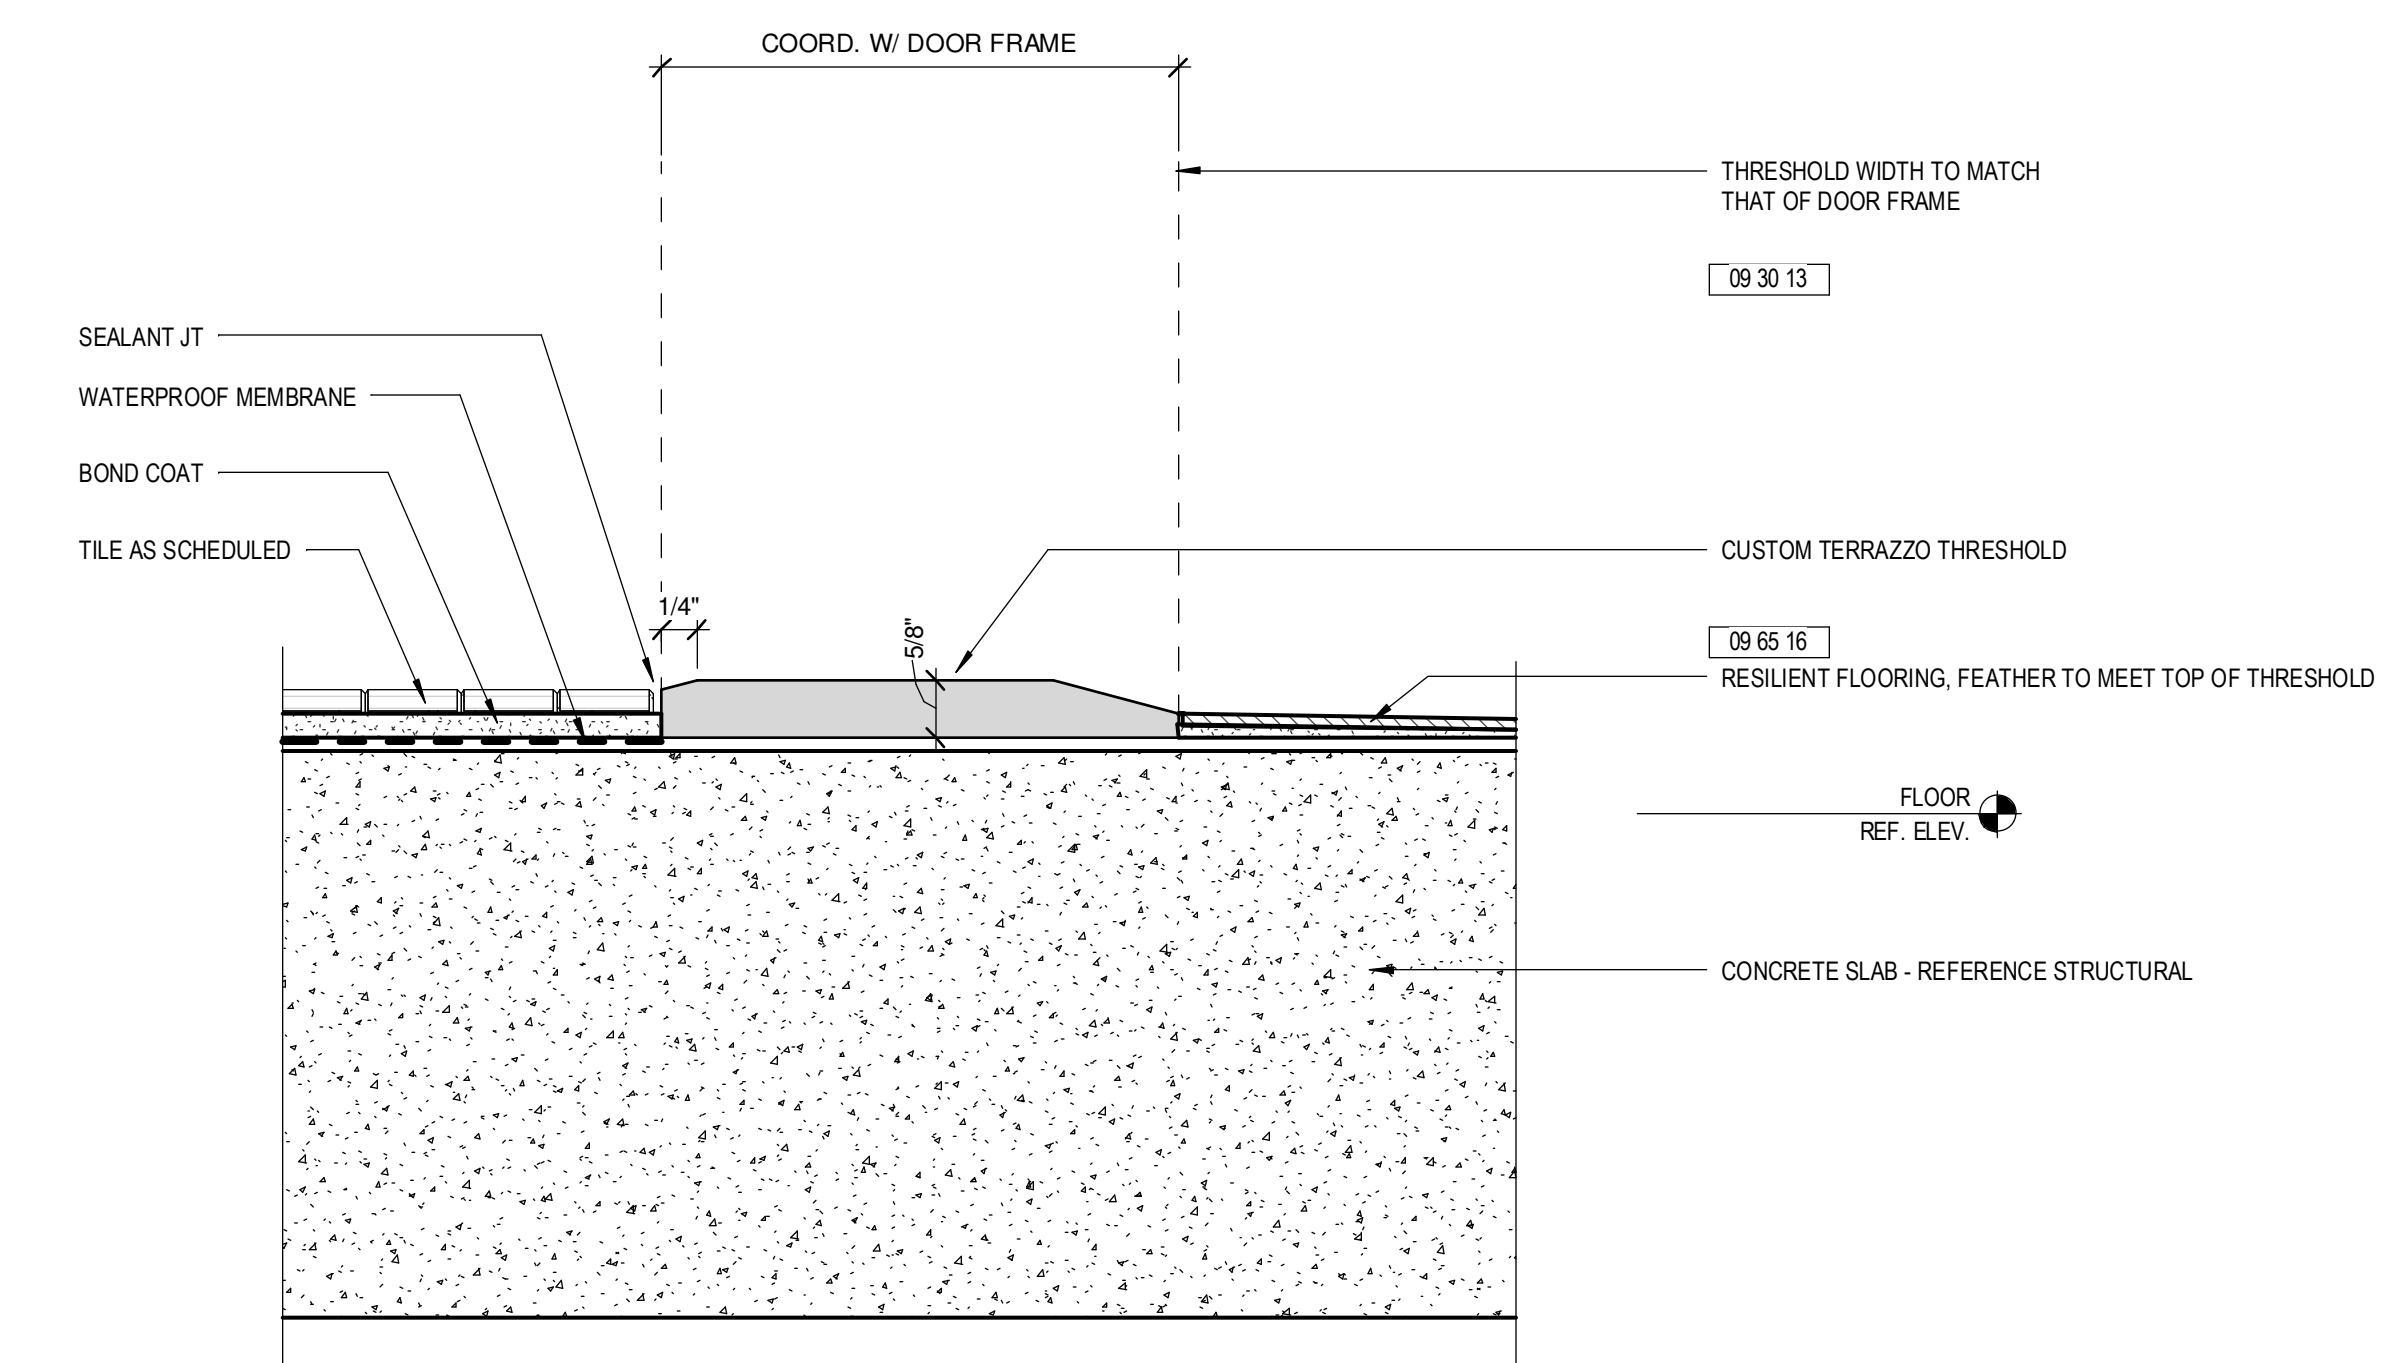
**2 DETAIL - PATIENT BATH - THRESHOLD**  
6" = 1'-0"

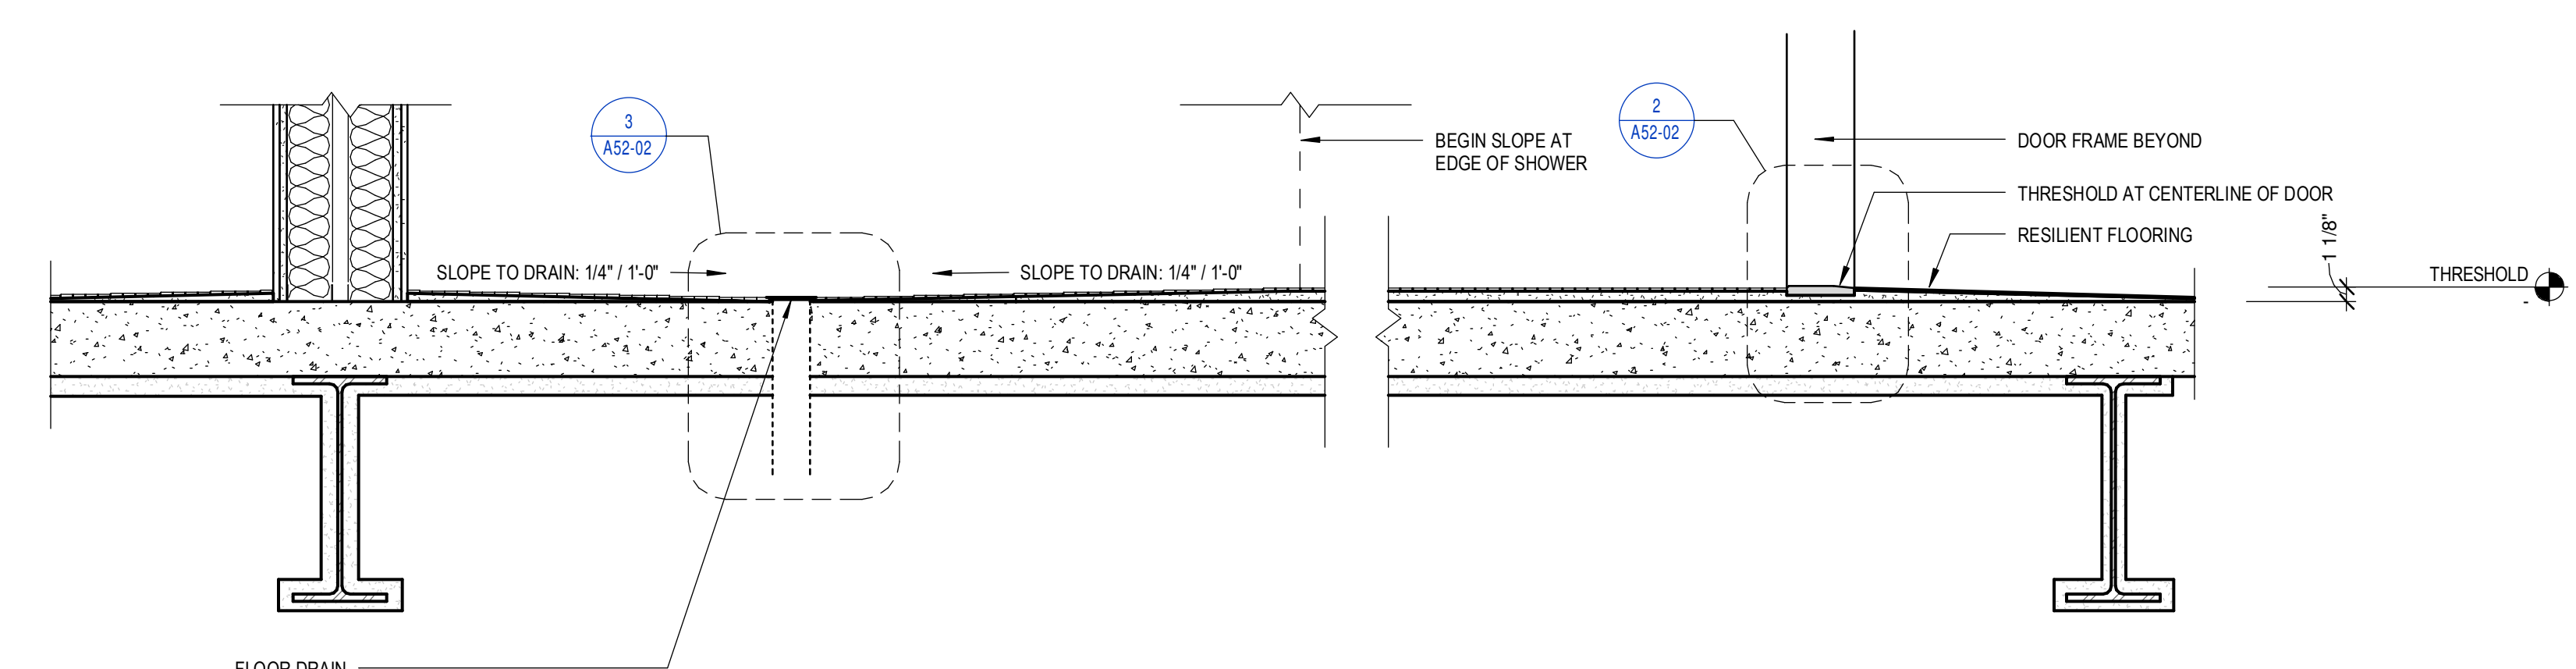
**1 FLOOR SLOPE AT PATIENT BATHROOM**  
1" = 1'-0"

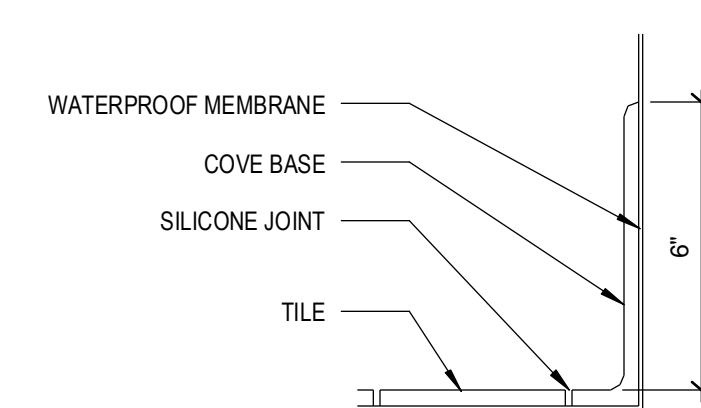
**6 TILE BASE AT VISITORS TOILET ROOMS**  
3" = 1'-0"

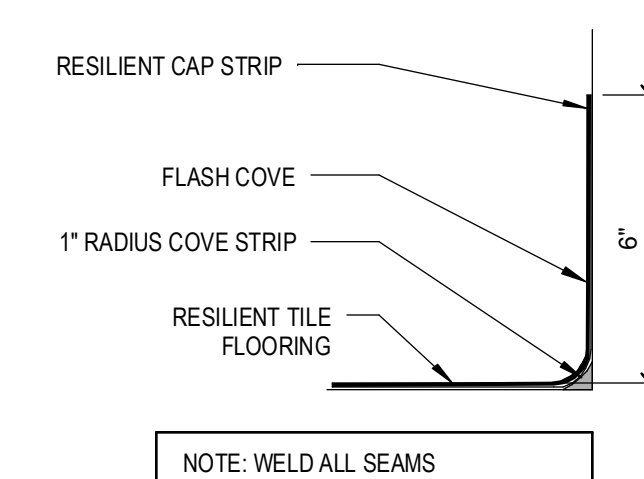
**5 RESILIENT FLASH COVE BASE**  
3" = 1'-0"
