ALTHOLZ GARAGE

147 Pine Street
Portland, Maine

Van Dam Architecture and Design

Proposed

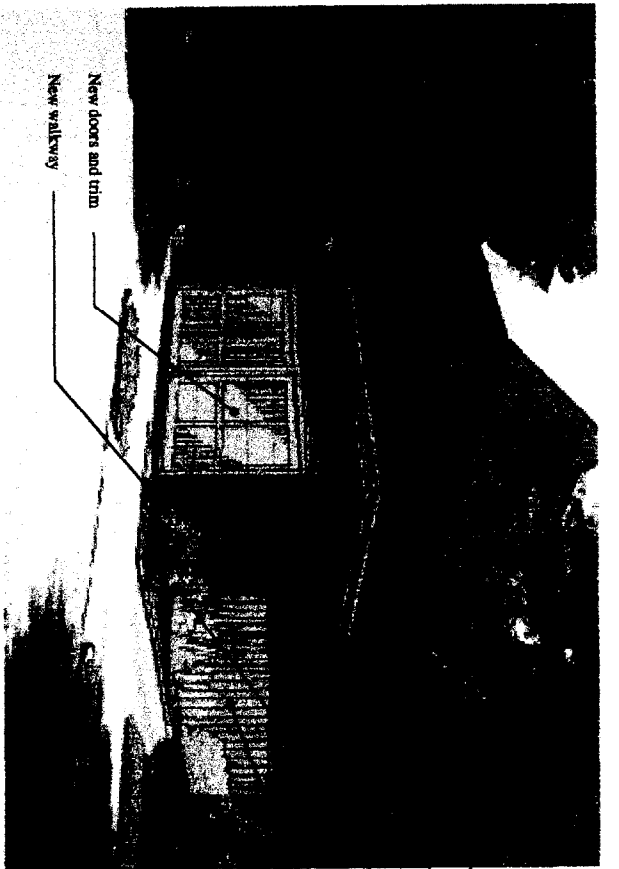
View from Neal St.

- New 2 1/2" painted pipe rail
- Red copper cap 2" @ street 4" @ deck
- New Brassco windows with obscured glass
- New fence
- New and existing plantings

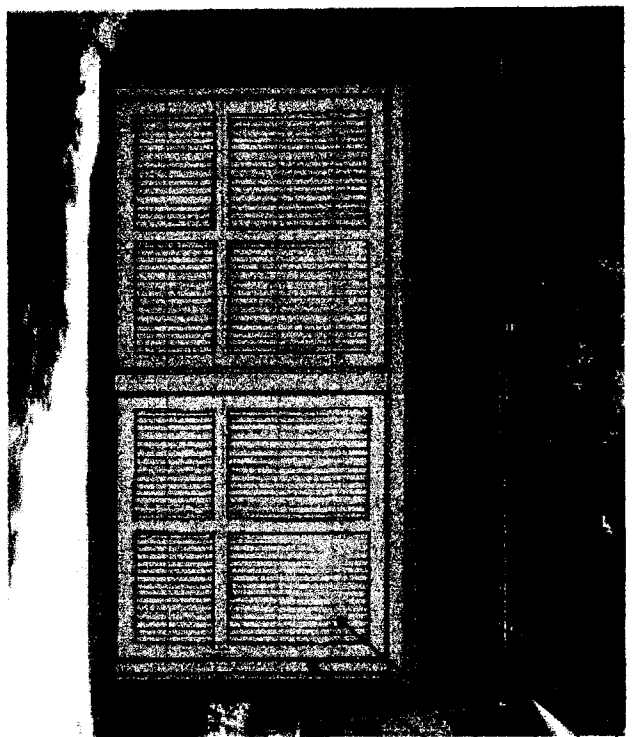
Elevation of doors

- New 2 1/2" pipe rail painted
- New red copper cap
- New head casing, final profile to be worked through w/staff
- New over head doors
- New casing

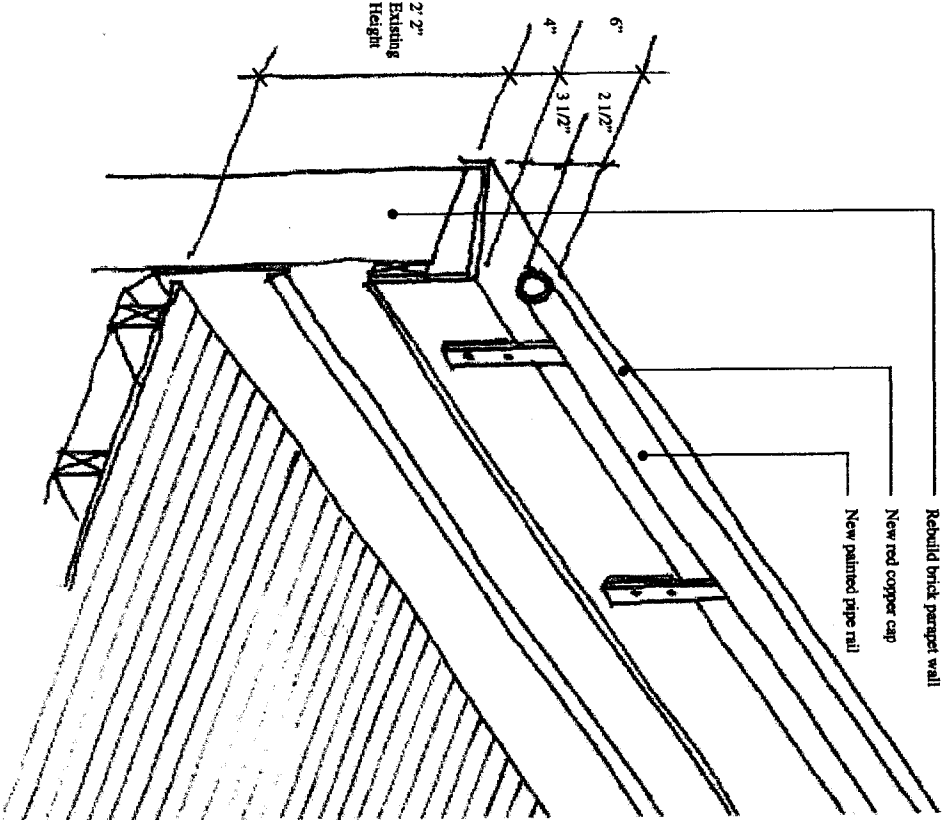
Perspective detail

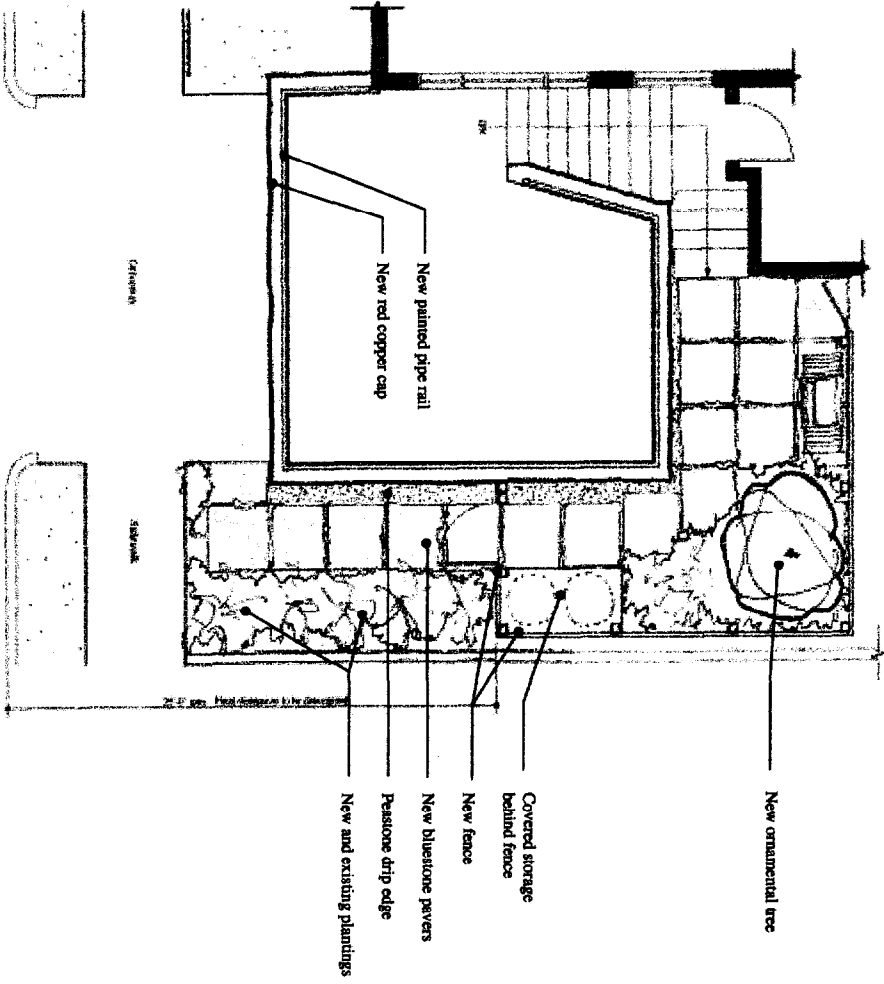
Proposed Plan
Scale: 1/4" = 1'
