COVER SHEET - PROJECT SCOPE

McEntee Addition/Reno for Kitchen: 150 Seashore Ave, Peaks Island, ME
Page 1 of 9 - 13 Feb 2012

WINKELMAN ARCHITECTURE

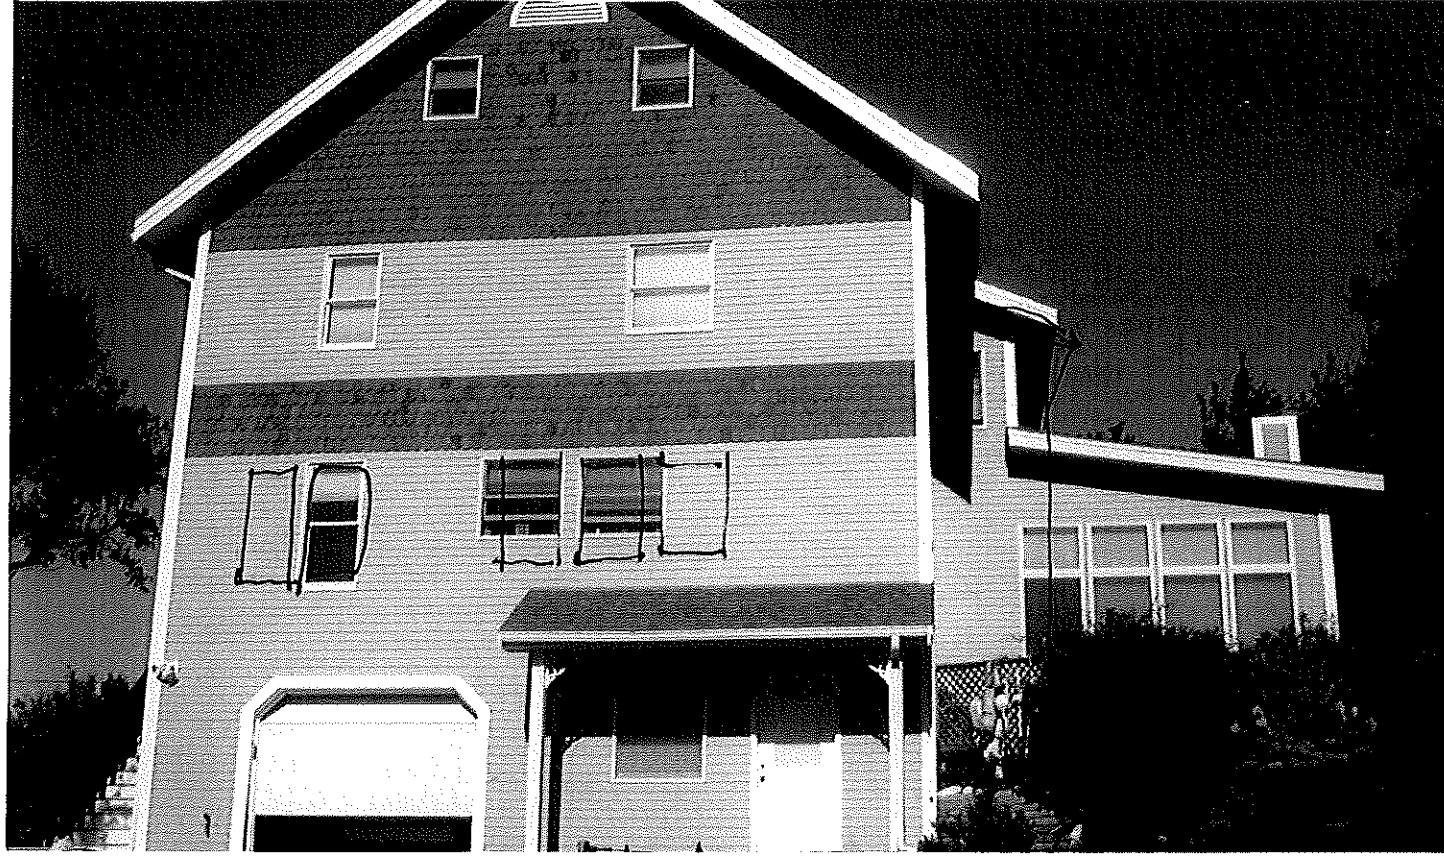
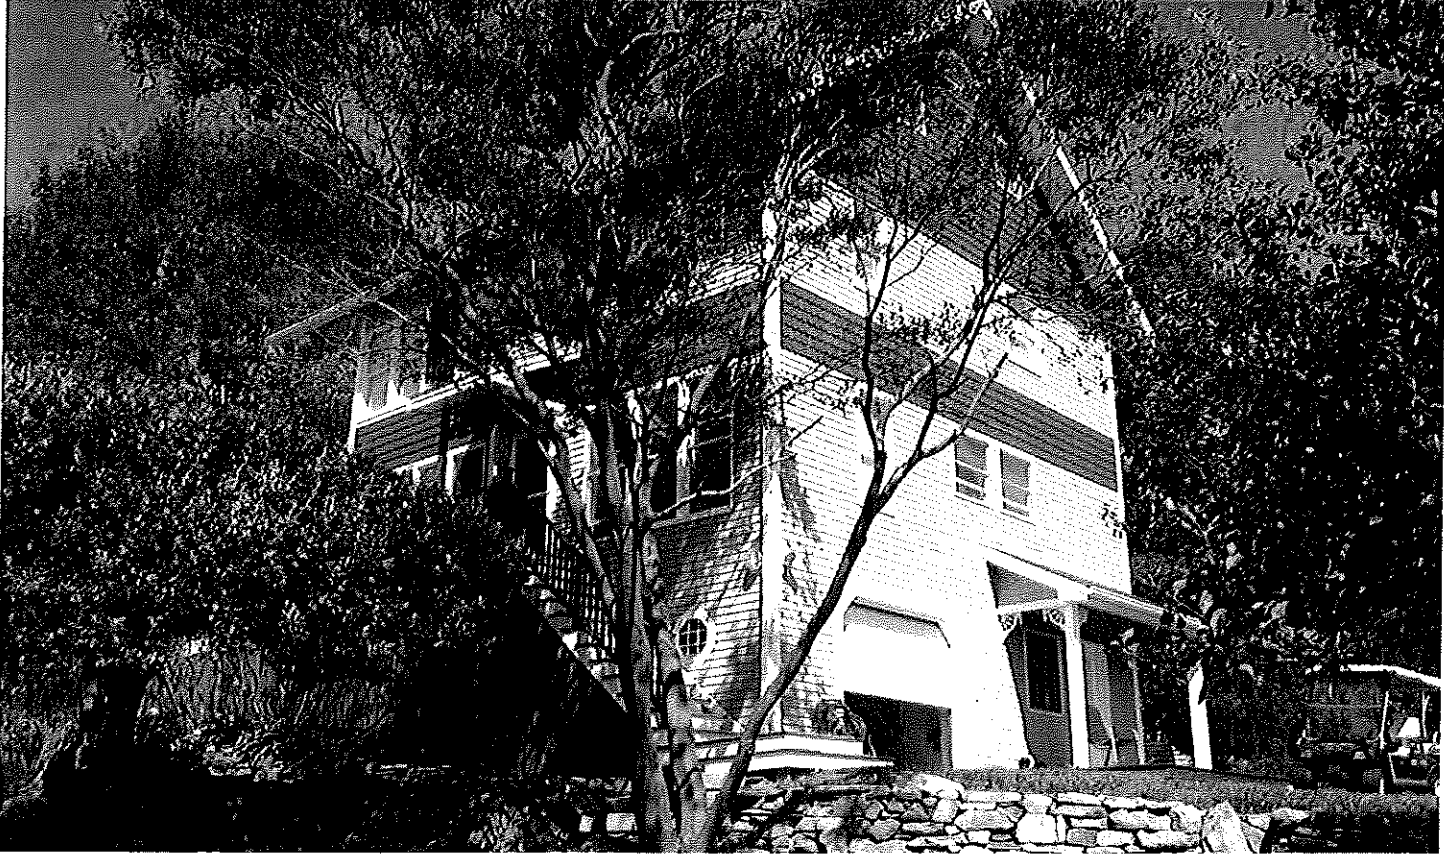
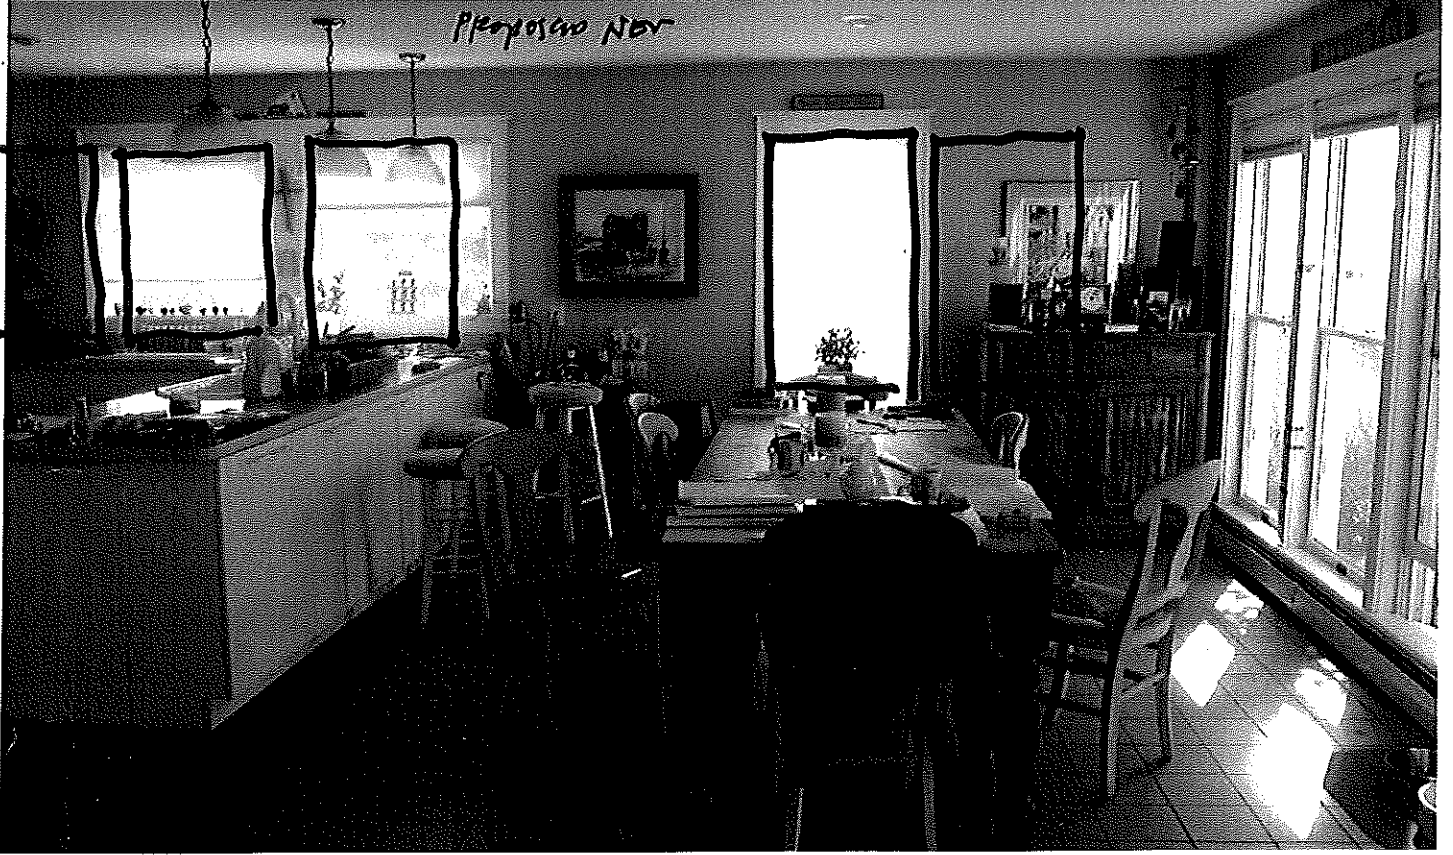
ADDITIONAL PHOTOS OF EXISTING CONDITIONS.
