Aquion Energy

Penetration, Ground Fault, Immersion, Flame Propagation, Roll-Over

TEST REPORT

MGA REPORT NO.: C12T1-192
TESTS PERFORMED ON: August 6 - 10, 2012
TEST DESCRIPTION: Penetration, Ground Fault, Immersion, Flame
Propagation, Roll-Over
ITEM DESCRIPTION*: Lithium Batteries
PROCEDURE NUMBER: TP033-04, TP030-02

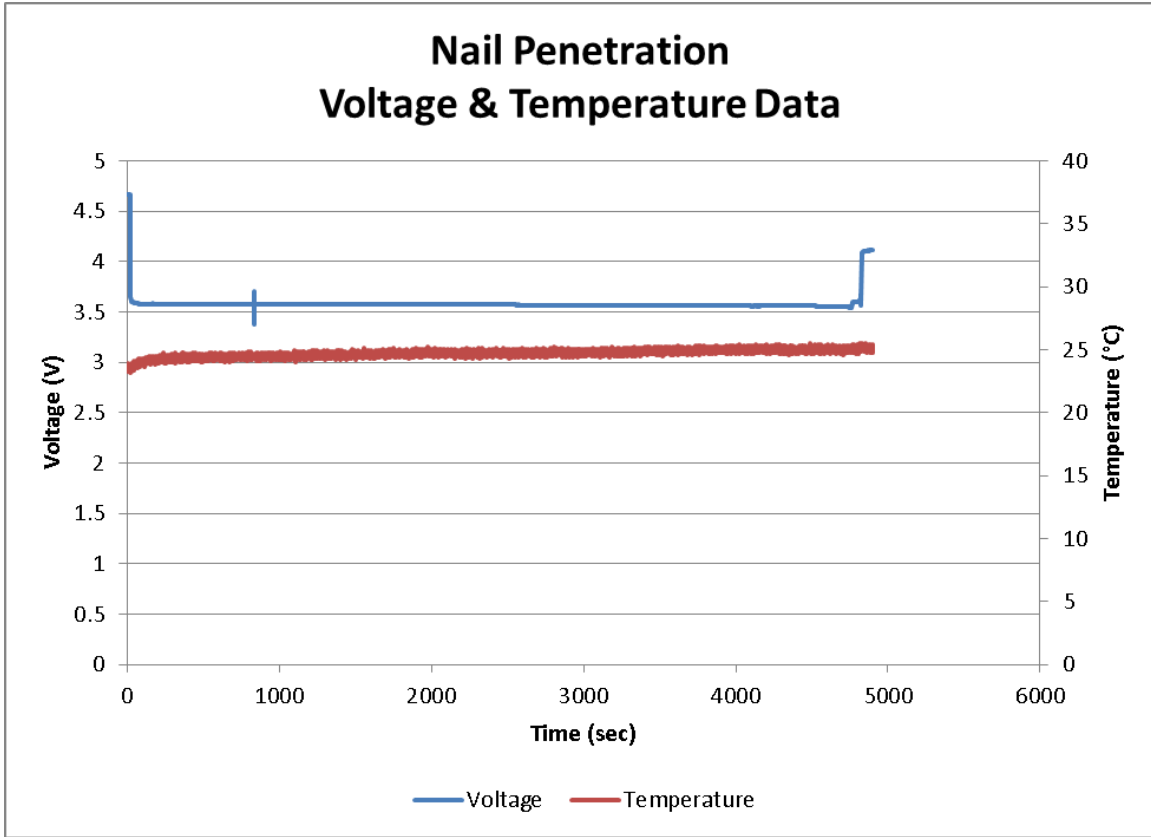
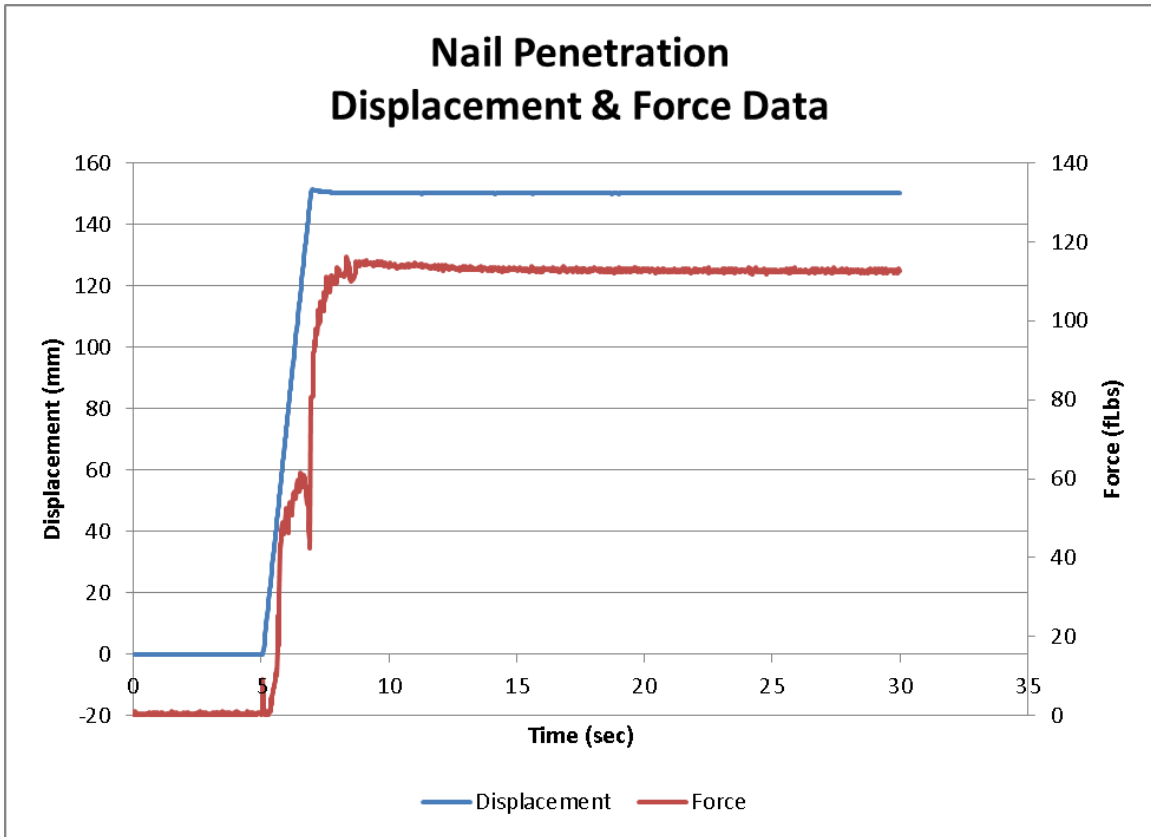
Nail Penetration

There was no visible damage as a result of the testing. The voltage did dropped slightly while penetrated. When the nail was removed, the voltage returned to normal levels.

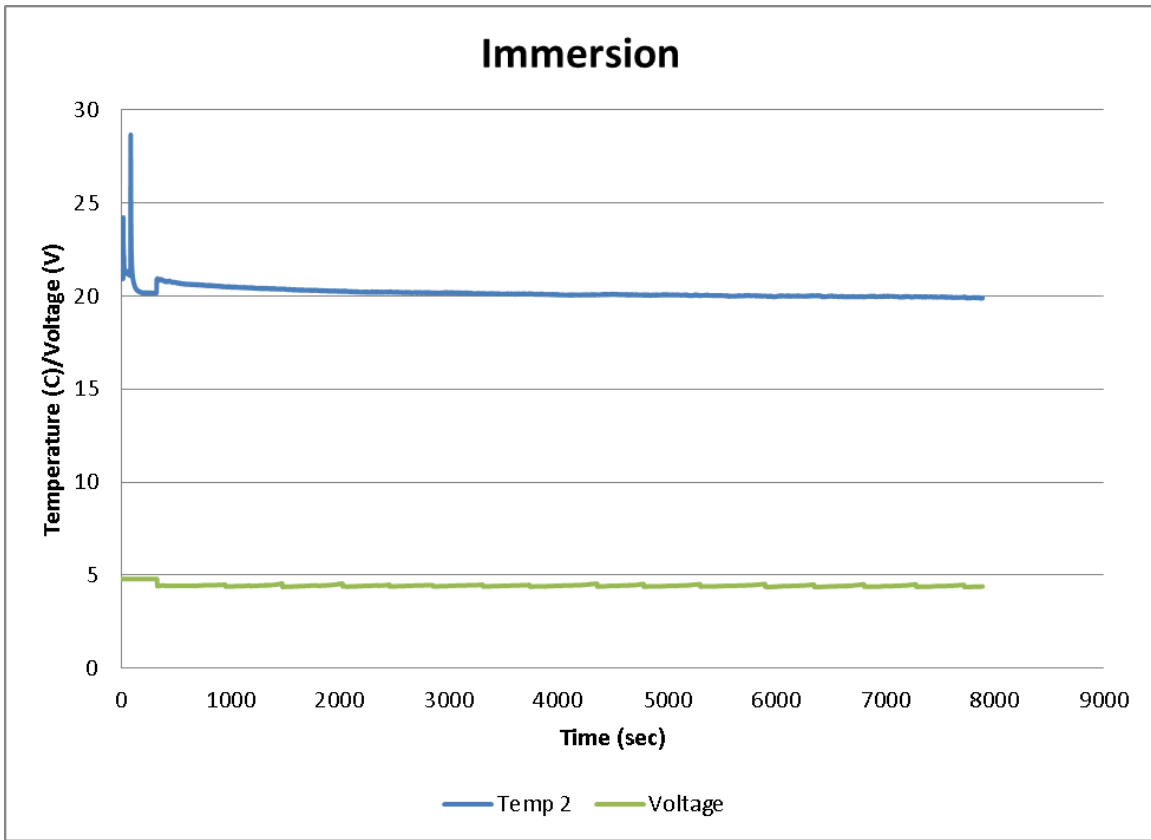
Water Immersion

There was no visible damage as a result of the test. Some discoloration was noticed in the water around the negative terminal. The battery voltage continually dropped, slightly, during testing.

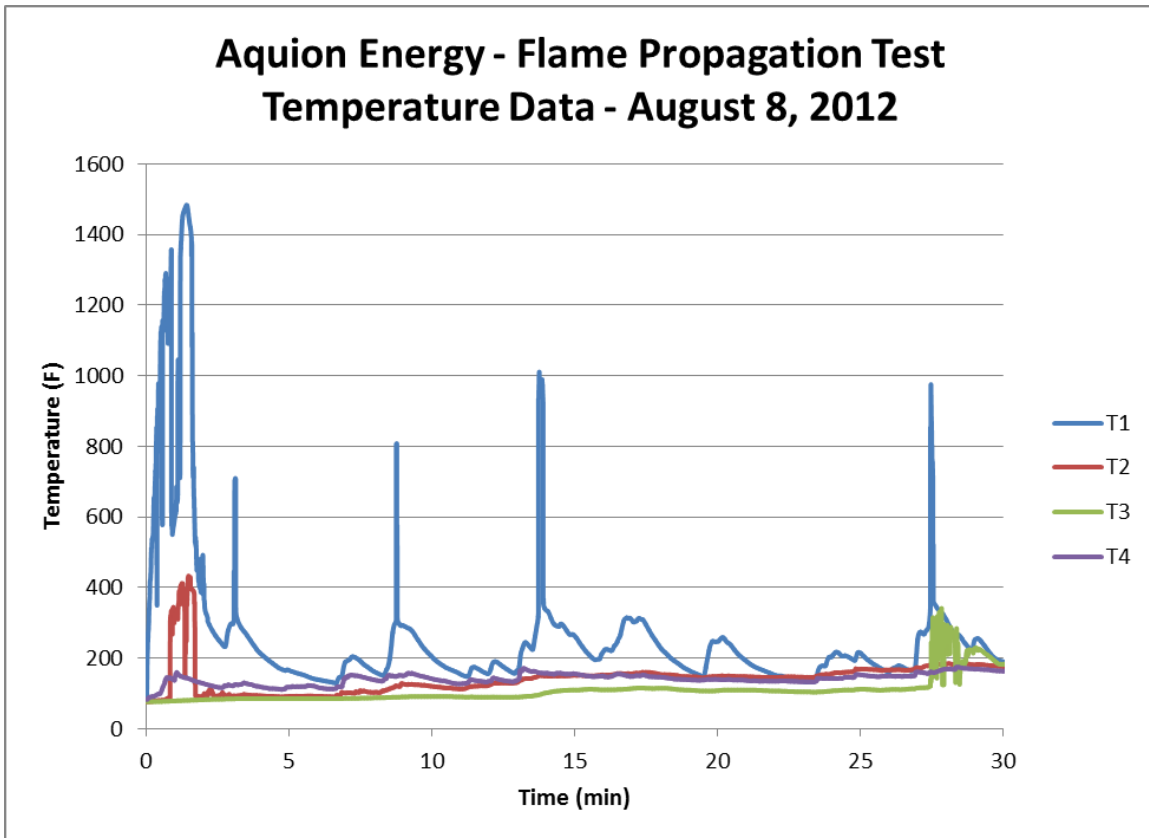
Flame Propagation

The battery did sustain melting and burn damage during the 30 minute burn period. Many of the cell cavities opened, allowing salt water to escape during testing. This appeared to happen on at least the bottom four (4) cells in the pack.

Additionally, the wiring harness sustained damage and the cells were no longer electrically connected in series. This caused a complete drop in overall pack voltage to 0.0 V, as measured across the lowest cell and highest cell terminals.

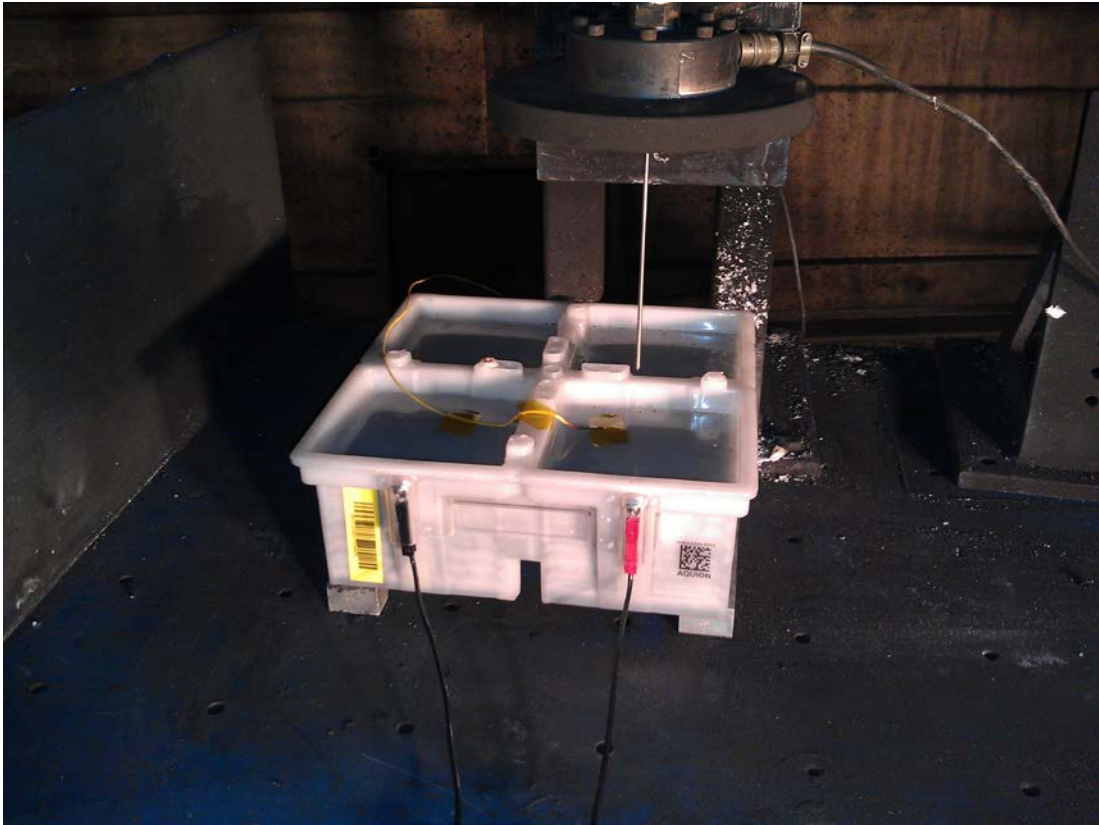
Pre Nail Penetration

One (1) single battery stack was subjected to a nail penetration in accordance with SAE J2464 4.3.3.

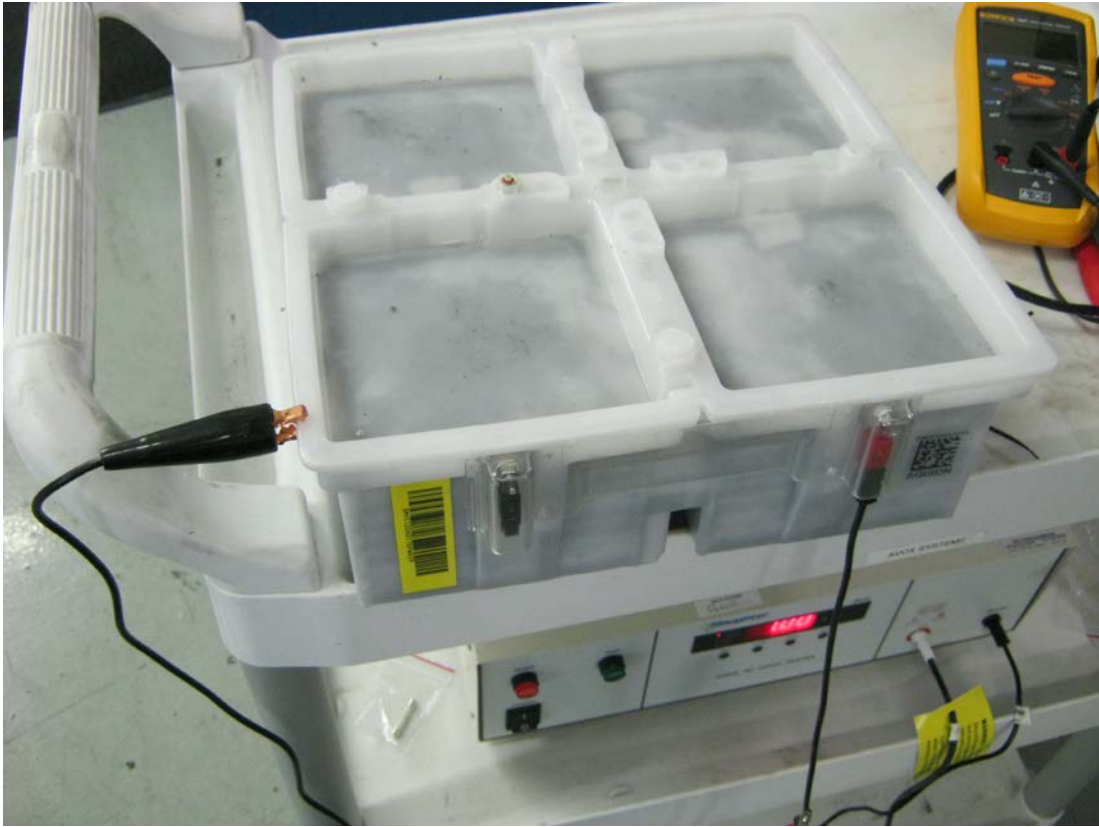
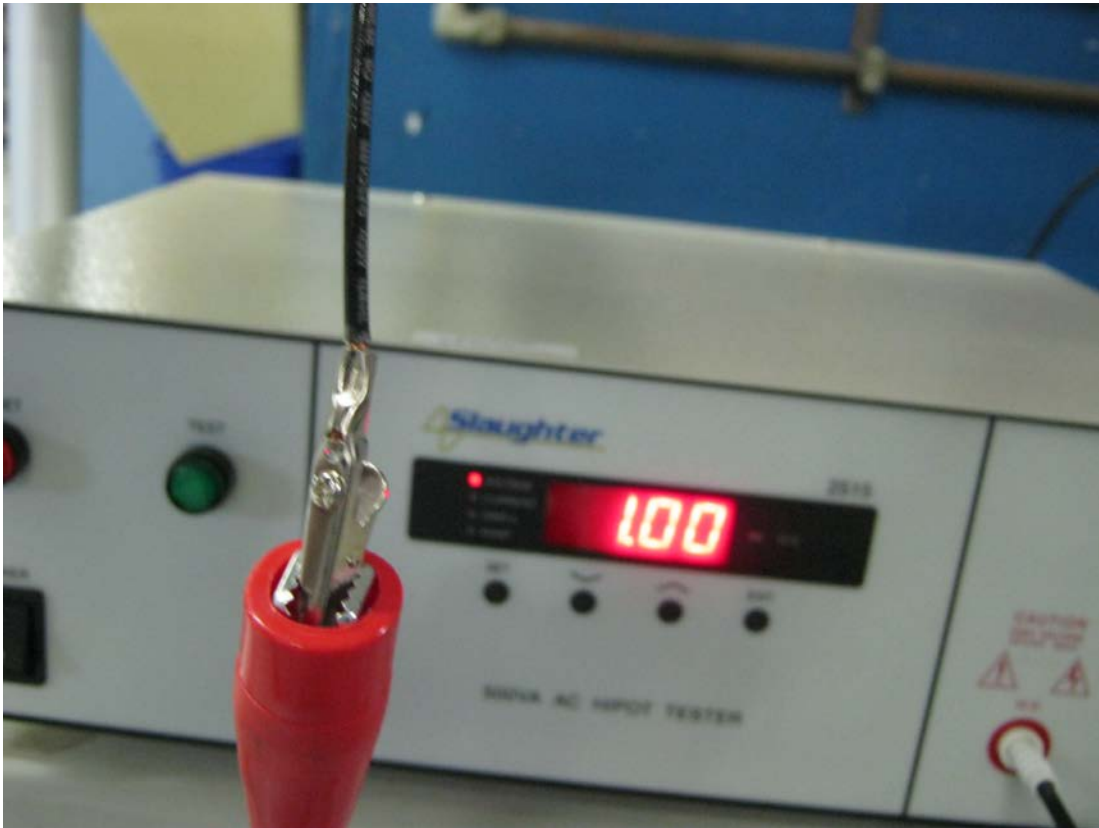
Ground Fault Isolation

Three (3) single battery stacks was subjected to a a ground fault isolation test in accordance with ASTM D149

There was no visible damage as a result of the testing.

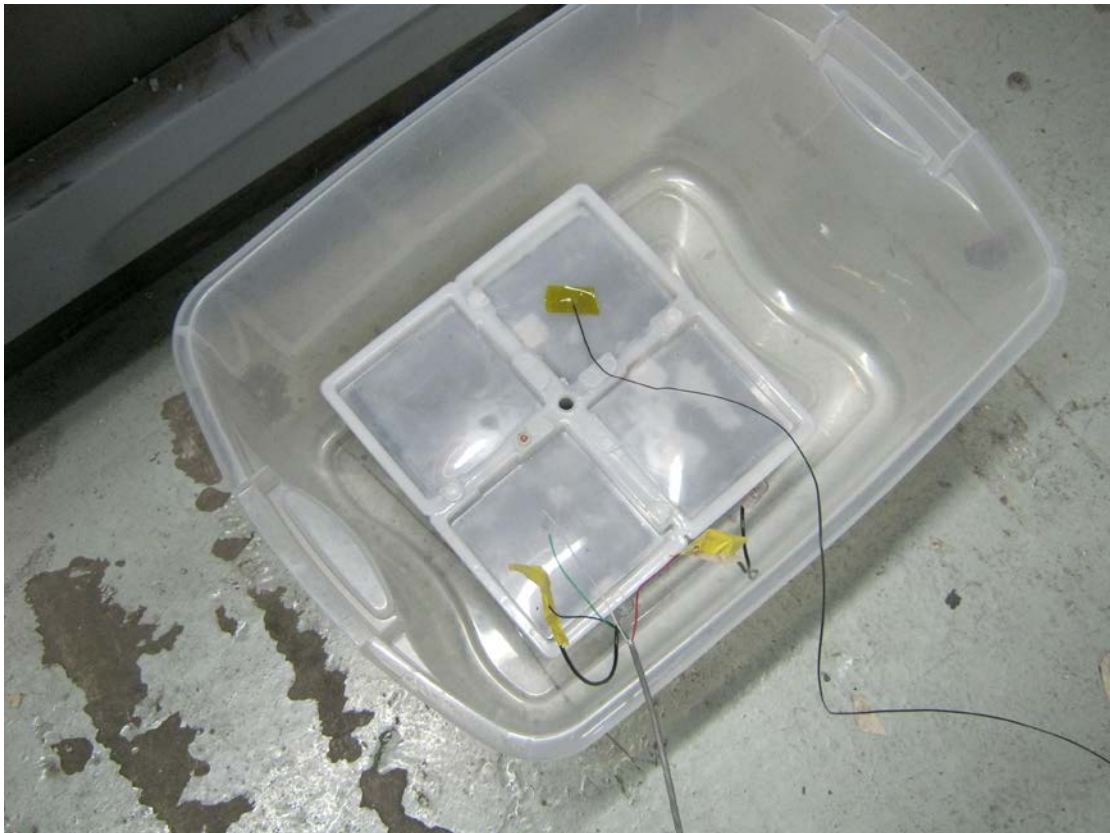
Pre Immersion

One (1) single battery stack was subjected to an immersion test in accordance with SAE J2464 4.3.5. ASTM D 1141 simulated sea water was used for this test.

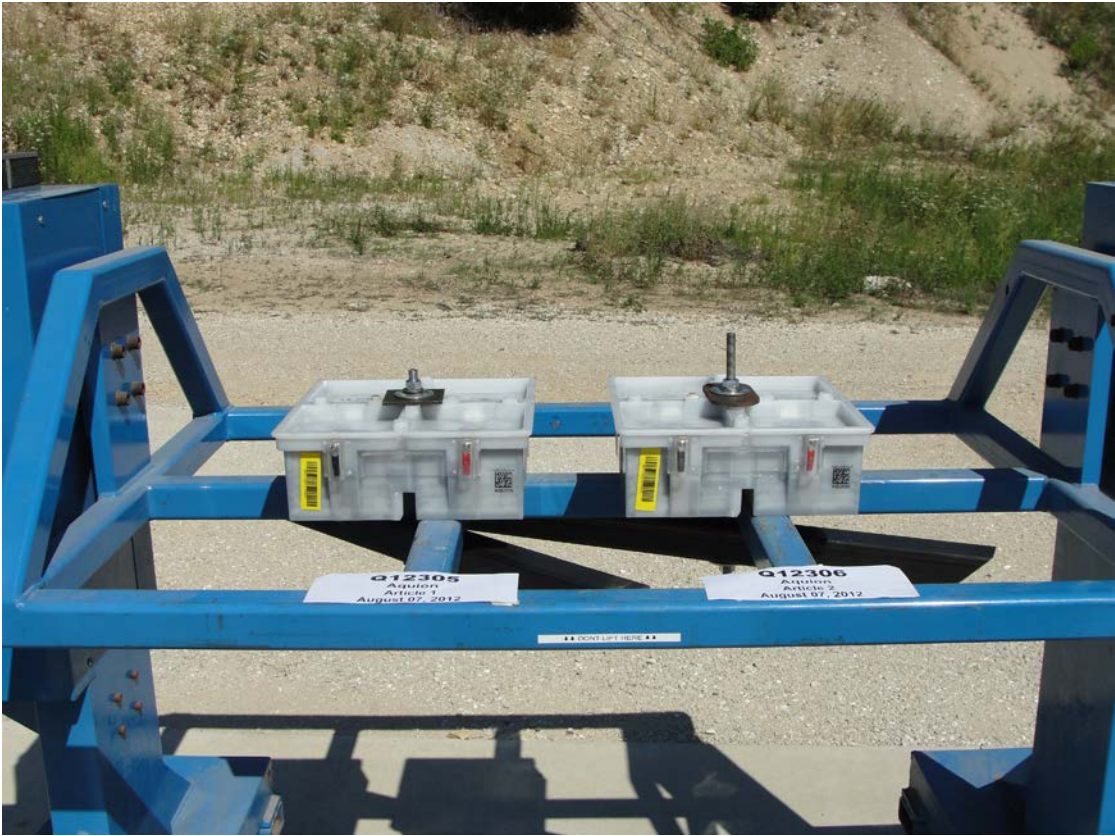
Roll-Over Testing

At the conclusion of the incremental roll testing, there were no signs of rapid disassembly, fire, or electrical isolation loss. There was no significant change in the cell weight or terminal voltage. Although there was an increase in all temperatures, T1-T6, this is attributed to a rise in ambient temperature.

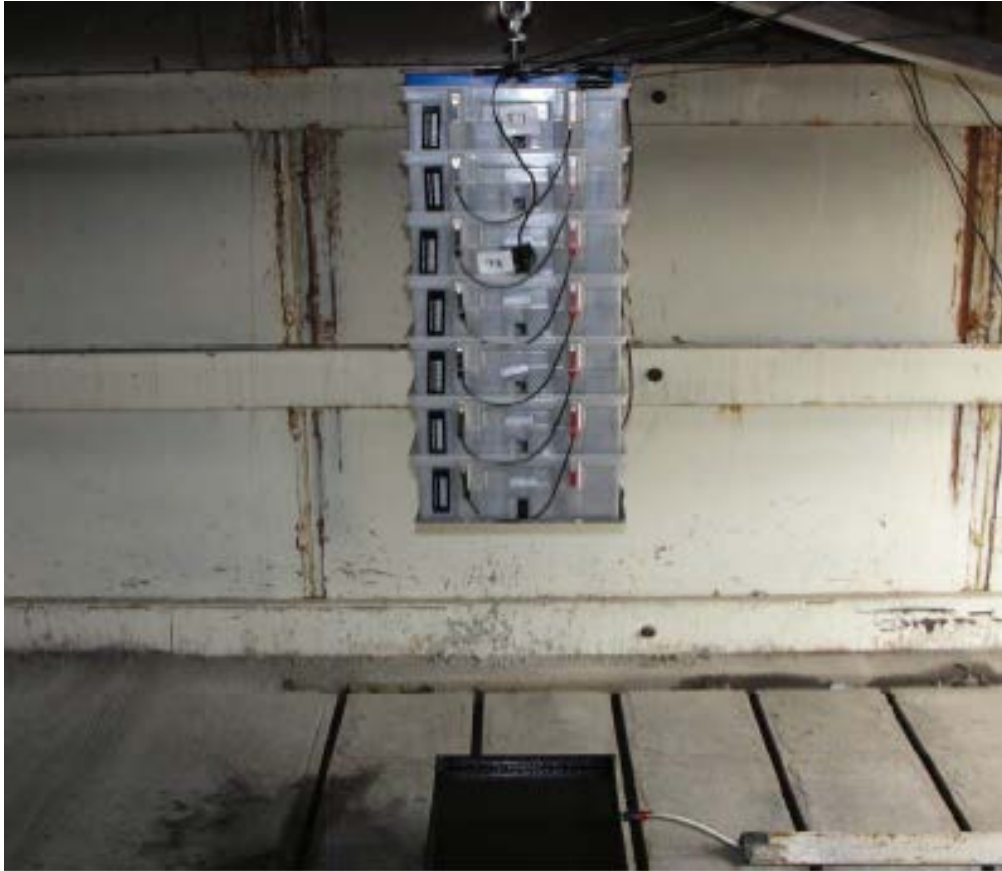
Pre Flame Propagation

One (1) seven stack battery was subjected to a flame propagation test in accordance with UL 1973.

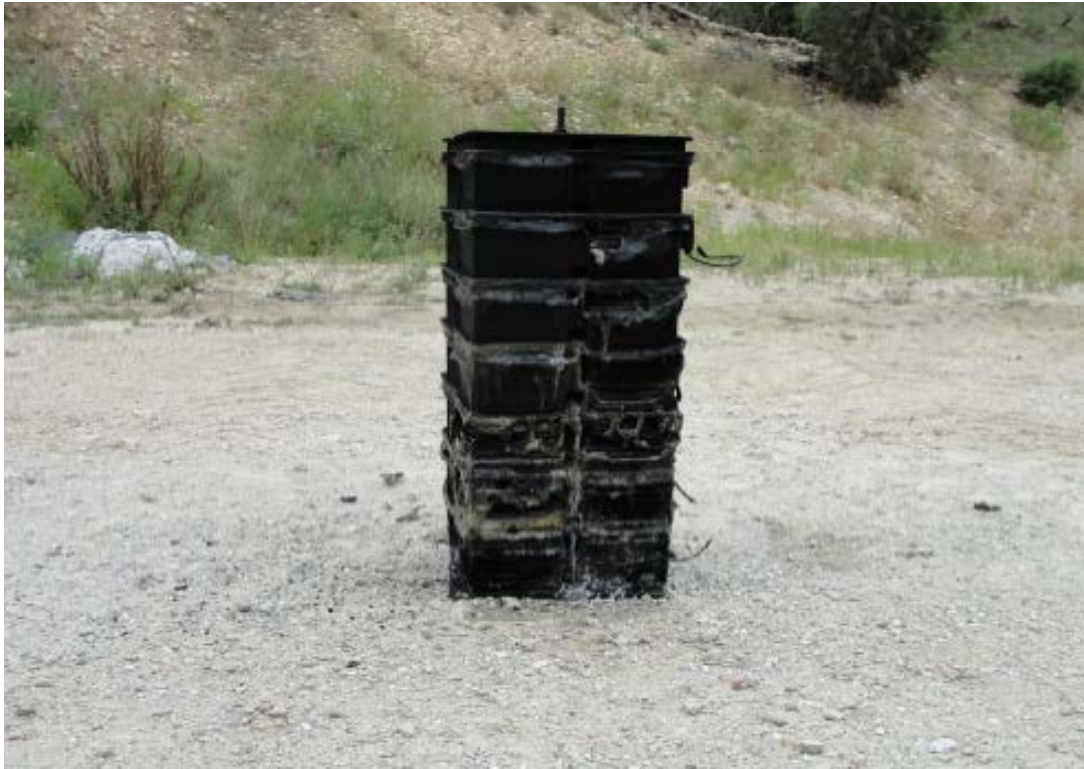
Post Flame Propagation

At the conclusion of the flame propagation test, the battery was removed from direct flame. The battery immediately self-extinguished. There was no sign of rapid disassembly.
