CONSTRUCTION OBSERVATION REPORT

Project: The Park Danforth **Client:** The Park Danforth **Client's Rep.:** Ron Norton S.W.COLE Project No.: 14-0065.2 Date: Ongoing weekly site visits Weather: Seasonal

Work in Progress: Northern Plasterwork: Application of spray fire resistant material (SFRM) on structural steel framing in new building area.

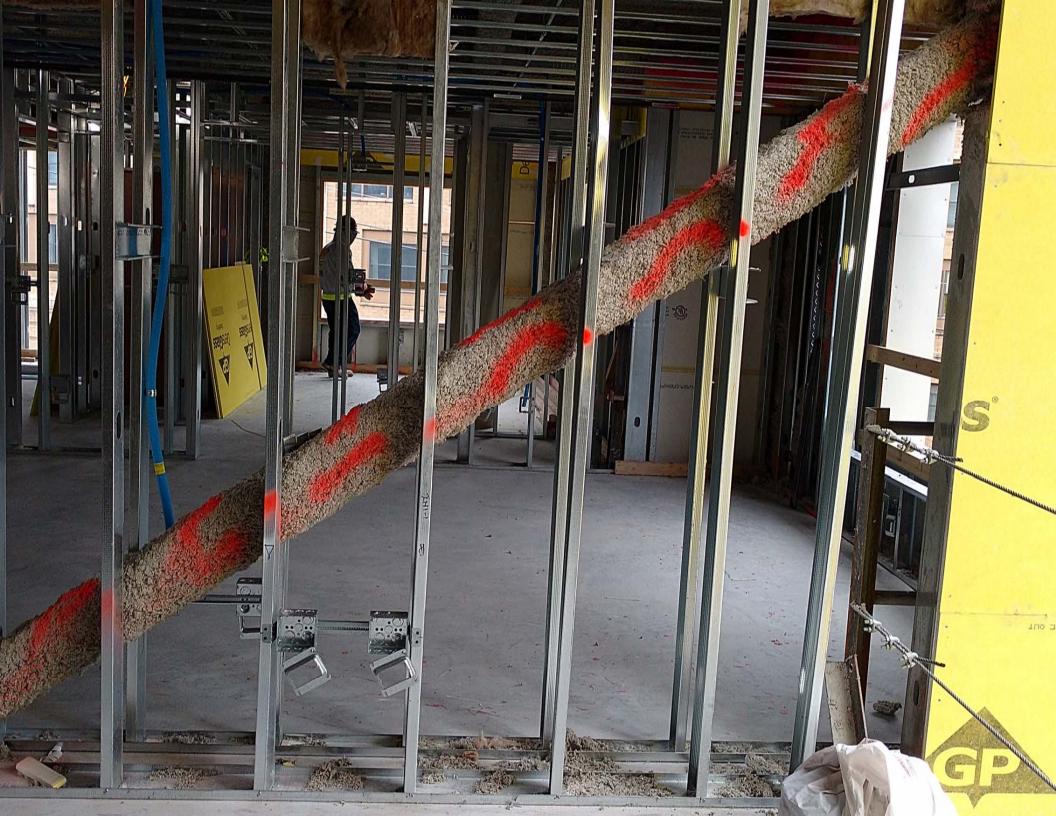
Time Onsite: Various Attachments: Photo Sheet: 1 of 1 S.W.COLE Rep.: K. Gimpel Rev. by: RED

Field testing being performed to date indicates the specified thickness is consistently being applied on decking and beam substrates. Most of the columns were also found to have the required thickness, however, column F/8 on the second floor and columns G/8, G/9 and G/10 on the third were found to have insufficient product thickness during initial testing. Also, all of the HSS bracing members on the east half of the second and third floors need additional fireproofing to satisfy the project specified thicknesses. To date, all of the density samples obtained have meet or exceeded the minimum 15-pcf value. Adhesion/cohesion tests set up have not been finalized yet because fireproofing has not sufficiently cured to allow for testing.

The locations found to have insufficient thicknesses were marked with paint and discussed with Northern Plasterwork (Dan). We understand PC is also aware of the areas pending completion and will leave them accessible as needed.
