266 Concord St West, Louise McCarthy 767-0642 (000 Building.JPG)

Pre inspection to legalize one existing no conforming unit to be a total of three units.

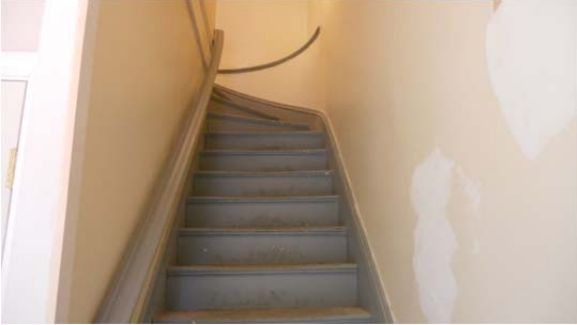
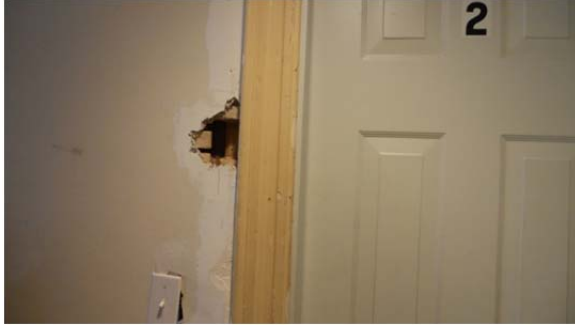
Front stair 1st to 2nd floors:

Stair NTC (Not to Code) Rise/run, winders, handrail (22", not continuous), Not 1hr (Holes in walls wood paneling on walls) (010-012 Front Stair.JPG)

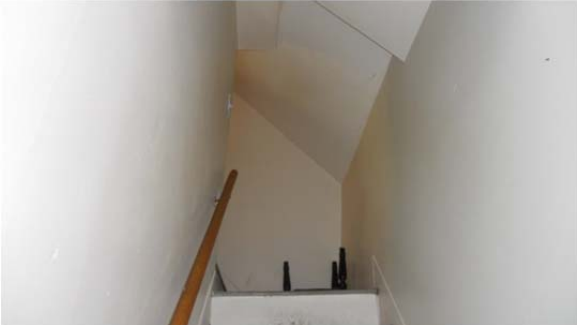
020 Second Floor Stair.JPG

Front stair 2nd to 3rd (Interior to apartment):

Stair NTC (Not to Code) Headroom, Rise/run, handrail (Secure and return to wall), No light (020 Second Floor Stair.JPG, 021 Second Floor Stair Headroom.JPG)

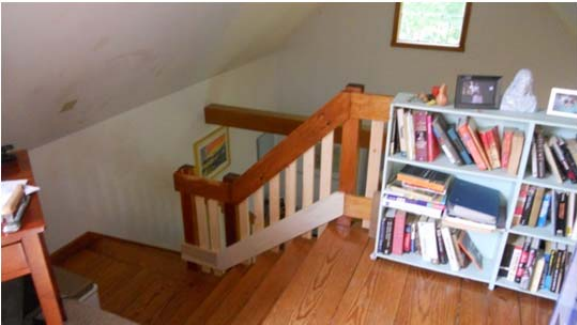
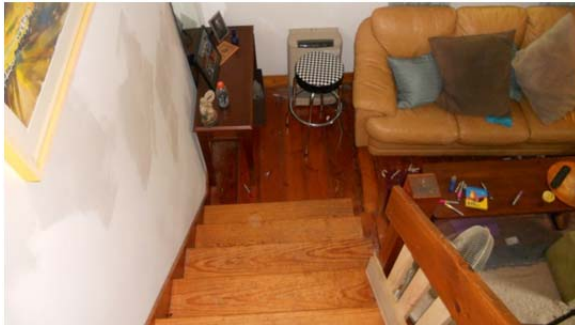
Rear Interior Stair 2nd to 3rd floors

Guard/Handrail NTC at interior stair

Headroom NTC at interior stair (38' to 76") (030-032 Rear Interior Stair.JPG)

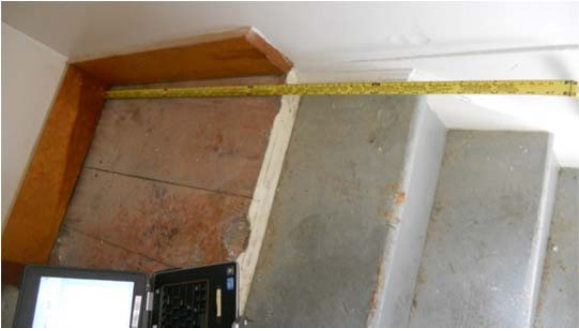
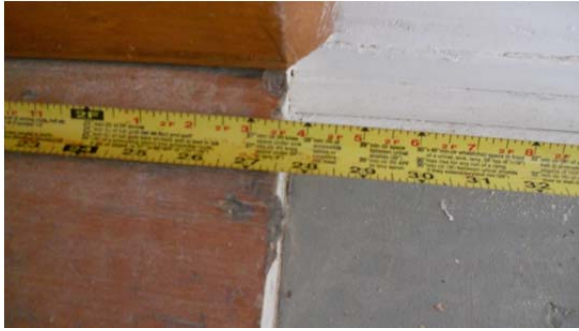
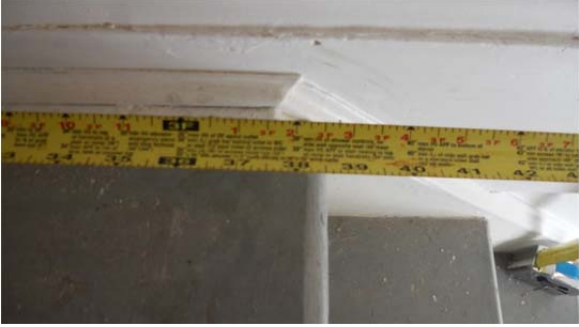
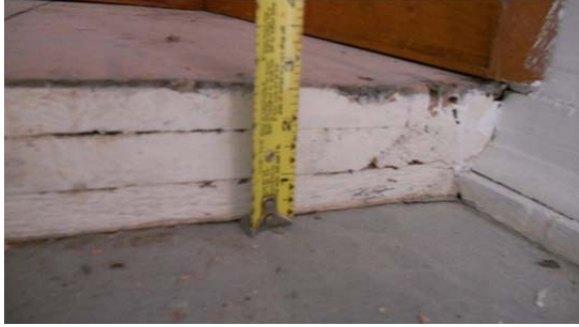
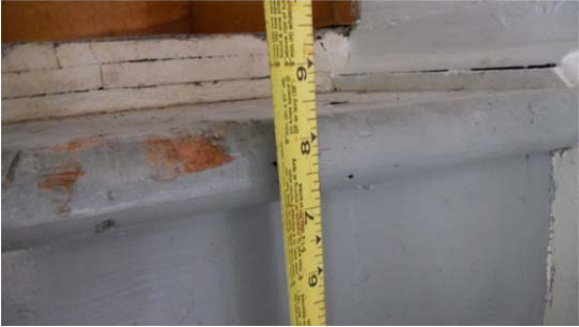
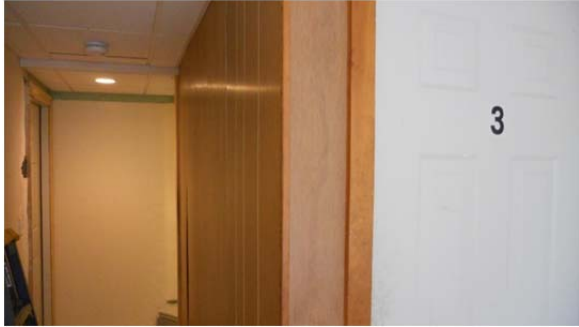
Rear common stair

Stair NTC 8"h x 7 ¾ r, Rise/run, Headroom at landing 82", Landing to short, Handrail NTC

Windows to be tempered

Paneling on walls (040-045 Rear Common Stair.JPG)

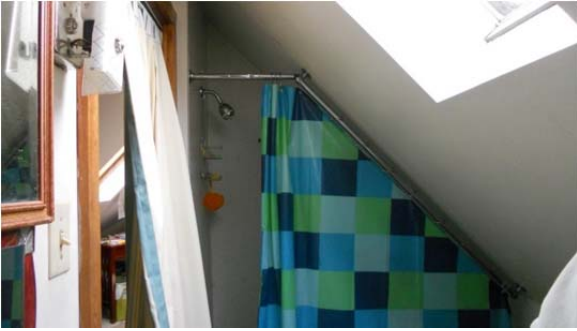
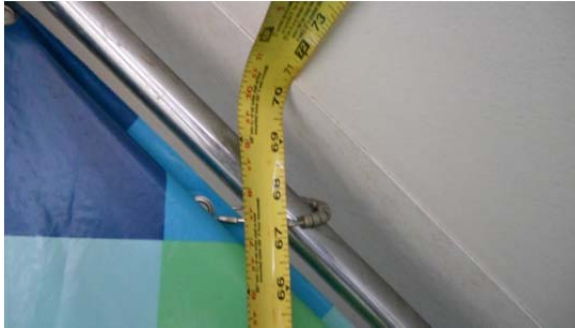
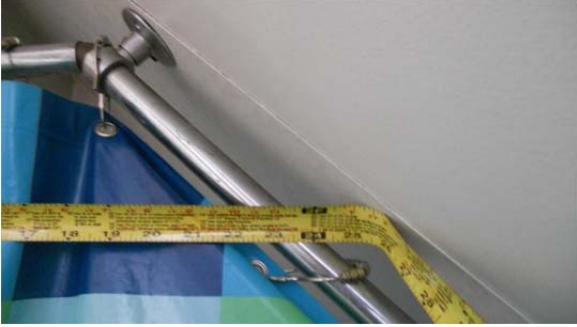
Headroom in bathroom toilet 66" (ceiling height 8' at peak to 1' over 7' wide) (050-052 Third Floor Headroom.JPG)

Headroom in living area limited (ceiling height 8' at peak, (center of room) down to 1' over 7' wide). Room is 14' wide

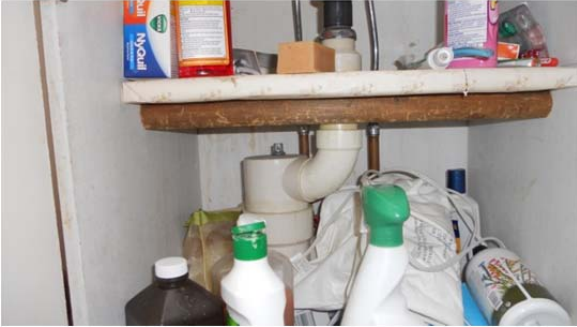
060 Plumbing Not to Code.JPG

Plumbing not to code (060 Plumbing Not to Code.JPG)

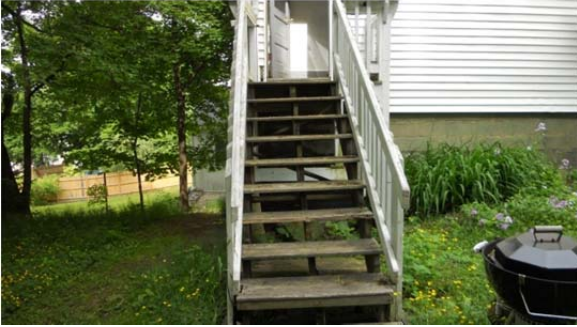
070 Rear Exterior Stair.JPG

Rear exterior stair

Guard rails weak, no handrail (070 Rear Exterior Stair.JPG)
