## UPDATED INFO

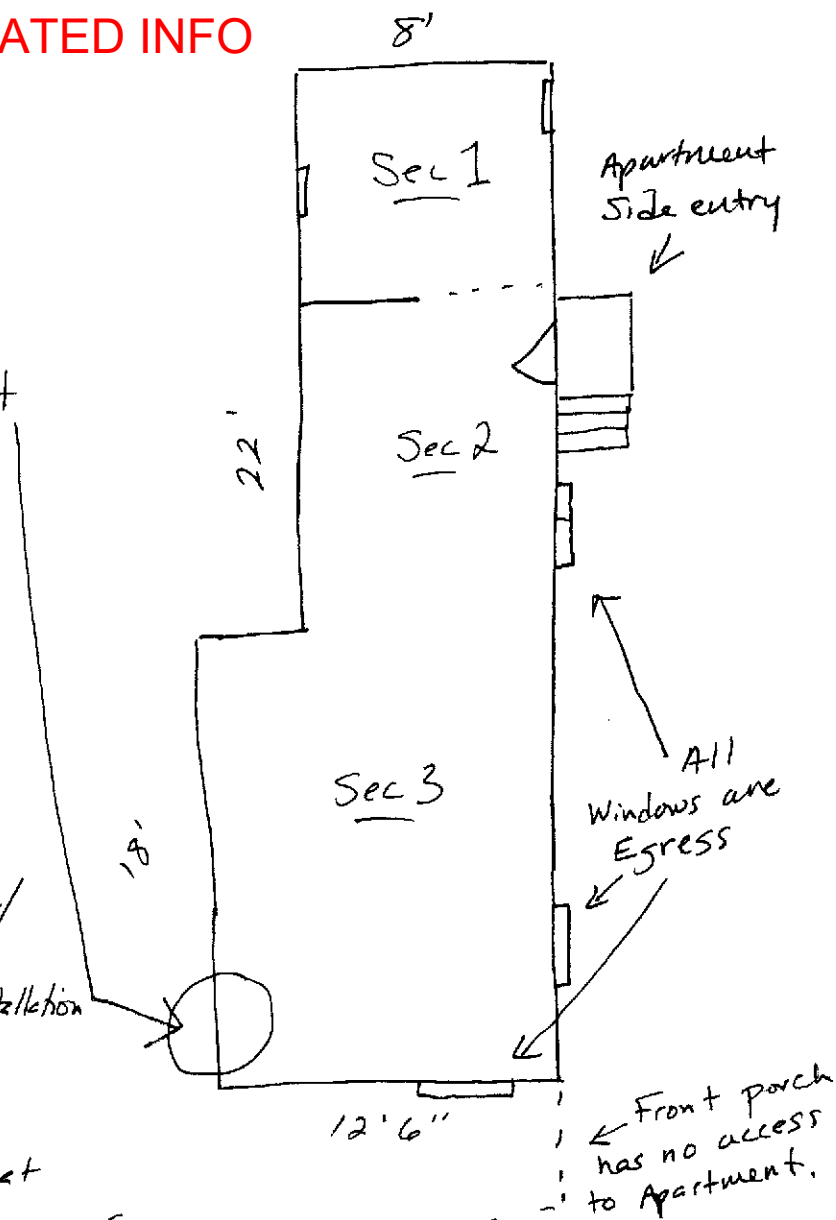
① Front porch has no connectivity to the apartment, the apartment is only accessible from the side entry door, which is an existing 3'x4' porch with existing railing & security light (Motion sensor). The front porch only services the main house.

② The shared door/entry from the main house to the Apartment was closed up with 3/4" plywood and the cavity was filled with Roxul Comfortbatt (4") fireproof insulation.

③ Sec 1: Walls & Ceilings are drywall. There is no shared wall to the Main house.

Sec 2: Exterior walls are & ceiling are drywall (Existing), shared wall to the main house is plaster/lathe + OSB which was skim coated over... probably for the installation of kitchen cabinetry. It was all existing.

Sec 3: Ceiling is plaster & lathe that was covered with 12" x 12" tile. Exterior wall & Interior Shared wall (with the main house) are plaster & lathe and filled w/ densepack cellulose (for insulation on the exterior wall & soundproofing on the interior/shared wall).

④ There are no longer any interconnections of the 2 units.
