LEVEL I SITE ALTERATION APPLICATION

Rockland Avenue Outfall

225672.77
City of Portland
December 2013

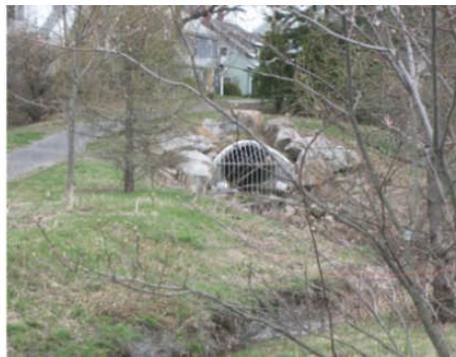
Figure 2-1: Photograph of Rockland Avenue Outfall

The stormwater runoff from the Rockland Avenue outfall carries pollution from the upstream developed areas into Capisic Pond. Erosion of the channel below the outfall has also been identified as a problem, as undermining of the outfall pipe may compromise infrastructure, and the erosion adds to sedimentation in the Pond. The following photograph shows the existing outfall:

In recent years, visitors to the Park have expressed concerns to the City about the visible impacts associated with the outfall, most notably the trash and sediment that collects in the channel below the outfall, erosion that occurs along the banks of the channel during high flow/high velocity storm events, and the overall “look” of the outfall pipe and associated aluminum trash rack. Park visitors and concerned citizens have also expressed concerns over what impact the stormwater discharges from this outfall have on the overall water quality of the Pond and the wildlife that relies on the habitat that the park offers. In February of 2012, project stakeholders (via a public meeting) expressed a desire to identify a stormwater quality treatment retrofit solution for the outfall which would stabilize the channel and provide trash and sediment removal.

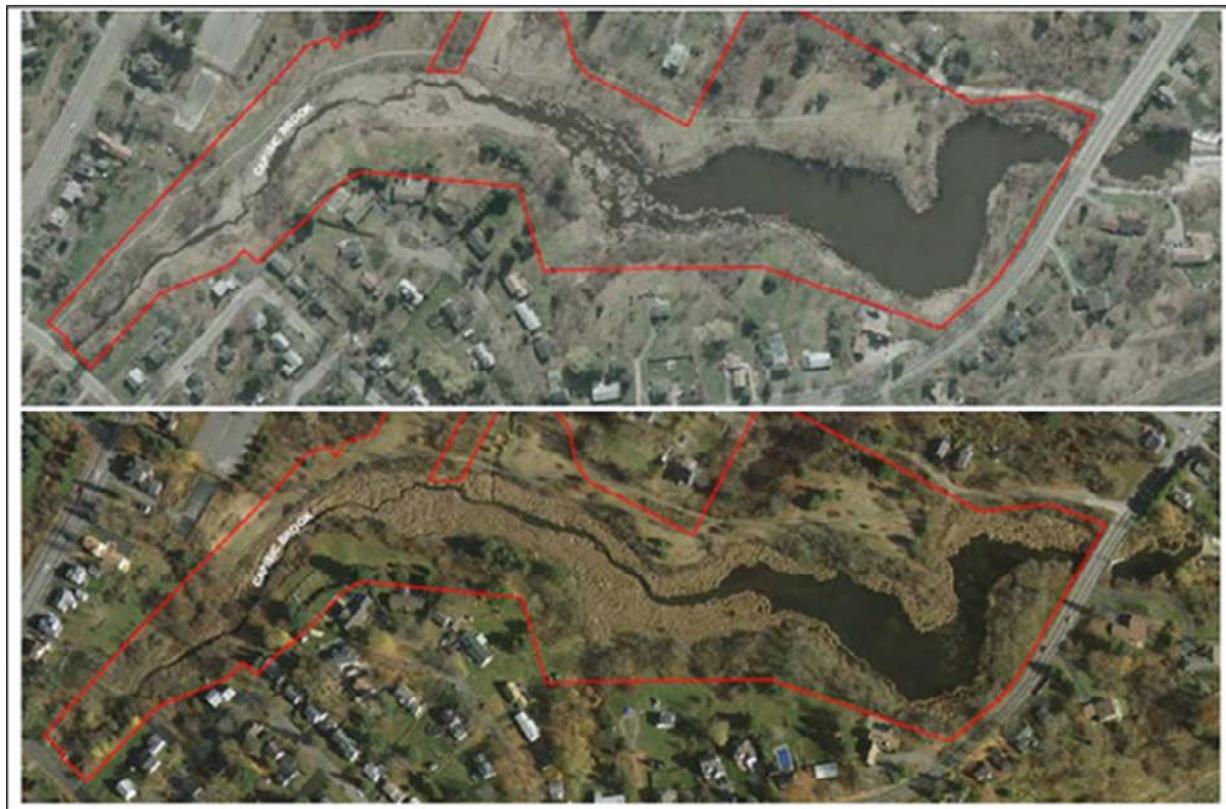
Figure 2-2: 2001 Aerial Imagery (Top) VS 2009 Aerial Imagery (Bottom)

Cattails are aggressive colonizers when they take hold and are often able to out-compete most other wetland plant species and form large monocultures (i.e. stands of a single plant species). The cattail stands can be very dense and will slow surface water, causing additional sediments to settle, furthering the sedimentation of the pond and favoring additional cattail growth. While emergent marsh habitat (including cattails) is utilized by a variety of waterfowl species, a monoculture is not the most beneficial scenario, as it does not provide habitat for as wide of a variety of species as a diverse wetland habitat. Additionally, as the cattails expand, the percentage of the wetland system that is dominated by open water begins to shrink, as demonstrated by the figure below. This can negatively impact the pond's rating for wading bird and waterfowl habitat.

The Maine Department of Inland Fisheries and Wildlife (MDIFW) rates Inland Waterbird and Waterfowl Habitats (IWWHs) based on five categories. For each potential habitat, points are assessed in the following categories: dominant wetland class, wetland diversity, size of the wetland, interspersions of different wetland types, and percentage of open water. All points are tallied, and a score is given to the habitat to determine its ranking as a low-, moderate-, or high-value. Capisic Pond is currently ranked as moderate value, but is trending quickly towards a low-value rating. Cattail encroachment is causing a loss of open water habitat, and is slowly leading to a degradation of the IWWH habitat and a reduction of the scenic and recreational aspects of the pond. With cattail encroachment, the pond is losing its ranking points for percent open water.

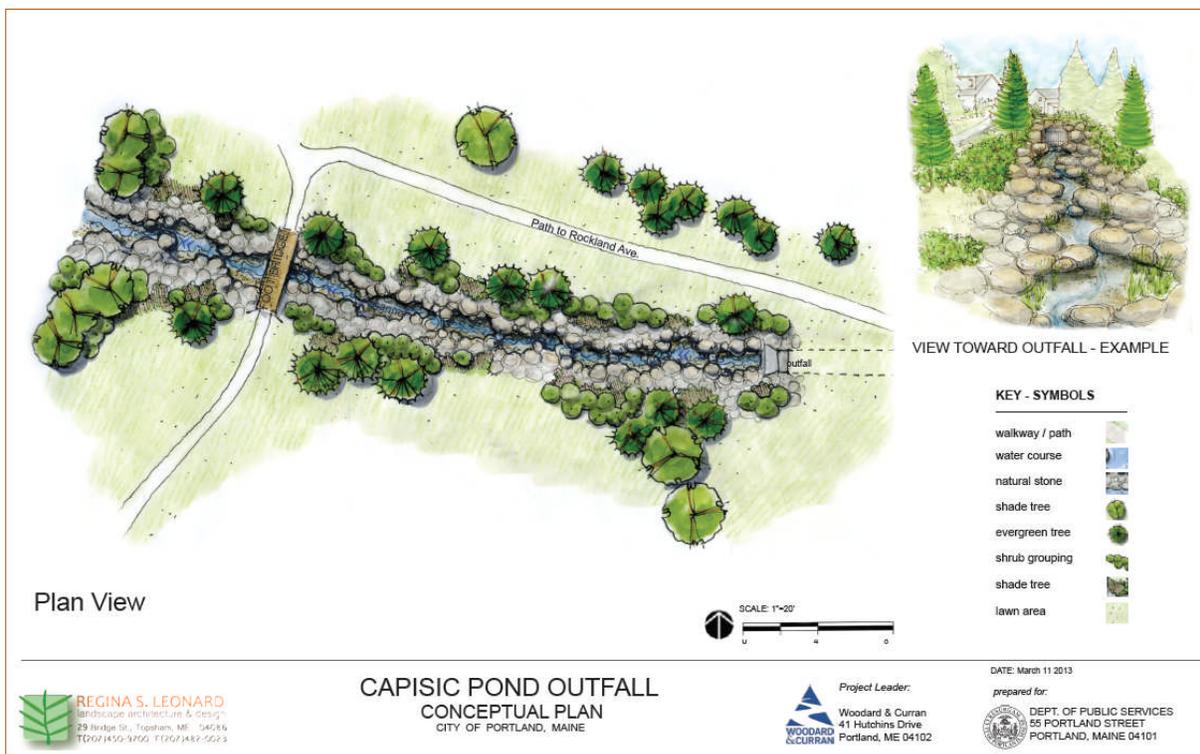
Figure 7-1 Rockland Avenue Outfall Conceptual Rendering

The proposed project will not alter existing stormwater drainage patterns. A negligible amount of impervious area will be created through the widening of a short section of existing gravel pathway to provide for maintenance access to the proposed water quality treatment unit. Approximately 150 square feet of additional gravel surface will be added. It is not anticipated that there will be an increase in peak stormwater flows at the site. The project will comply with the standards of Section 5 of the City of Portland Technical Manual, as discussed in Section 9 of this Report. Groundwater contamination is not anticipated to occur as a result of this project.

The proposed Rockland Avenue Outfall project will help to reduce the amount of pollution and sediment being discharged into Capisic Pond. This will help to ensure the success of future Capisic Pond enhancement projects that aim to increase the open water area of the pond and diversify the pond's wetland species. In addition, the project will address structural pipe issues by resetting and structurally securing displaced sections of pipe near the outfall end and will provide a means of channel stabilization to remediate the existing scour and erosion that is occurring within the drainage channel.

An underground, in-line trash and sediment control structure will also be installed near the park entrance at Rockland Avenue, uphill of the outfall. This system will require quarterly inspections in the first year to monitor sediment and debris loading, followed by at minimum annual cleaning via vac-truck thereafter. The damaged end of the existing 60-inch reinforced concrete outfall pipe will be repaired, reset and structurally secured. All areas within the project limit of work will be temporarily impacted and restored.

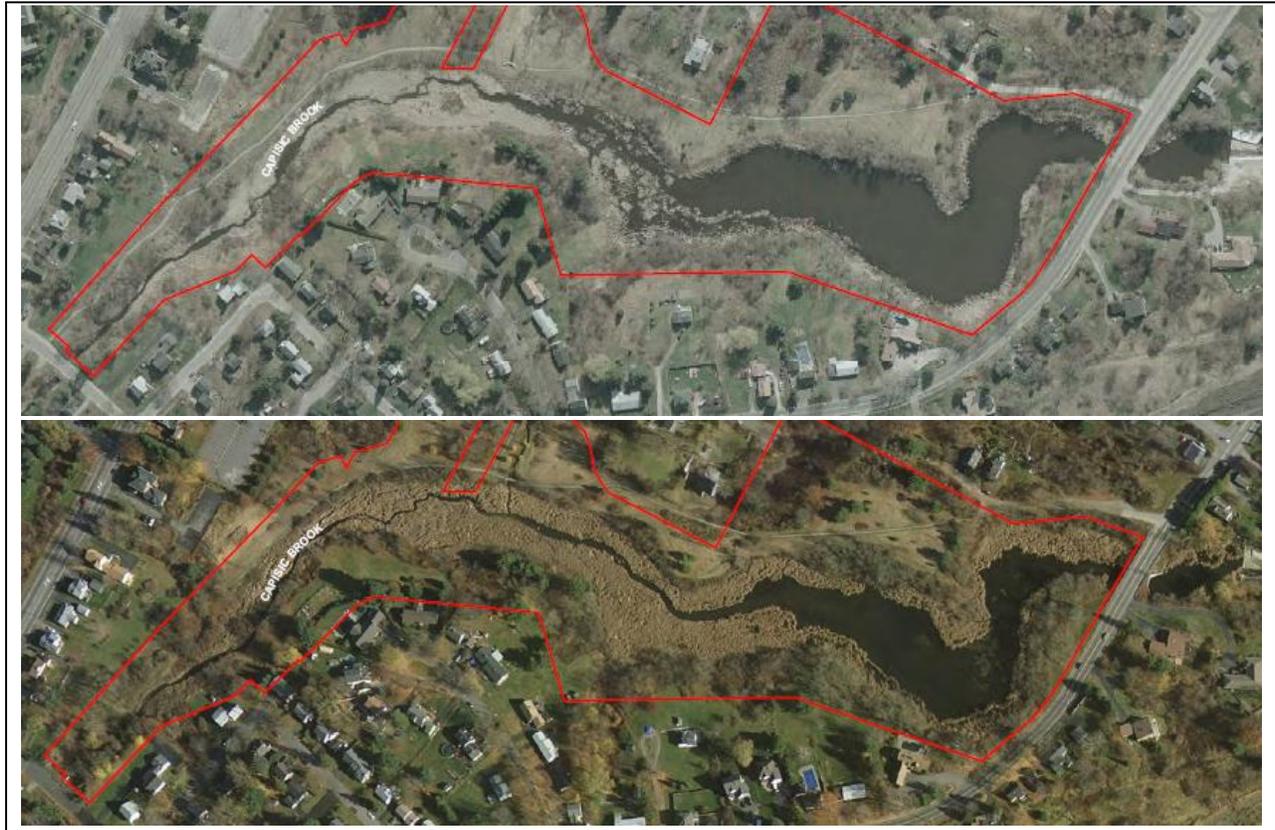
Figure 5. 2001 aerial imagery (top) compared with a 2009 image (bottom) indicates expansive growth of cattails around the pond margins and interior.

Capisic Pond was last dredged in the 1950s. Over the years, as expansion of impervious surface from development has increased runoff into Capisic Brook, sediments have built up in the pond. The sedimentation, combined with the lower water elevation afforded by the dam lowering efforts of 1996 and 2001, has reduced the water level in the pond. The shallow, turbid water favors the growth of cattails, which outcompete most other species in these types of habitats. A review of historic aerial

photographs has shown a decrease in the open water component of the park over the last few decades, with the largest cattail expansion taking place within the last 10-15 years (see Figure 5) .

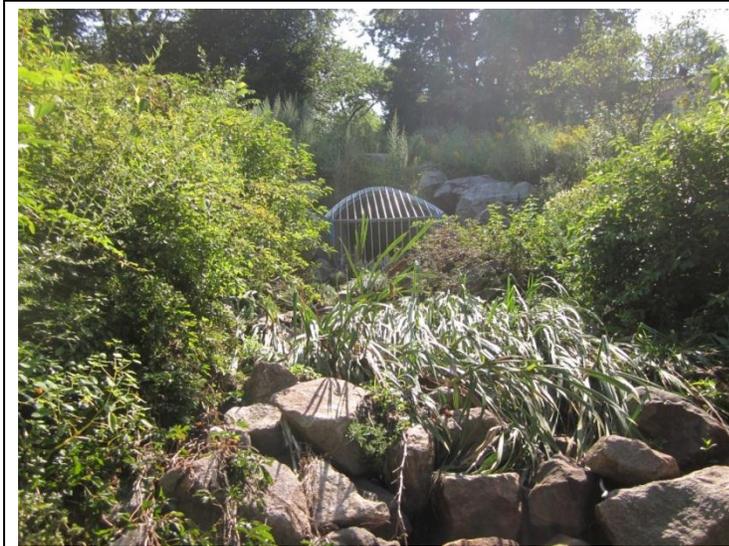
Looking east at Rockland Avenue outfall and start of **Stream 1**.

ID	Stream Type	Width	Depth	Substrate	Comments
1	Perennial	3-15'	18"	Boulder, cobble, gravel, sand, mud	Stream 1 (unnamed) begins at the Rockland Avenue outfall and flows for a short distance before entering Capisic Pond on the west side of the gravel trail. Stream is eroded and receives strong, concentrated stormwater flows post heavy rain events.
2	Perennial	15-20'	12-24"	Cobble, sand, mud	Within the survey area, stream 2 (Capisic Brook) flows south under Lucas Street through shady shrub habitat toward Capisic Pond. Directly south of Lucas Street the brook is shallow, fast moving, and rocky. As the stream approaches the pond, the habitat opens to emergent marsh and becomes deeper and meandering with slower water velocities before becoming open water and emergent marsh (<i>i.e.</i> Capisic Pond); the stream reforms as a fast-moving rocky-bottom stream below the dam south of Capisic Street (outside of study area).

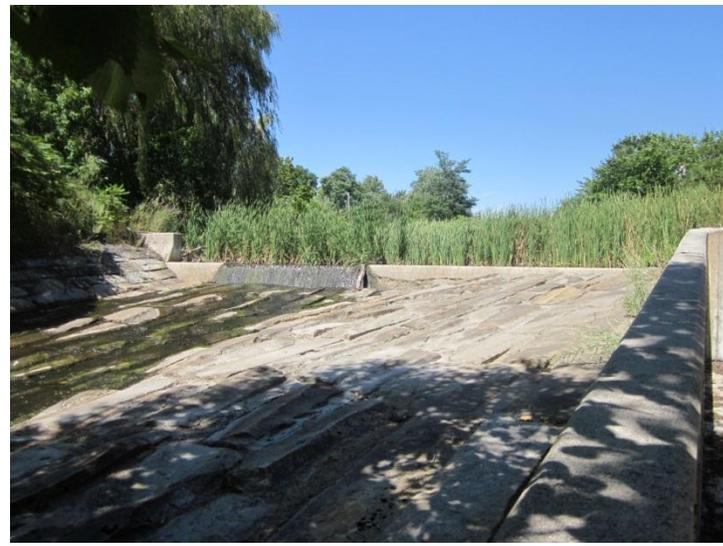
Look north at the weir dam on the south side of Capisic Street.

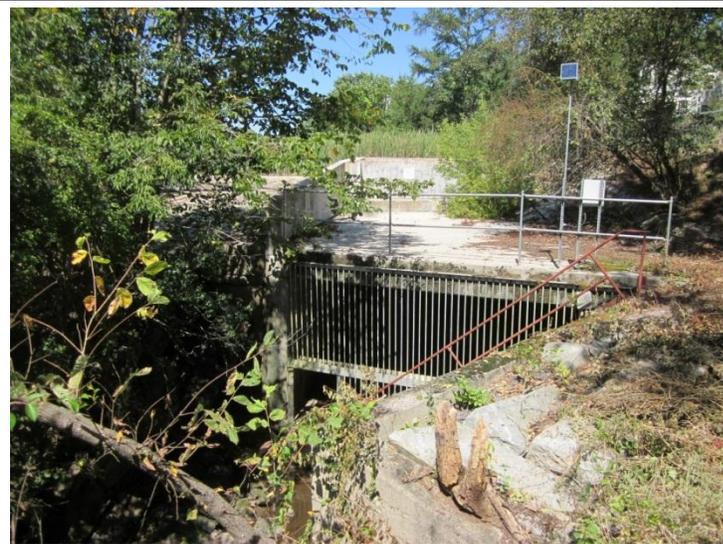
Concrete diversion chamber below weir dam.

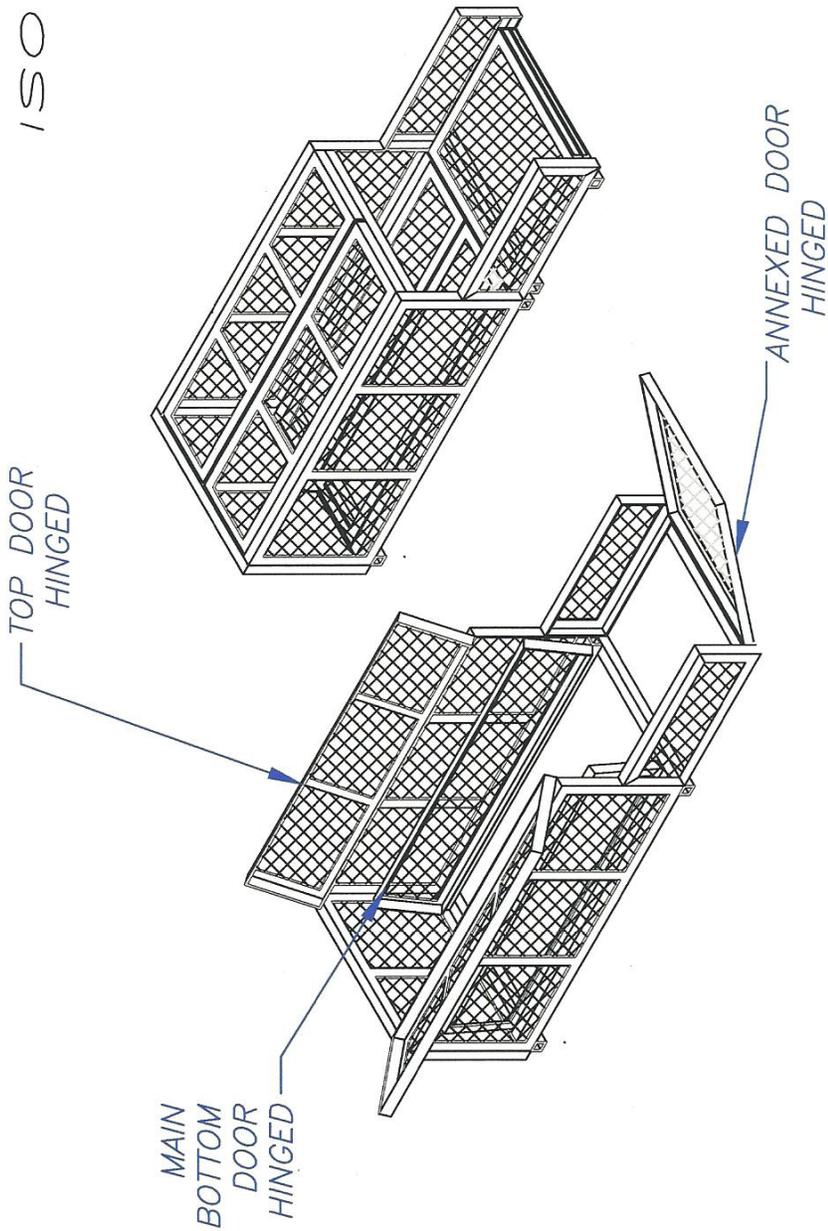
SUNTREE TECHNOLOGIES LIDDED BASKET—TYP

ISO VIEW

NOTE: SIZE MAY VARY DUE TO STRUCTURE.

1. Visually inspect the unit from the surface for broken or missing hinges or handles.
2. Open access points (i.e. Manhole covers or hatches) and secure properly.
3. A visual inspection should be made of the basket screen system to determine the remaining capacity for debris, and to check for cracks, or damages.
4. A visual inspection should be made of the StormBoom; check for missing or broken parts.
5. A visual inspection should be done of the sediment chambers; this may require opening the bottom doors of the screen system (if possible).
6. A visual inspection should be made of the overall condition of the vault, typically joint areas, as well as inflow and outflow pipe grout areas.

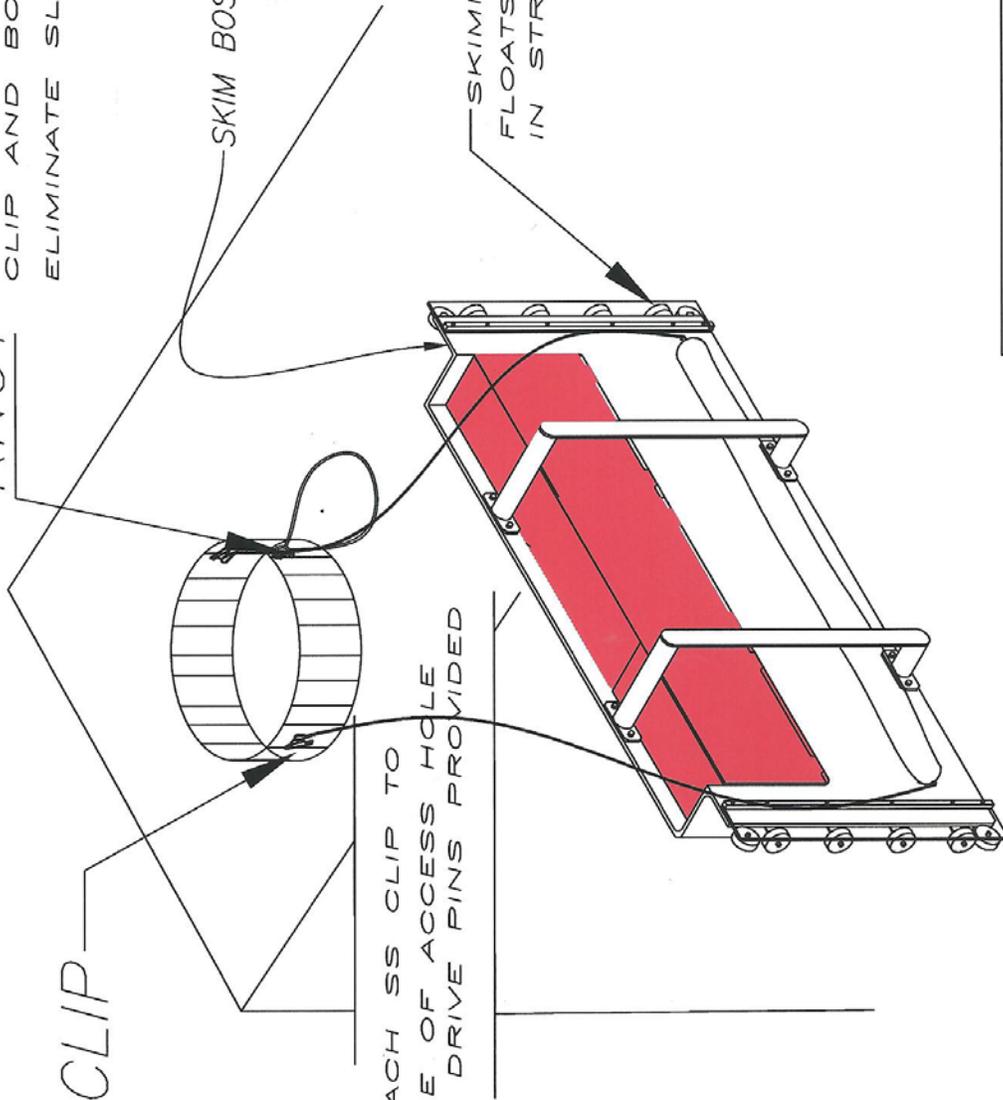
PROJECT: SUNTREE TECHNOLOGIES, INC. 798 CLEARLAKE RD. SUITE #2 COCOA, FL 32922	
DRAWING #: NUTRIENT SEPARATING BAFFLE BOX STORM BOOM ATTACHMENT	
FILE NAME: NSBB-STORM BOOM TYP.	DATE: 05/18/11
REVISION: SCALE: SF = 72	DATE:
REVISION:	DATE:
DRAFTER: N.R.B. UNITS = INCHES

SKIMMER PANEL FLOATS IN TRACK IN STRUCTURE.

1. After opening access vacuum out screen system—estimate volume collected.
2. After cleaning screen system—open bottom doors and vacuum out sediment chambers—estimate volume collected.
3. Replace storm boom if completely blackened.
