<b>To:</b>	Eric Smith	<b>From:</b>	Bryan Beaulieu
<b>Company:</b>	EJ Drywall	<b>Date:</b>	11/15/14
<b>Re:</b>	Hilton Garden Inn - Portland, ME - Porte Cochere Assessment

**Description:**

Our office was informed that an accident occurred at the Hilton Garden Inn located at Portland, Maine one evening in November of 2014. A moving van had hit the soffit framing of the porte cochere and made some visual damage. We were tasked with determining the extent of the structural damage.

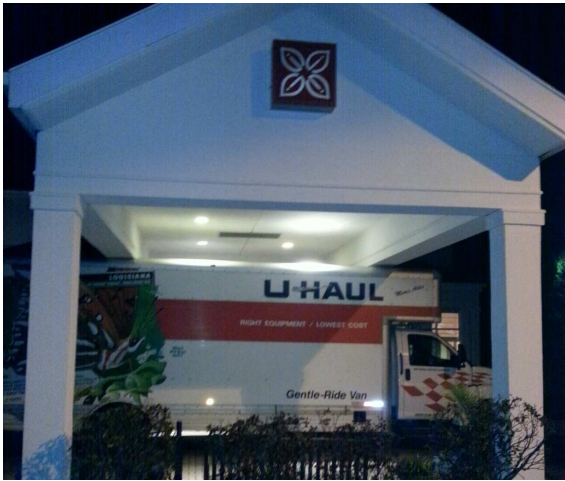
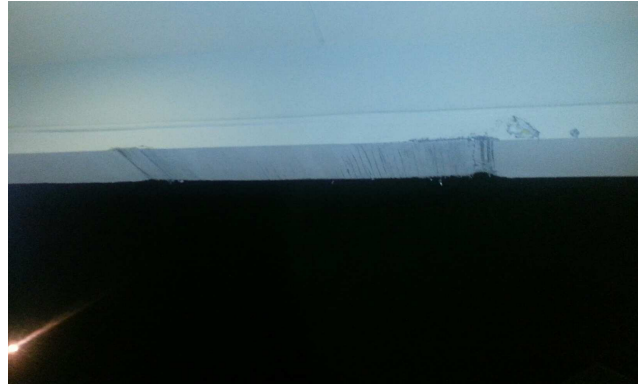
Photos Provided By Eric Smith

On the morning of Friday, November 14th, I visited the site and met with Al Delaney of the Hilton Garden Inn to go over the damage. The extent of the damage is the sheathing material and minor crushing damage to the light gage soffit framing in an isolated area. The framing may have temporarily shifted a small amount during the incident to cause the cracking where the soffit meets the wall. Considering the brittle nature of the material used to face the soffit, this is not surprising. The frame was checked to see if the porte cochere remained shifted but was found to be perfectly upright. The hole on the vertical face of the soffit was done with a hammer and not the vehicle.

Based on the damage observed, the structural steel system (the WF beams and tube steel columns) were not impacted by the accident. Only the non-structural cladding system in an isolated area sustained some damage and can likely just be patched over or removed and replaced. It is our opinion that the porte cochere does not pose any danger after this accident.
