**SELF-IMPLEMENTING CLEAN-UP PLAN
FOR PCBs**

INTERIOR RENOVATION

**UNUM
PORTLAND, MAINE**

**SELF-IMPLEMENTING CLEAN-UP PLAN FOR PCBs
INTERIOR RENOVATIONS
UNUM SITE
PORTLAND, MAINE**

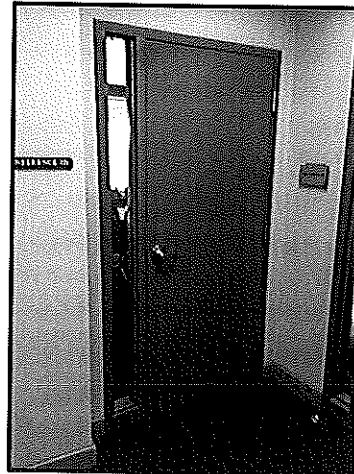
Typical Sidelight Window

Sidelight windows, located inside metal door frames, are located in and near rooms 122, 123, 126, and 146. Caulking between window glass and metal frames appears to have been applied by the manufacturer, and has not been tested for the presence of PCBs. Nonetheless, it will be assumed to contain PCBs at concentrations greater than 50 mg/Kg. The door slabs are not in contact with the sidelight windows or caulking. Wherever these windows are encountered in the HO-1 atrium renovation area, the following steps will be taken:
