**LIMITED SUBSURFACE
INVESTIGATION**

Waxler Property
421 Warren Avenue
Portland, Maine

February 16, 2006

ARC Job No. RR-05862

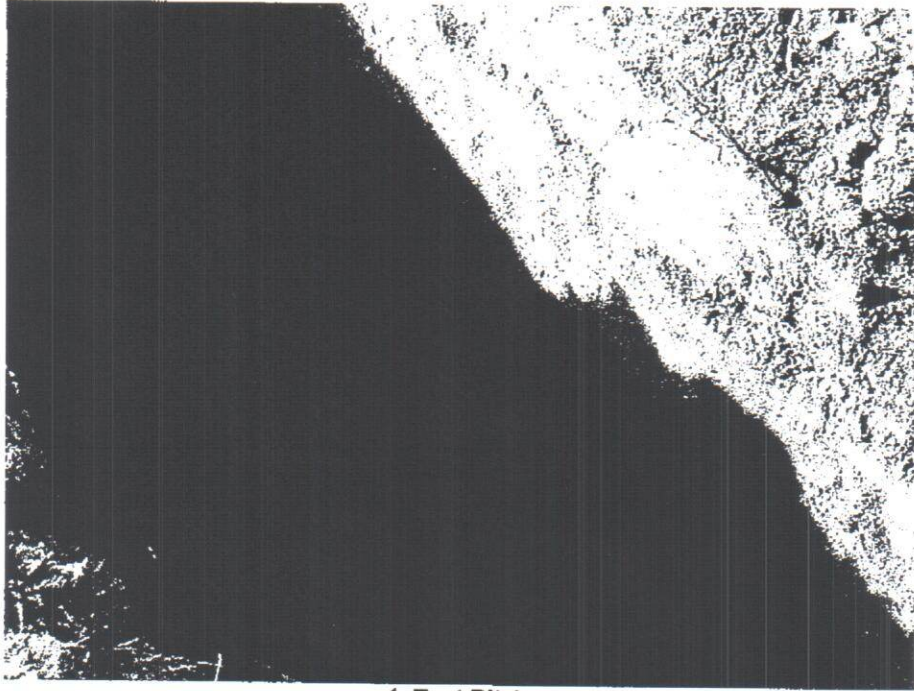
The groundwater table was not encountered during this assessment. One area of perched groundwater was encountered in Test Pit 1, but there was not a sufficient volume of water to collect a representative sample. No groundwater samples were collected during this assessment.

1. Test Pit 1.

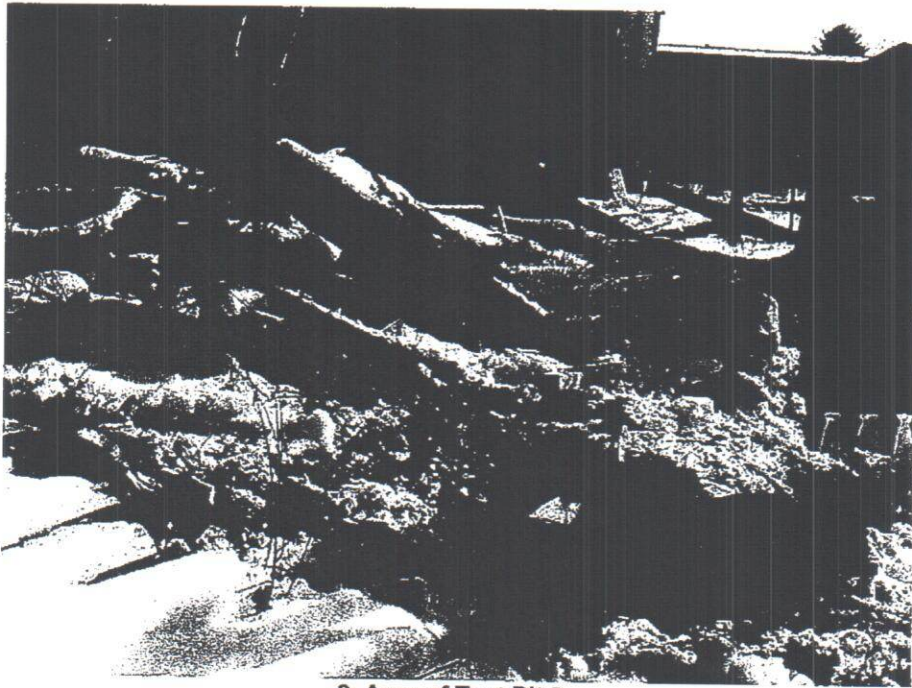
2. Area of Test Pit 2.

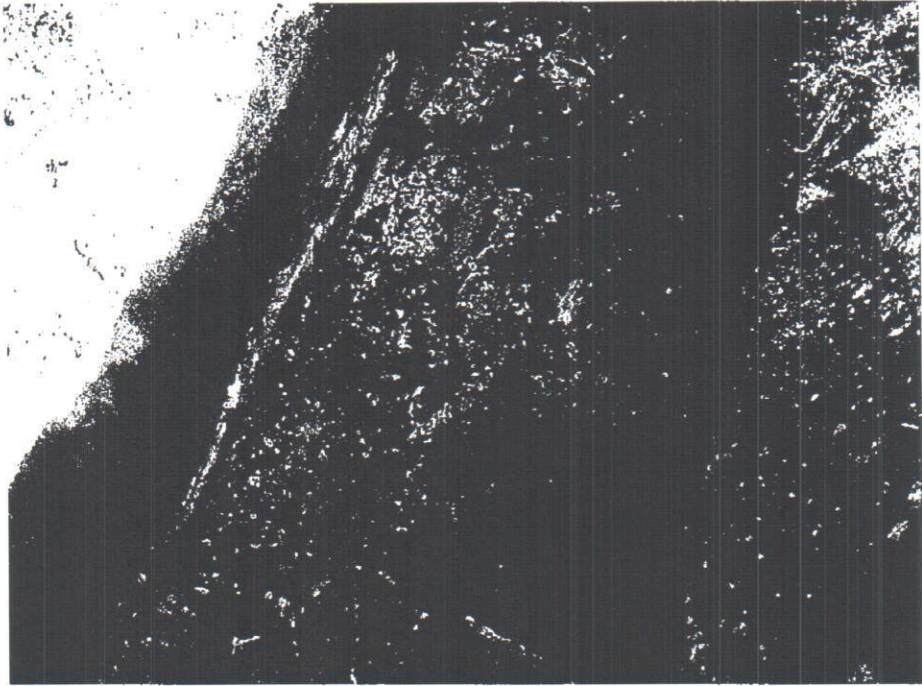
3. Bottom of Test Pit 2.

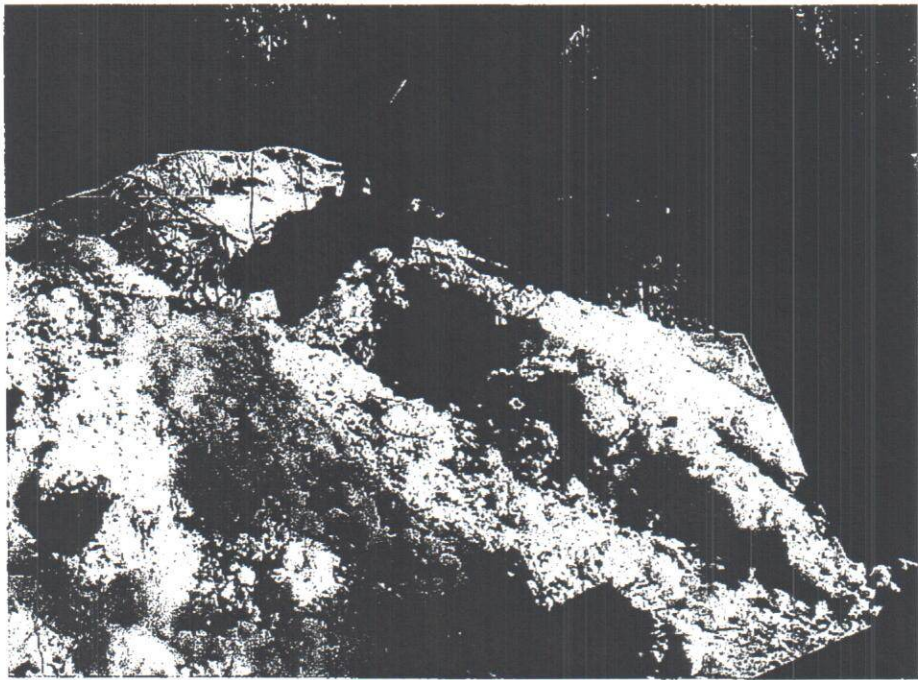
A portion of the soil sample collected from Test Pits TP3-S2 (from the soil pile) and TP7 (from dark colored soil), was collected for laboratory analysis. The sample to be analyzed for volatile organic compounds ("VOCs") and Gasoline Range Organics ("GRO") was collected in a dedicated, graduated plastic syringe, and placed into a methanol preserved 10 mL glass VOA vial with septum cap. The sample to be analyzed for Diesel Range Organics ("DRO") analysis was placed into a pre-cleaned 4 ounce amber glass jar packed as full as possible to minimize headspace. All sample containers were placed in an insulated cooler with ice packs for storage and transport, and were delivered to Eastern Analytical in Concord, NH. The samples were analyzed for GRO using method ME 4.2.17, VOCs using EPA method 8260B, and for DRO using method ME 4.1.25. Laboratory analysis sheets and chain of custody documentation are attached in Appendix B.

4. Test Pit 3 in Soil Pile.

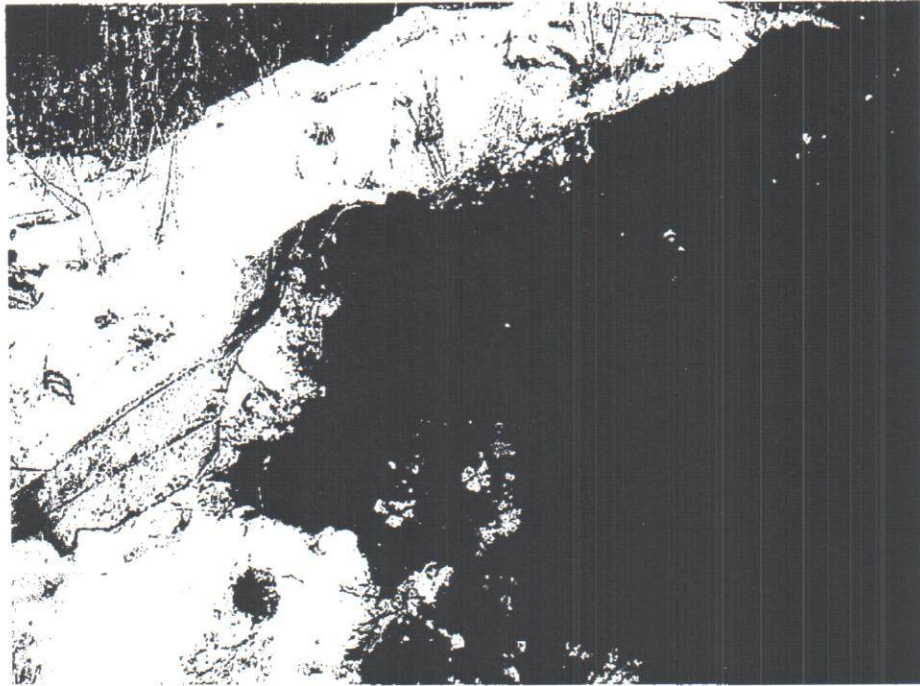
- Besides a small amount of solid waste materials including an automobile tire, asphalt, building materials, wood and metal objects (all located in the soil pile), there was no evidence of solid waste landfilling at the site.

5. Solid waste in Soil Pile.

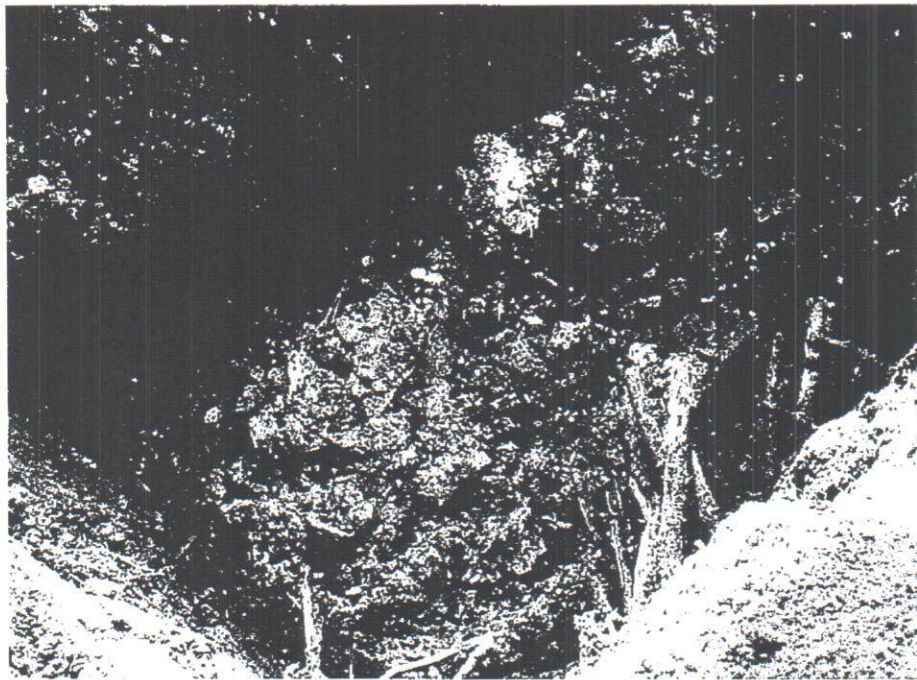
6. Bottom of Test Pit 3.

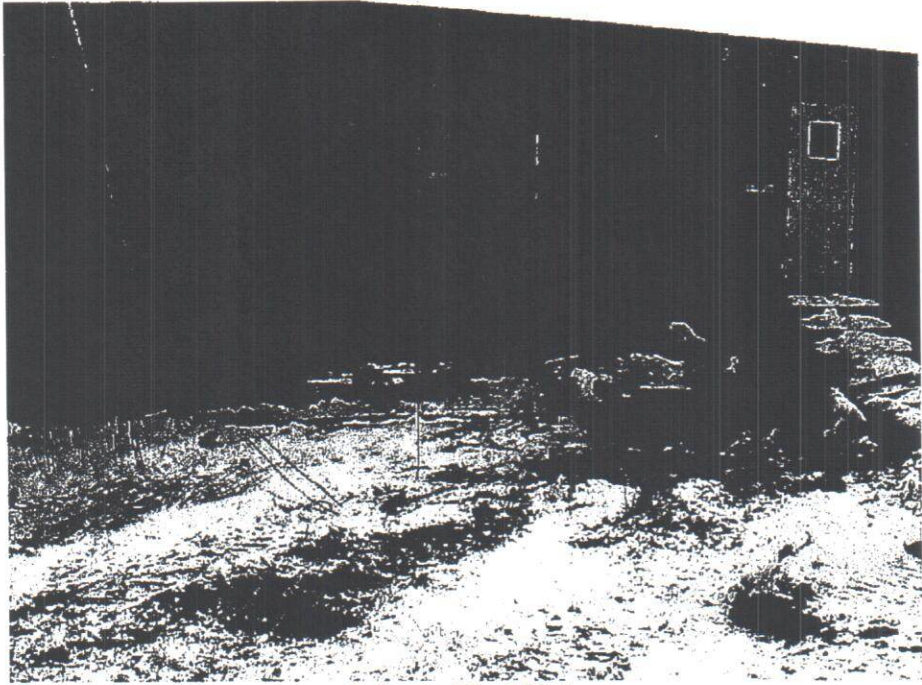
7. Area of Test Pit 4.

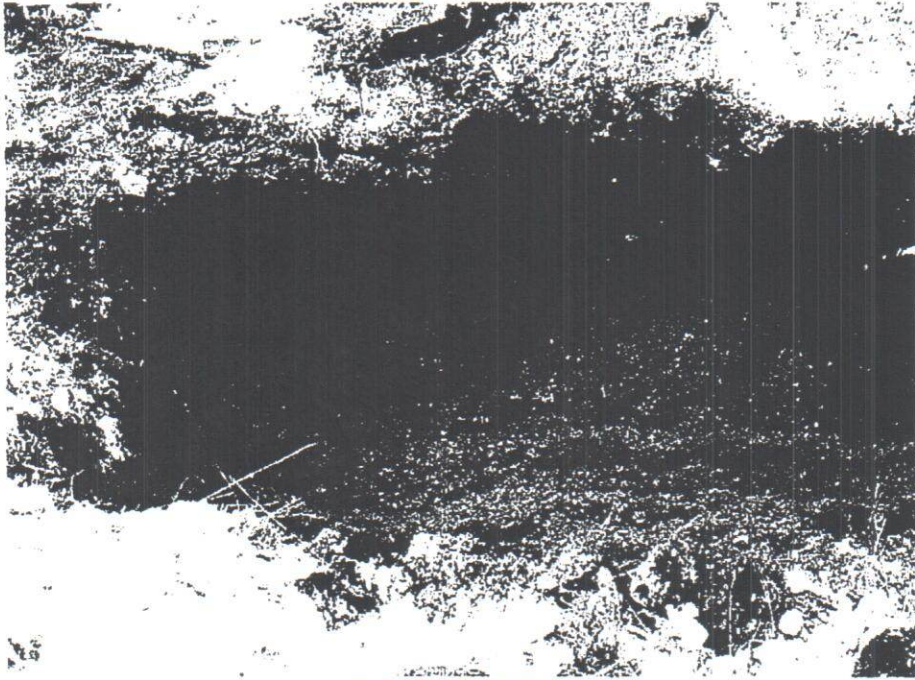
9. Soil in Test Pit 4.

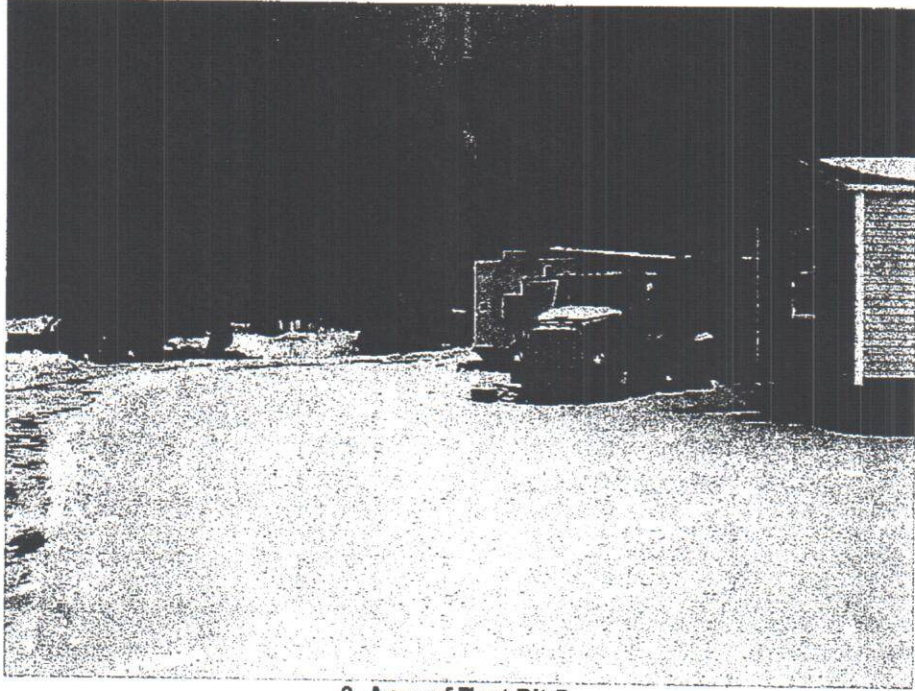
9. Area of Test Pit 5.

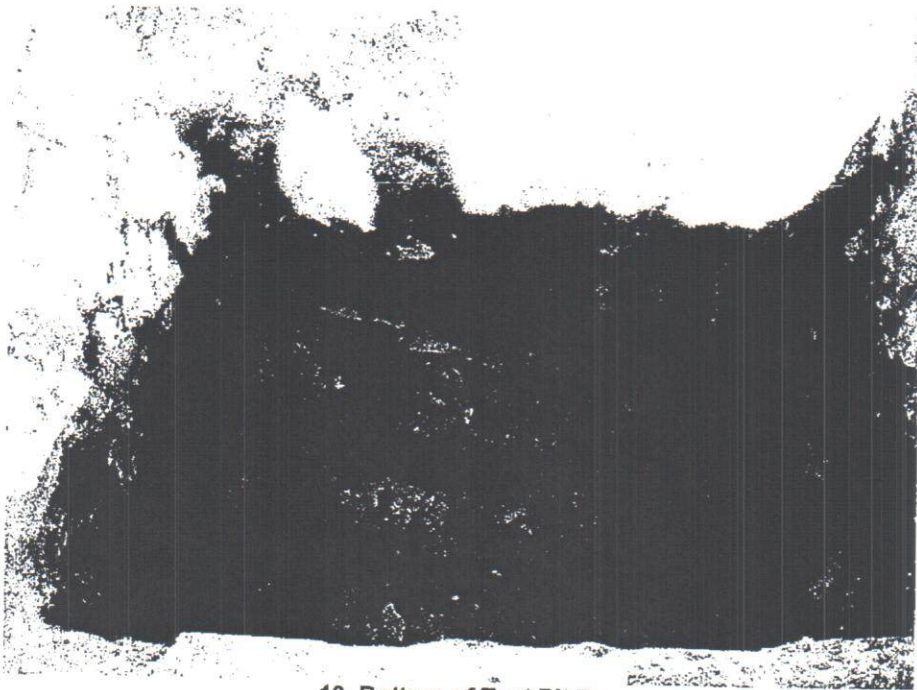
With the exception of 6 parts per million of DRO at TP7, no contaminants were detected at concentrations in excess of laboratory method detection levels. No contaminants were detected at concentrations in excess of Maine Stringent Cleanup Goals Standards.

10. Bottom of Test Pit 7.

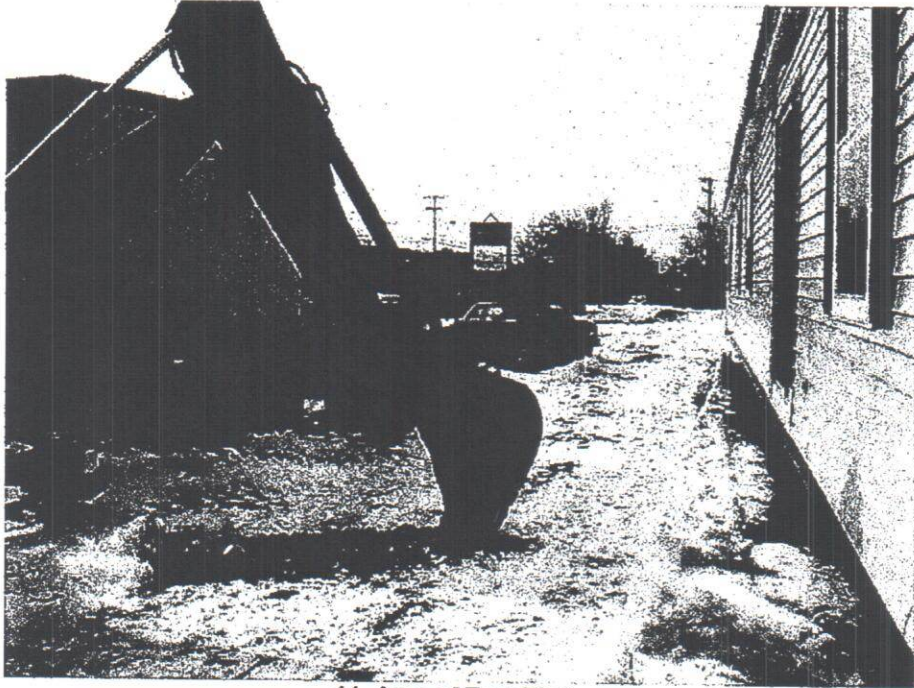
11. Area of Test Pit 9.

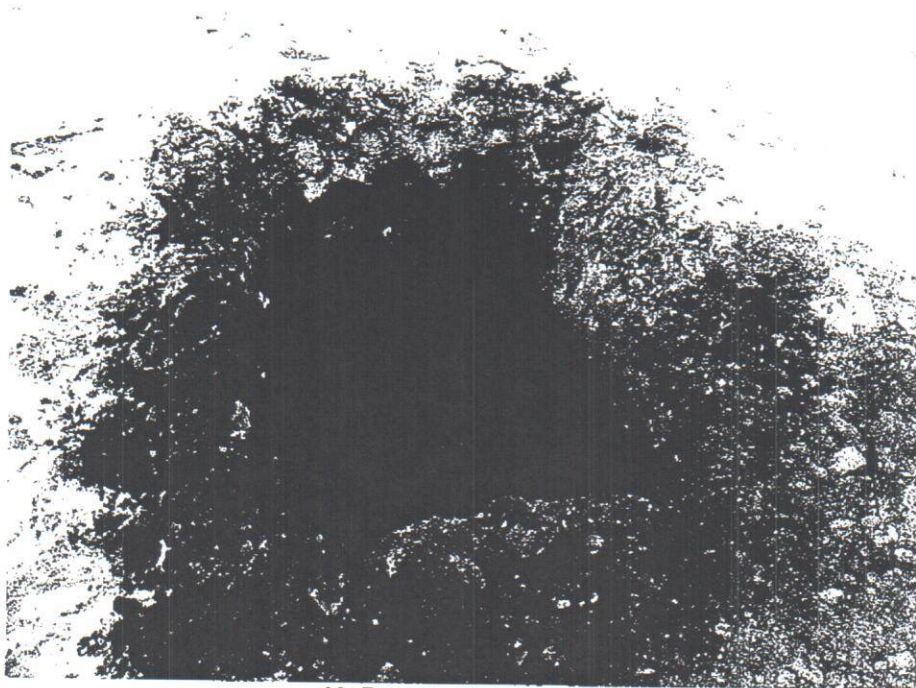
12. Bottom of Test Pit 9.

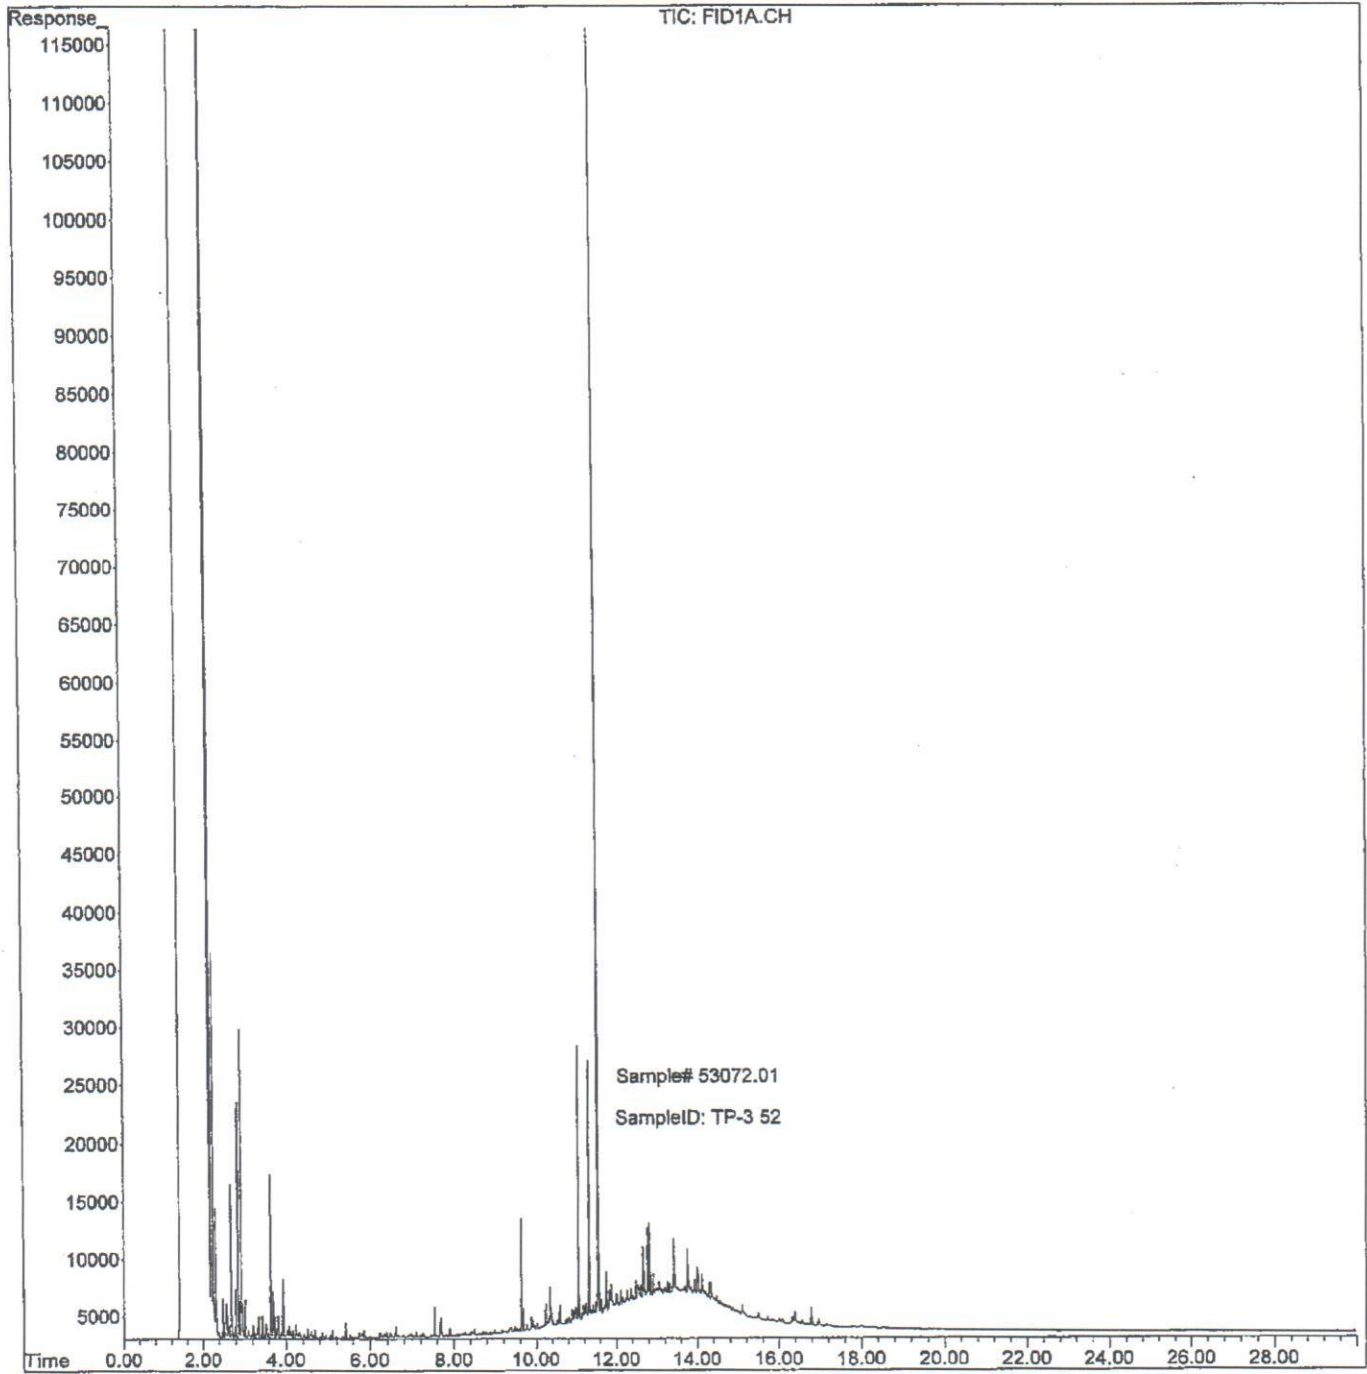
File : W:\2\DATA\FEB06\FEB1406\SV021414.D
Operator : JTO
Acquired : 14 Feb 2006 18:36 using AcqMethod RUN8100X.M
Instrument : FID
Sample Name: 53072.01
Misc Info : S021406MEDRO1
Vial Number: 14

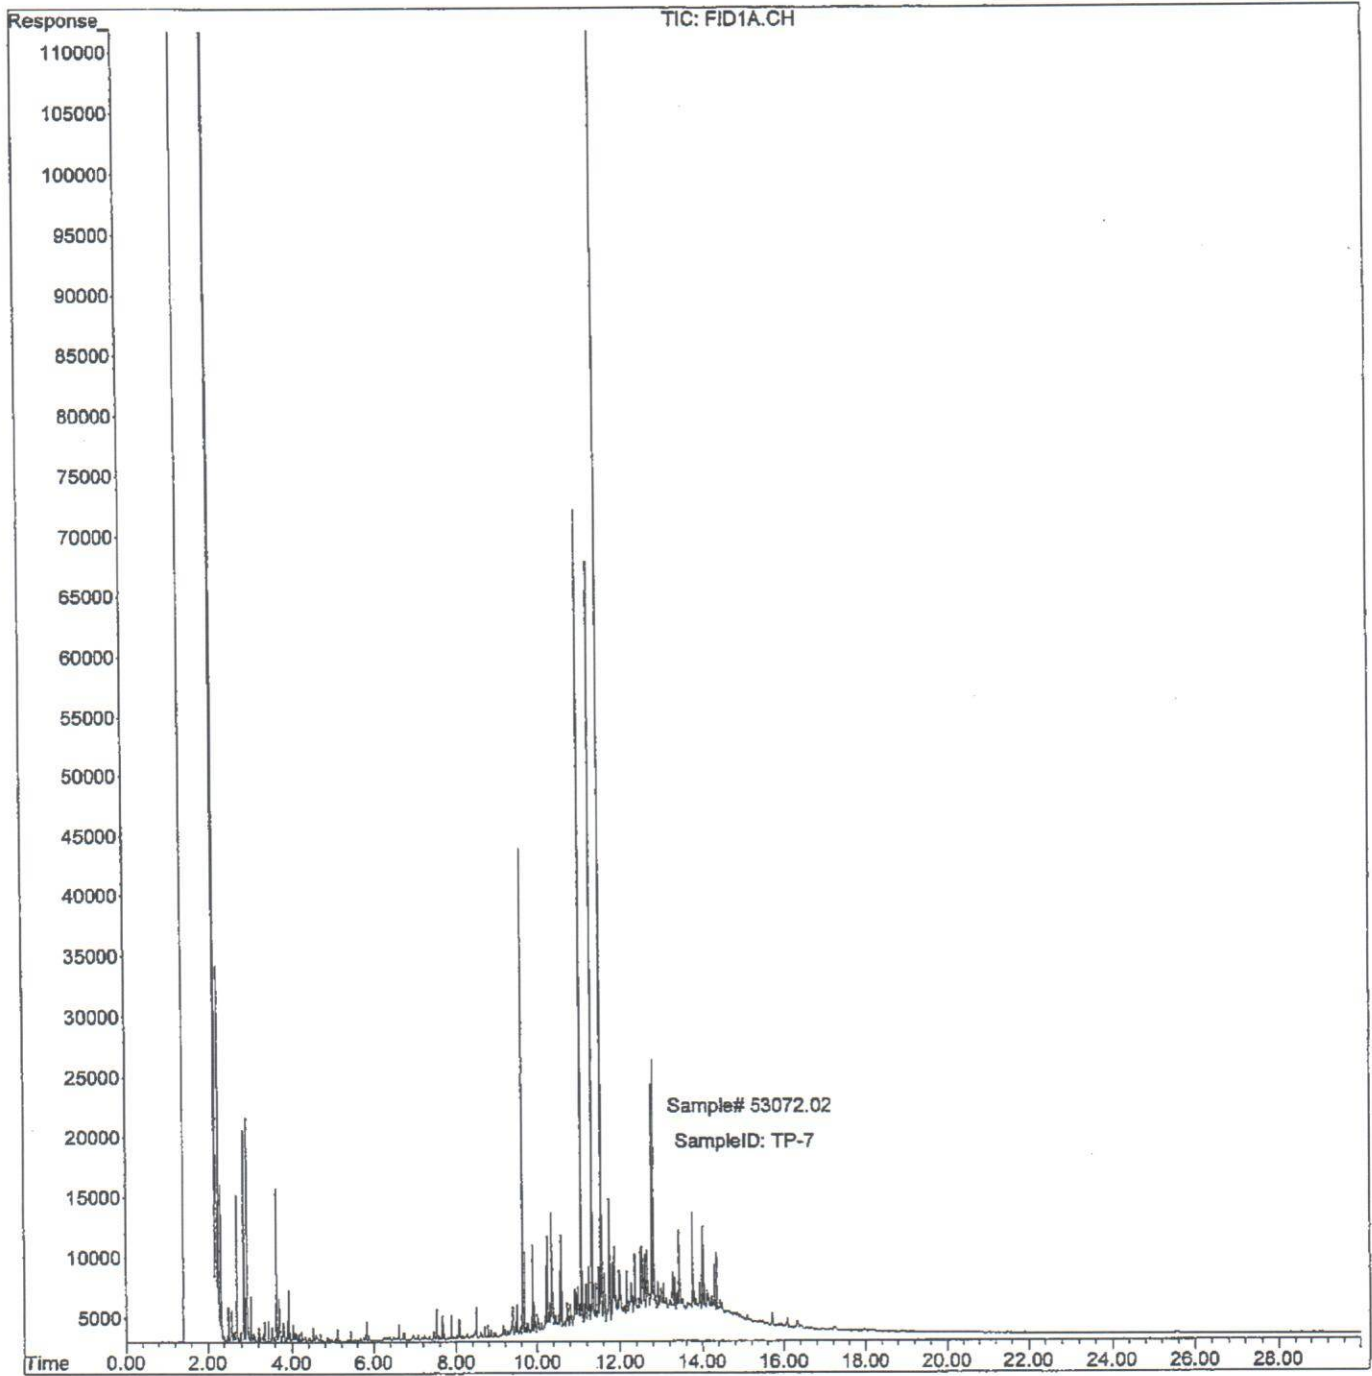
File : W:\2\DATA\FEB06\FEB1406\SV021415.D
Operator : JTO
Acquired : 14 Feb 2006 19:22 using AcqMethod RUN8100X.M
Instrument : FID
Sample Name: 53072.02
Misc Info : S021406MEDRO1
Vial Number: 15

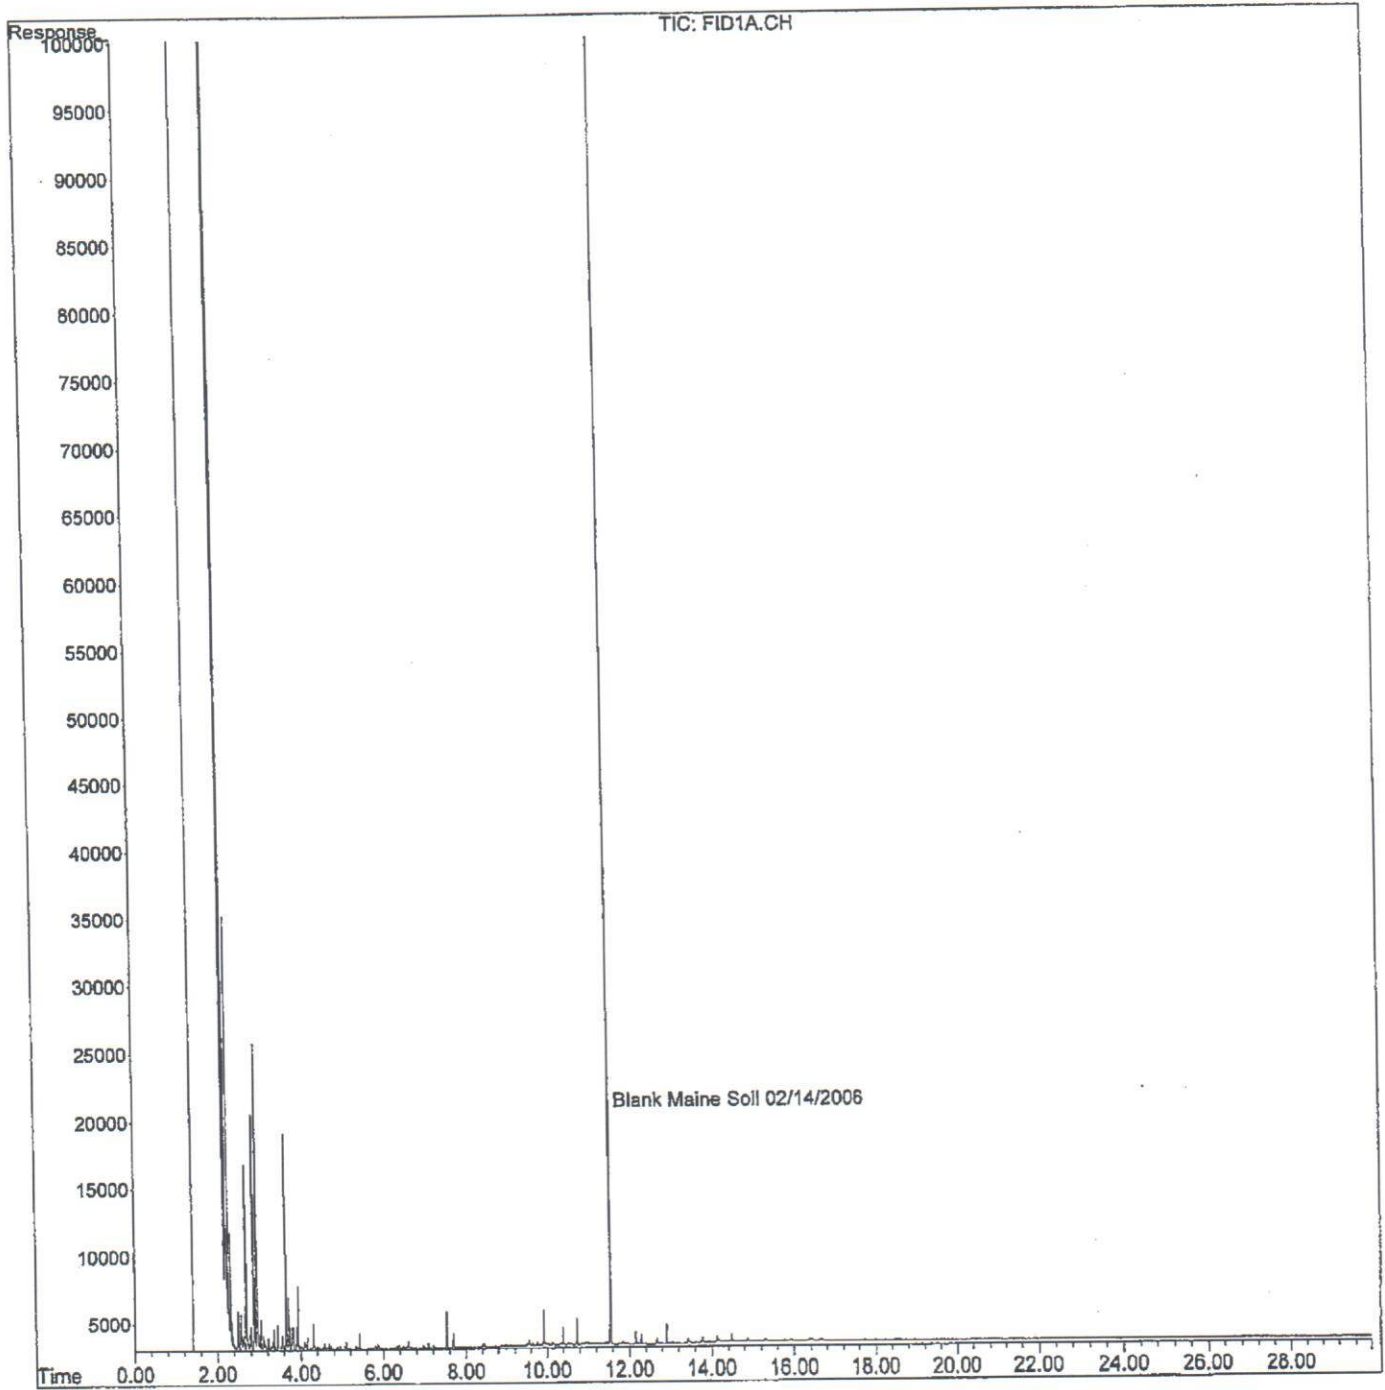
File : W:\2\DATA\FEB06\FEB1406\SV021413.D
Operator : JTO
Acquired : 14 Feb 2006 18:06 using AcqMethod RUN8100X.M
Instrument : FID
Sample Name: BLNKS021406MEDRO1
Misc Info : S021406MEDRO1
Vial Number: 13
