**Level III Final Site Plan Application;**  
**50 Industrial Way, LLC - Allagash Brewing Company**  
**Tax Map 326 Block B, Lot 8, Lot 9 and Lot 10**

On behalf of 50 Industrial Way, LLC, Sebago Technics, Inc. is submitting this Final Site Plan application for an expansion of the Allagash Brewing facility located at 50 Industrial Way in Portland, Maine. As you will recall, we met with the Planning Board at their July 8<sup>th</sup> workshop meeting to introduce the proposed phased development for this property.

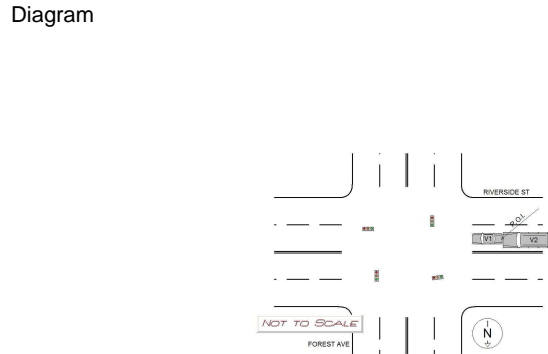
**Narrative**  
 V1 WAS STOPPED AT A RED LIGHT. V2 MOVED FORWARD DID NOT REALIZE THAT V1 WAS STOPPED FOR THE RED LIGHT AND HIT V1 IN THE REAR END. V1 AND V2 HAD MINOR DAMAGE AND WERE ABLE TO DRIVE AWAY.
