**Project:** Casco Bay PG – Stair/Elevator Tower Restoration  
**Project #:** WO 3604  
**Date/Time:** June 30, 2016, 9:00 a.m.  
**Observers** Joshua Martin-McNaughton, Author (BSE)

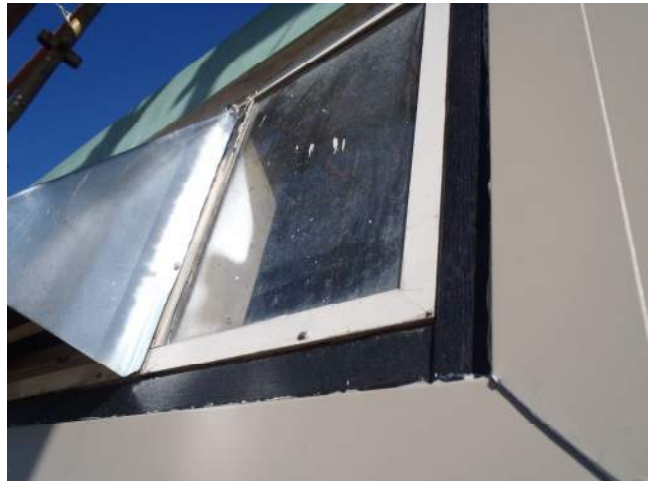
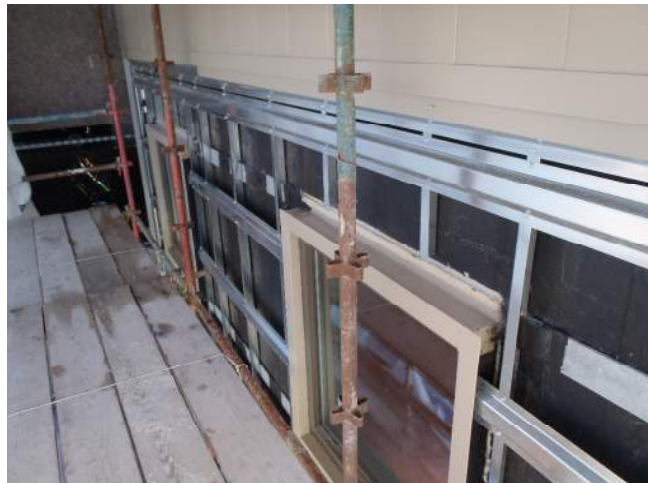
1. Items 2, 3 & 4 below address the exterior punch list items for levels 4 and 5.
2. The windows, elevator curtain wall and wall panels need to be washed down of dust and debris prior to removal of the staging.
3. At the elevator louver, there is exposed wood blocking coated in air/vapor barrier, see adjacent photo. The exposed wood needs to be covered in metal flashing and the louver perimeter sealed.
4. At a few locations staging and equipment have bumped into the wall panel and scraped small areas of paint off. These areas are to be touched up with paint to match the wall panel.
5. The metal wall panel installers are working at level 3 and the levels below, see adjacent photo. Staging is anticipated to start to be removed once the above items are completed.
