**Project:** Casco Bay PG – Stair/Elevator Tower Restoration  
**Project #:** WO 3604  
**Date/Time:** May 17, 2016, 10:00 a.m.  
**Observers** Joshua Martin-McNaughton, Author (BSE)

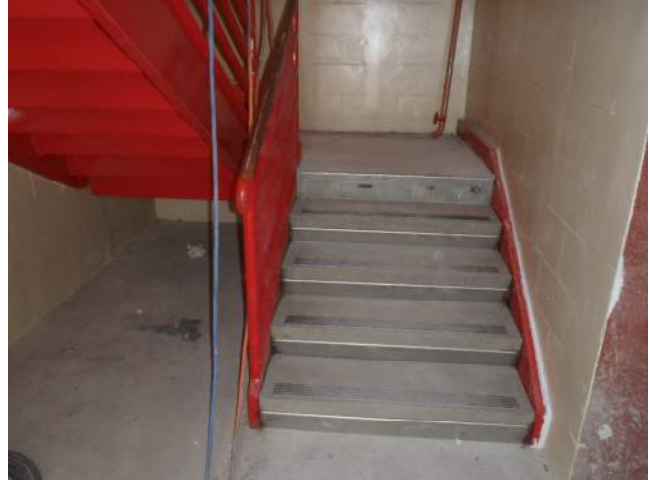
1. The precast stair treads and cast-in-place landing have been installed at grade level. See adjacent photo. There was a discussion during the 5/12 project meeting to address the rough surfaces of a few of the cast-in-place concrete stair treads. Although not a safety hazard, installation of tread covers or application of sand/epoxy coating would protect the treads from further damage and make them look better.

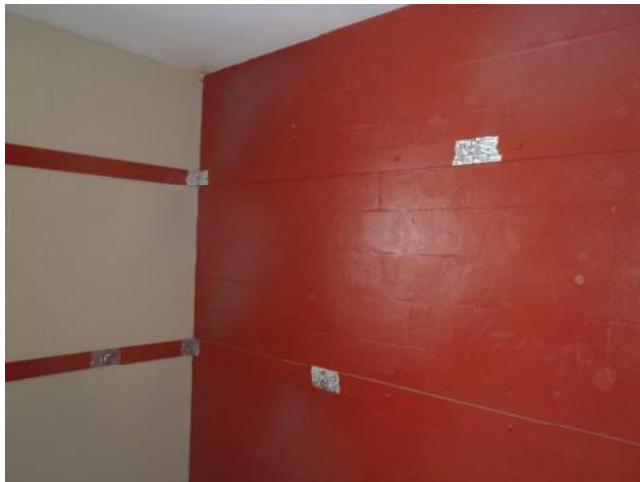
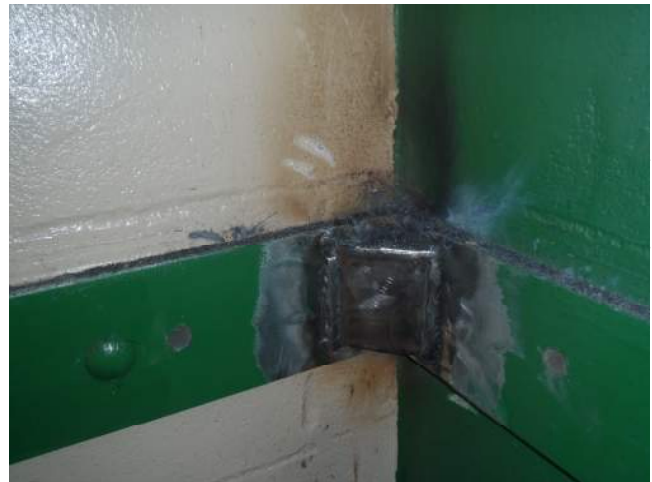
2. The steel plate bands have been bolted to the CMU walls. The steel plates were butt welded at the splices and fillet welded to one another at the inside and outside corners. See photo below. The welded splices as installed were not an approved detail. BSE discussed the issues with KISC and Smith Custom Fabrication and the splices will be installed as originally detailed. The butt welds at the plate splices will have to be ground down flush to weld the new splice plates as originally detailed. At the inside corners the through bolts interrupt where the steel angle splices were to be welded. BSE discussed the condition with SCF and 3" mitered channels are to be welded to the plates. See photo below.

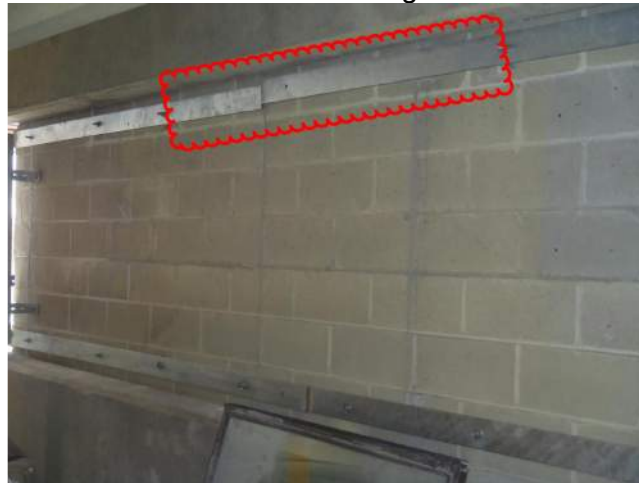
3. Where the through bolts are anchored through the exterior portion of the wall, the bolt/nut assembly and steel plate have been detailed with air/vapor barrier membrane.
4. BSE asked that where gaps occur between the steel plate bands and CMU wall that the area be packed with grout to provide bearing between the plate and CMU wall.
5. At the 2<sup>nd</sup> and 3<sup>rd</sup> levels, bolts were missing at the exterior steel plate along the garage side. See photo below (Level 2 shown). Due to misalignment and stringer interference the bolts were only installed at the interior. BSE asked that drilled and epoxied anchor bolts be installed into the grouted/reinforced cells at the missing locations.

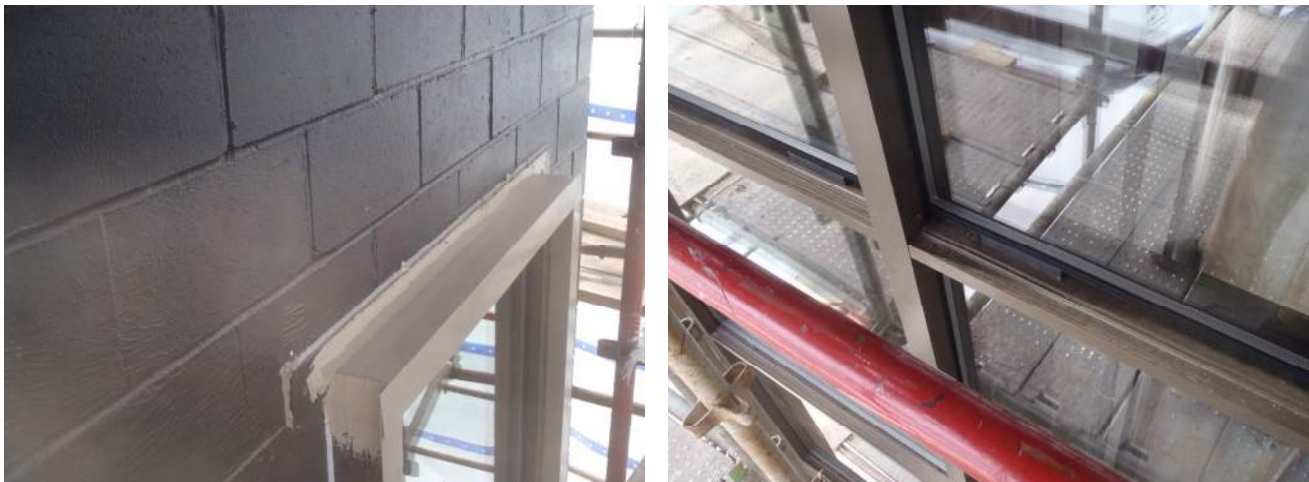
6. All through bolt threads need to be “upset” to prevent the nuts from potentially backing off.
7. Elevator mechanics are working on restoring the elevator.
8. Electricians are in the process of installing light fixtures, outlets and conduit runs.
9. The majority of the interior painting has been completed and touch ups in a few areas will be required. Stair handrails have been reinstalled.
10. The windows frames and flashing were being in the process of being installed. The curtain wall frame was installed at the elevator shaft. See photos below.

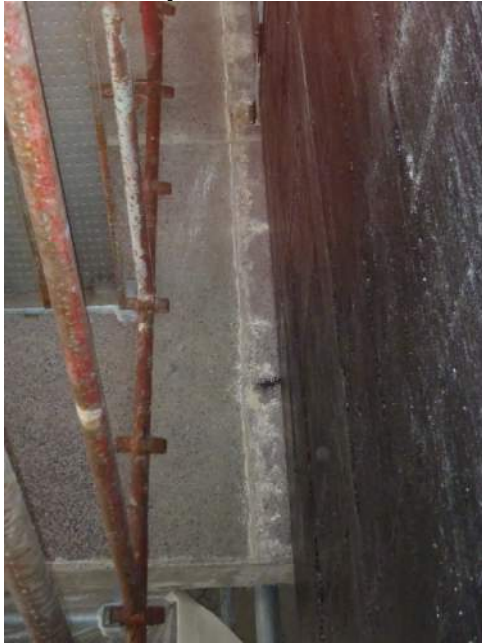
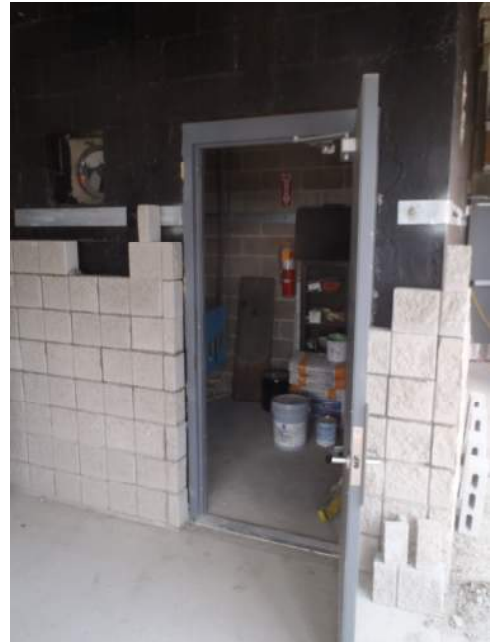
11. The old joint sealant between the precast spandrel and masonry should be removed prior to installation of the split face block. See photo below. New backer rod and joint sealant is to be installed at this joint.

12. Split face block wall rebuild has begun at the ground level. See photo above. Once the masonry is above the soffit, the masonry can transition to standard 4" wide CMU as it will not be seen.
