# Final Report of Structural Special Inspections

Project: *New 3-Unit Building*  
Location: *62 Cumberland Street; Portland Maine*  
Owner: *Eco Capital, LLC*  
Structural Design Professional in  
Responsible Charge: *David A. Price, PE / Price Structural Engineers, Inc.*  
Date: *July 19, 2011*

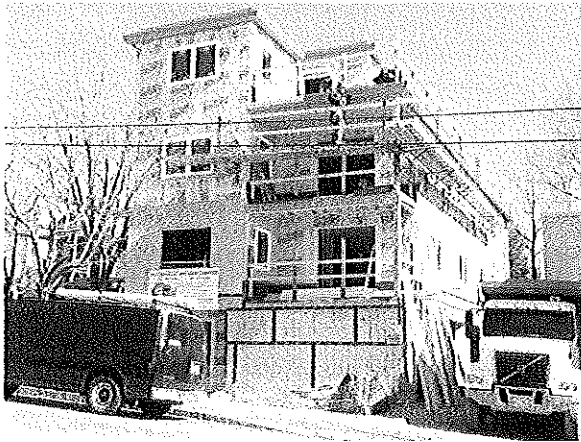
**Photo # 1 – North elevation**

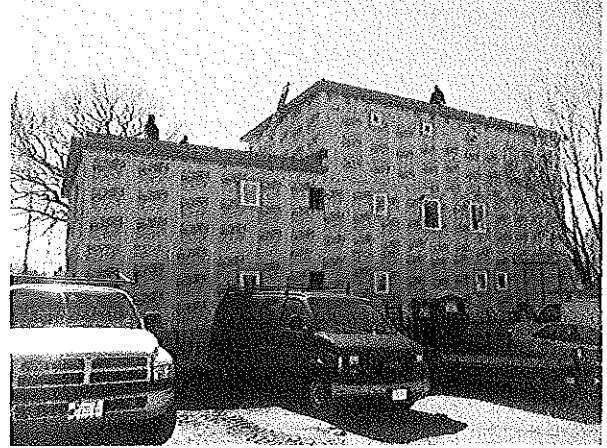
**Photo #2 – East elevation**

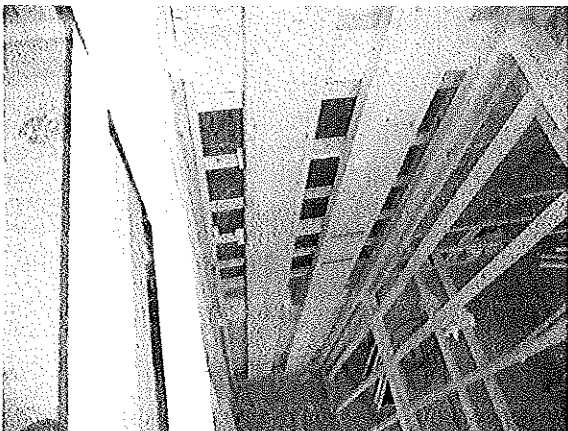
**Photo # 17 – 2<sup>nd</sup> Flr: Elevator shaft framing**

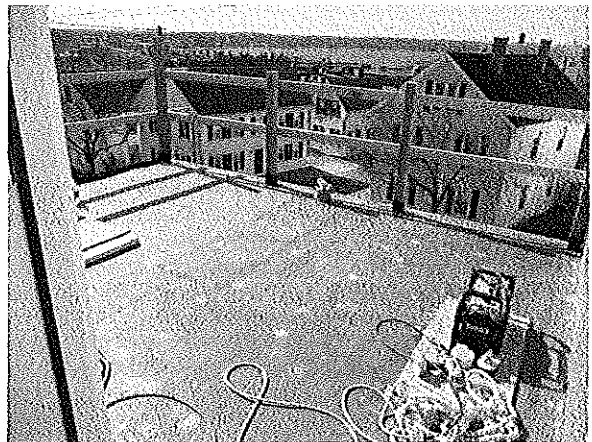
Photo #24 – 3<sup>rd</sup> Flr: View looking at Back Cove
