Rear 80 CUMBERLAND AVENUE

File: BP 48/171 (80 Cumberland
Avenue, rear)-1

Subject: demolition of city-owned building at the rear of 80
Cumberland Avenue

Subject: Conditions on city-owned lot at the rear of 30 Cumberland Avenue where building has been demolished—reply to your memorandum of April 15

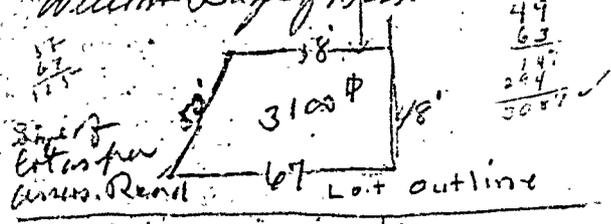
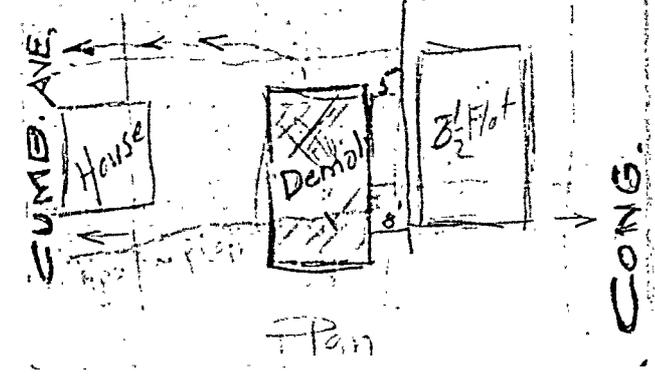
① base 4 1/2" brick wall
+ 1/2" in mortar.
② ground base in bc.
concrete card and cast fill

③ depth abt 4' filled in
with soil.

The situation is now that this former brick underpinning
wall has been left standing and is called upon to retain a height
of dirt of 4' at one point and tapering off less at the ends. The
wall is not good masonry, and while it may stand for a long time,
it probably will sometime collapse due to the weight of earth be-
hind it, and such collapse could occur at any time if the earth
which the wall holds should be further weighted down by some
vehicle or by storage of goods on the ground.

The remainder of the foundation wall may also cave into the cellar at any time, and it is my recommendation, after the liability of the City has been established, that this remainder of the wall be pulled over into the excavation, to avoid having it fall on someone who, though a trespasser, would perhaps have some grounds for damages.
