DEVELOPMENT REVIEW COORDINATOR
POST APPROVAL PROJECT CHECKLIST

Project Name: Seaport Lofts (Bay House Phase II)

This report presents the results of our independent technical evaluation of excessive retaining wall movements and damage to adjacent properties potentially associated with the construction of the Seaport Lofts development project located on Newbury Street in Portland, Maine. This work was undertaken at your request, in accordance with our proposal dated 13 May 2015, as authorized by Joseph Cahoon, Jr. (attorney with Richardson, Whitman, Large and Badger who was authorized by Travelers to execute the agreement) on 14 May 2015.

Haley & Aldrich, Inc. (Haley Aldrich) was retained in mid-May to conduct an independent technical evaluation to assess the cause(s) of the excessive retaining wall movements and damage to adjacent structures and to determine possible measures to stabilize the site so that construction could continue.

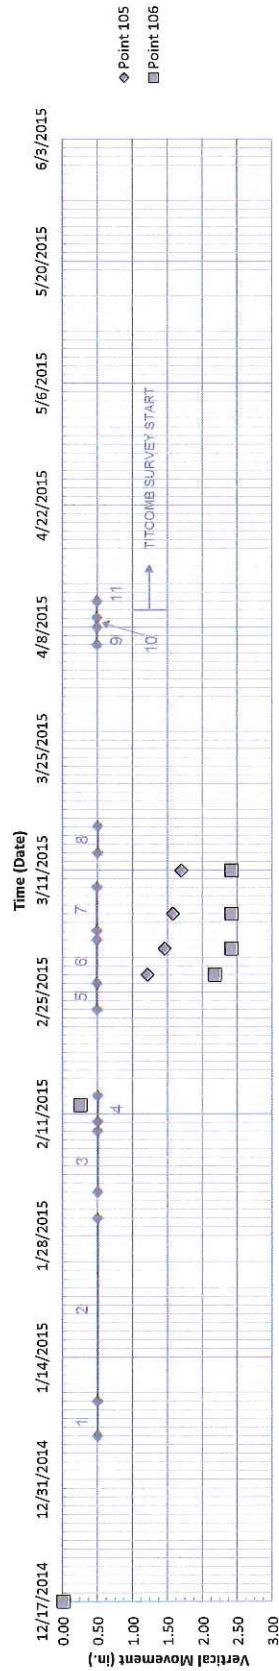
Monitoring Points on Ground Uphill of Sheeting

- Excavation to the lower brace level within the SOE system (event No. 5 above) and installation of the lower brace level (event No. 6) precipitated up to 1.5 to 2 in. of settlement of the existing retaining wall and ground surface immediately north of the SOE system (HBF points 105 through 109; see Figure 1, Appendix B). Excavation from the lowest brace level to finish subgrade level inside the SOE system (event No. 7) resulted in 0 to ¼ in. of additional settlement of these points. The settlement trend of these points following event No. 7 showed diminishing or no settlement (see Figure 1, Appendix B).

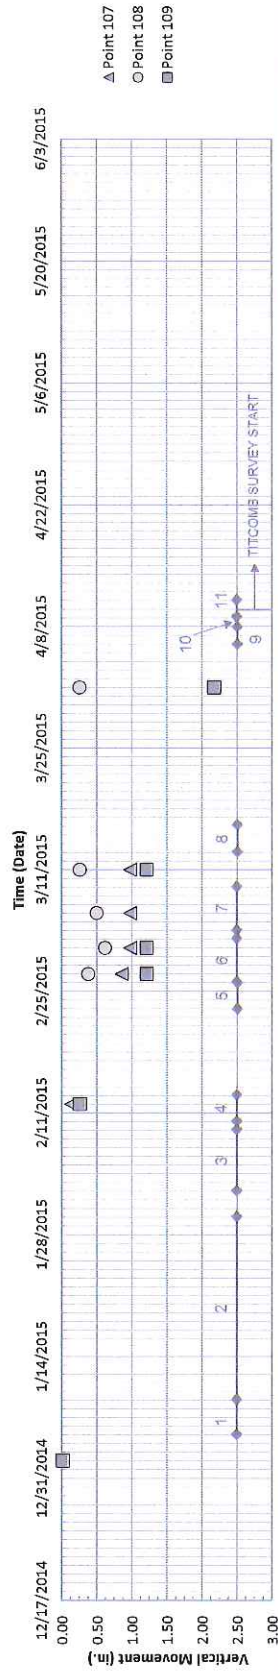
Monitoring Points on Existing Retaining Wall Adjacent to Blue House

- There is little evidence of additional settlement of the existing retaining wall and ground surface immediately north of the SOE system (except HBF points 107 and 109) associated with forming/pouring of the new retaining wall, backfilling and brace removals (events No. 9 through 11). Points 107 and 109 located on the existing retaining wall behind 48 Hancock Street (blue house) settled about 1 in. (see Figure 1, Appendix B) during construction of the wall itself (i.e., after reaching subgrade and prior to backfilling). It is possible that this additional settlement was precipitated by excavation for the installation of catch basin CB-4 and associated piping located 10 to 15 ft south of the existing wall. The bottom of the excavation for CB-4 is several feet lower than the excavation for the retaining wall footing.

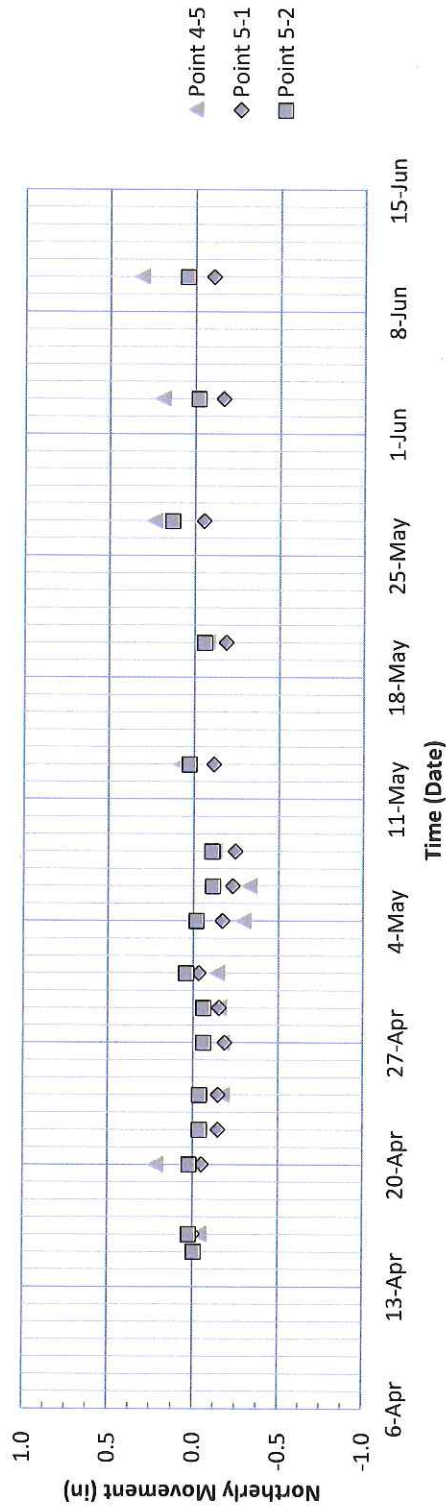
Foundation Movement, 48 Hancock Street (blue house)

established after the new retaining wall movement and movement of 48 Hancock Street (blue house) was observed.

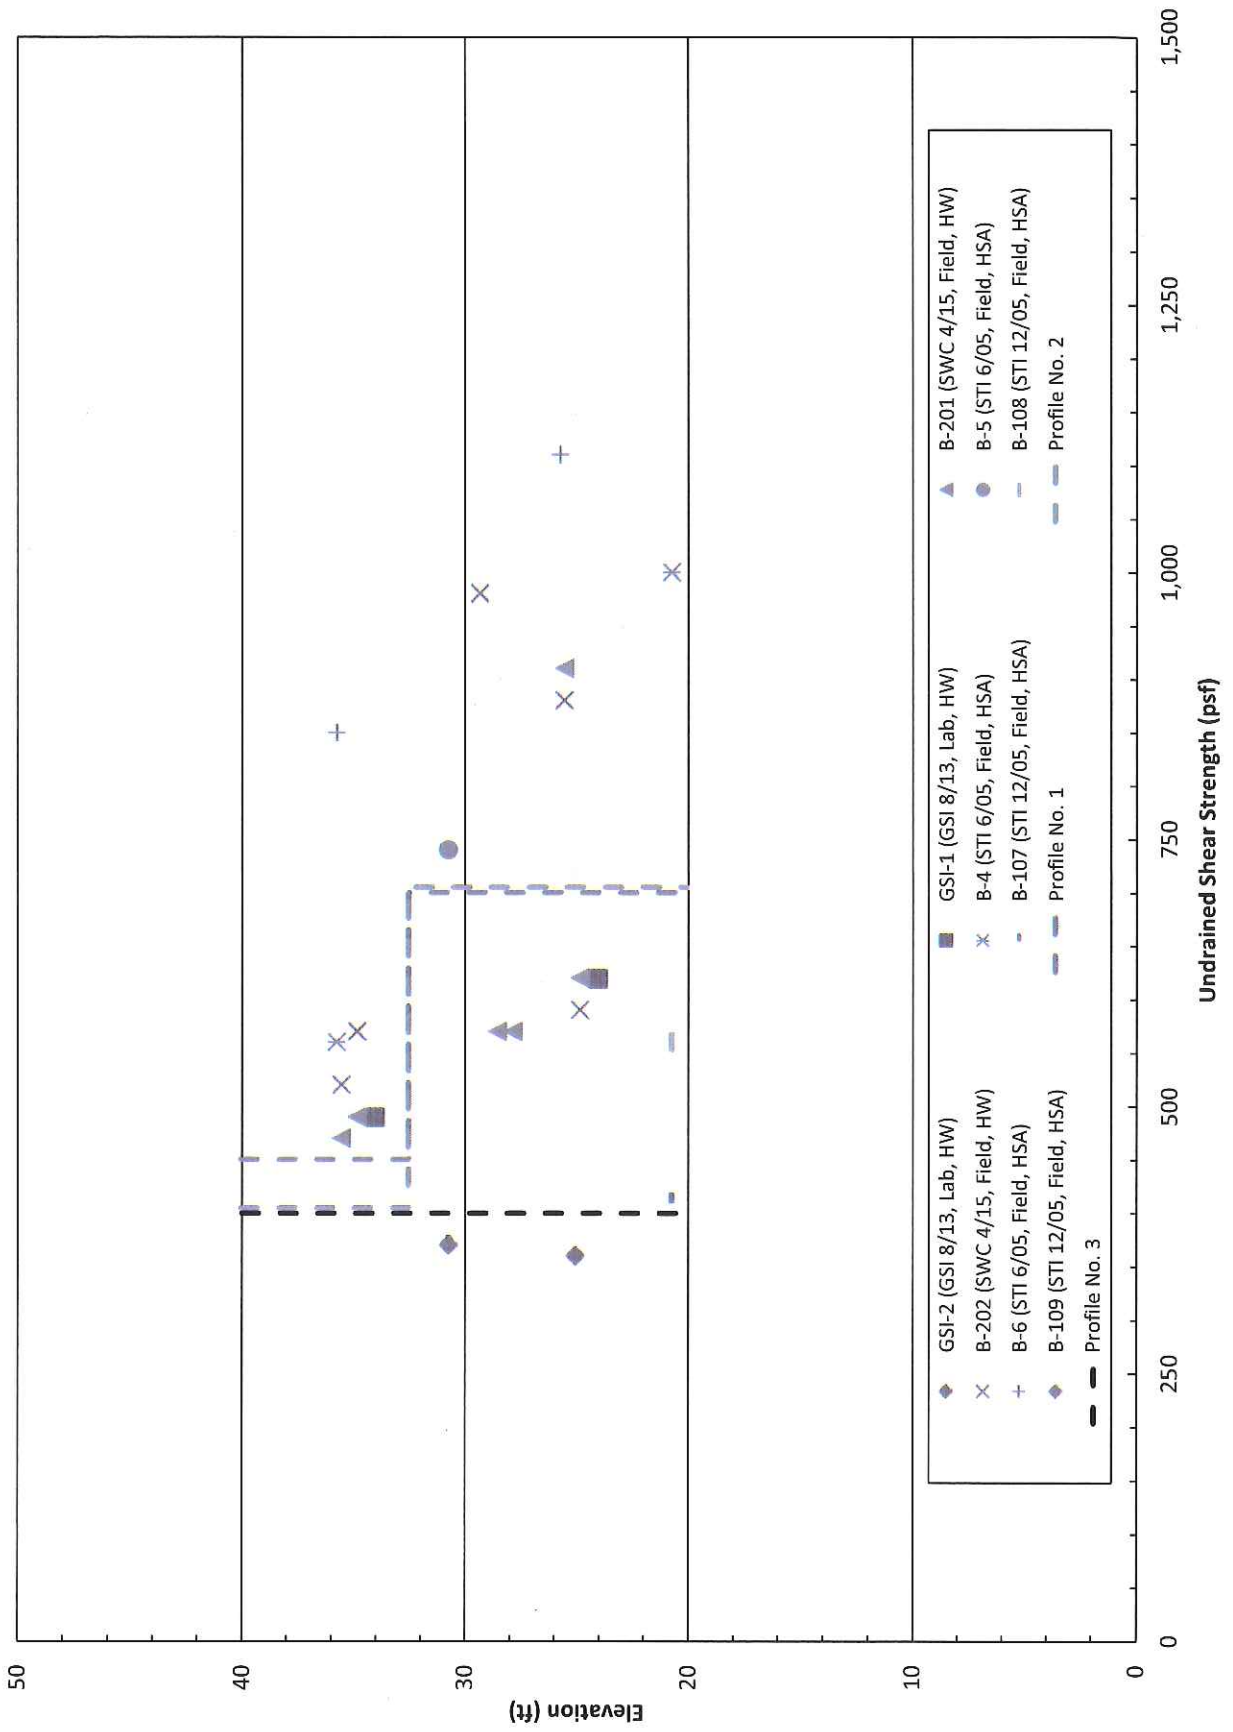
Newbury Street Lofts Marine Clay Undrained Shear Strength Data

3. Refer to Figure 2 for marine clay undrained shear strength profile details. Undrained shear strength values shown taken from in-situ vane shear and laboratory unconfined compressive strength tests completed by Geotechnical Services, Sebago Technics and SW Cole within and from test borings drilled on site.
