Structural Special Inspections Report

Maine Eye Retina & Surgery Center

Portland, Maine
December 22, 2016

Structural Engineer of Record
Becker Structural Engineers, Inc.
75 York Street
Portland, ME 04101
207. 879. 1838

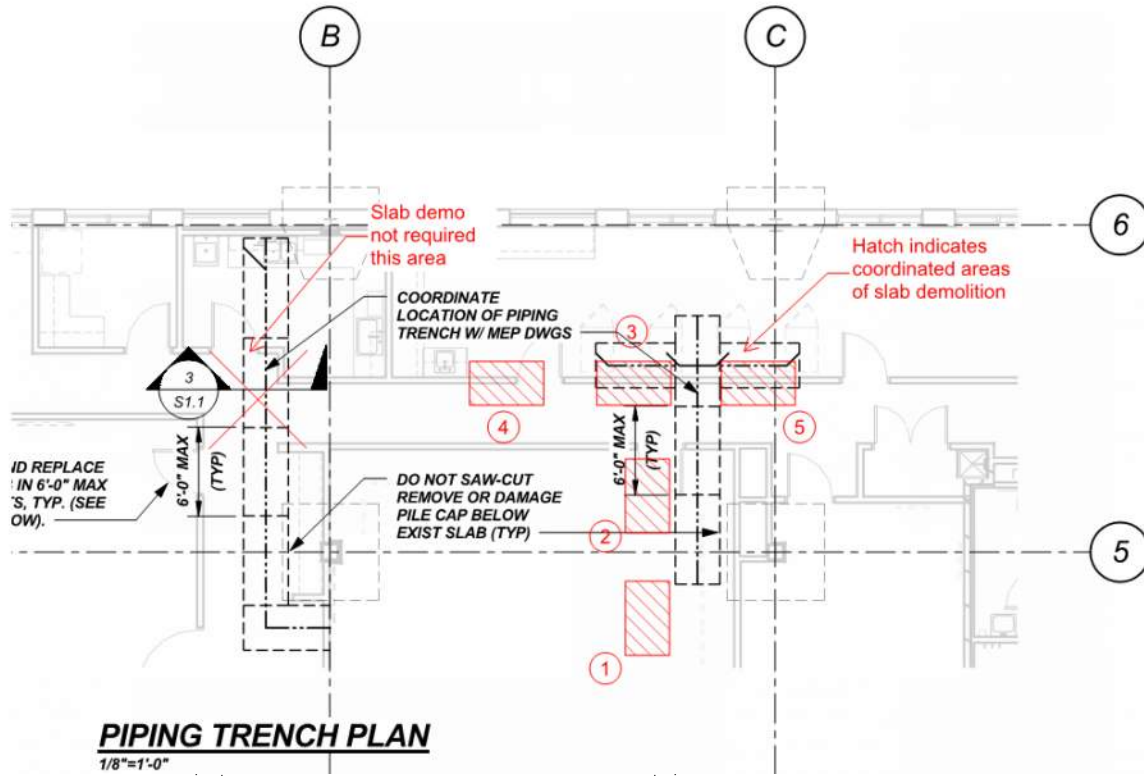
Figure 1: Slab Cut Locations for New MEP Installation

The reinforcement in the exterior pad was observed to be in conformance with the structural drawings. During my visit, I also observed the coupler and reinforcement installation in openings 1 and 2 in the ground floor slab (see figure 1, and photos 1 and 2). The reinforcement and couplers were installed per the structural drawings and per the requirements identified in the Concrete Report on 8/15. The GC was instructed to place concrete in these two openings only. Reinforcement work within openings 3,4 and 5 is ongoing, and we will inspect this during future visits to the site.
