Structural Special Inspections Report

PEARL PLACE BUILDING 1& 2

Portland, Maine
December 5, 2007

Structural Engineer of Record
Becker Structural Engineers, Inc.
75 York Street
Portland, Maine 04101

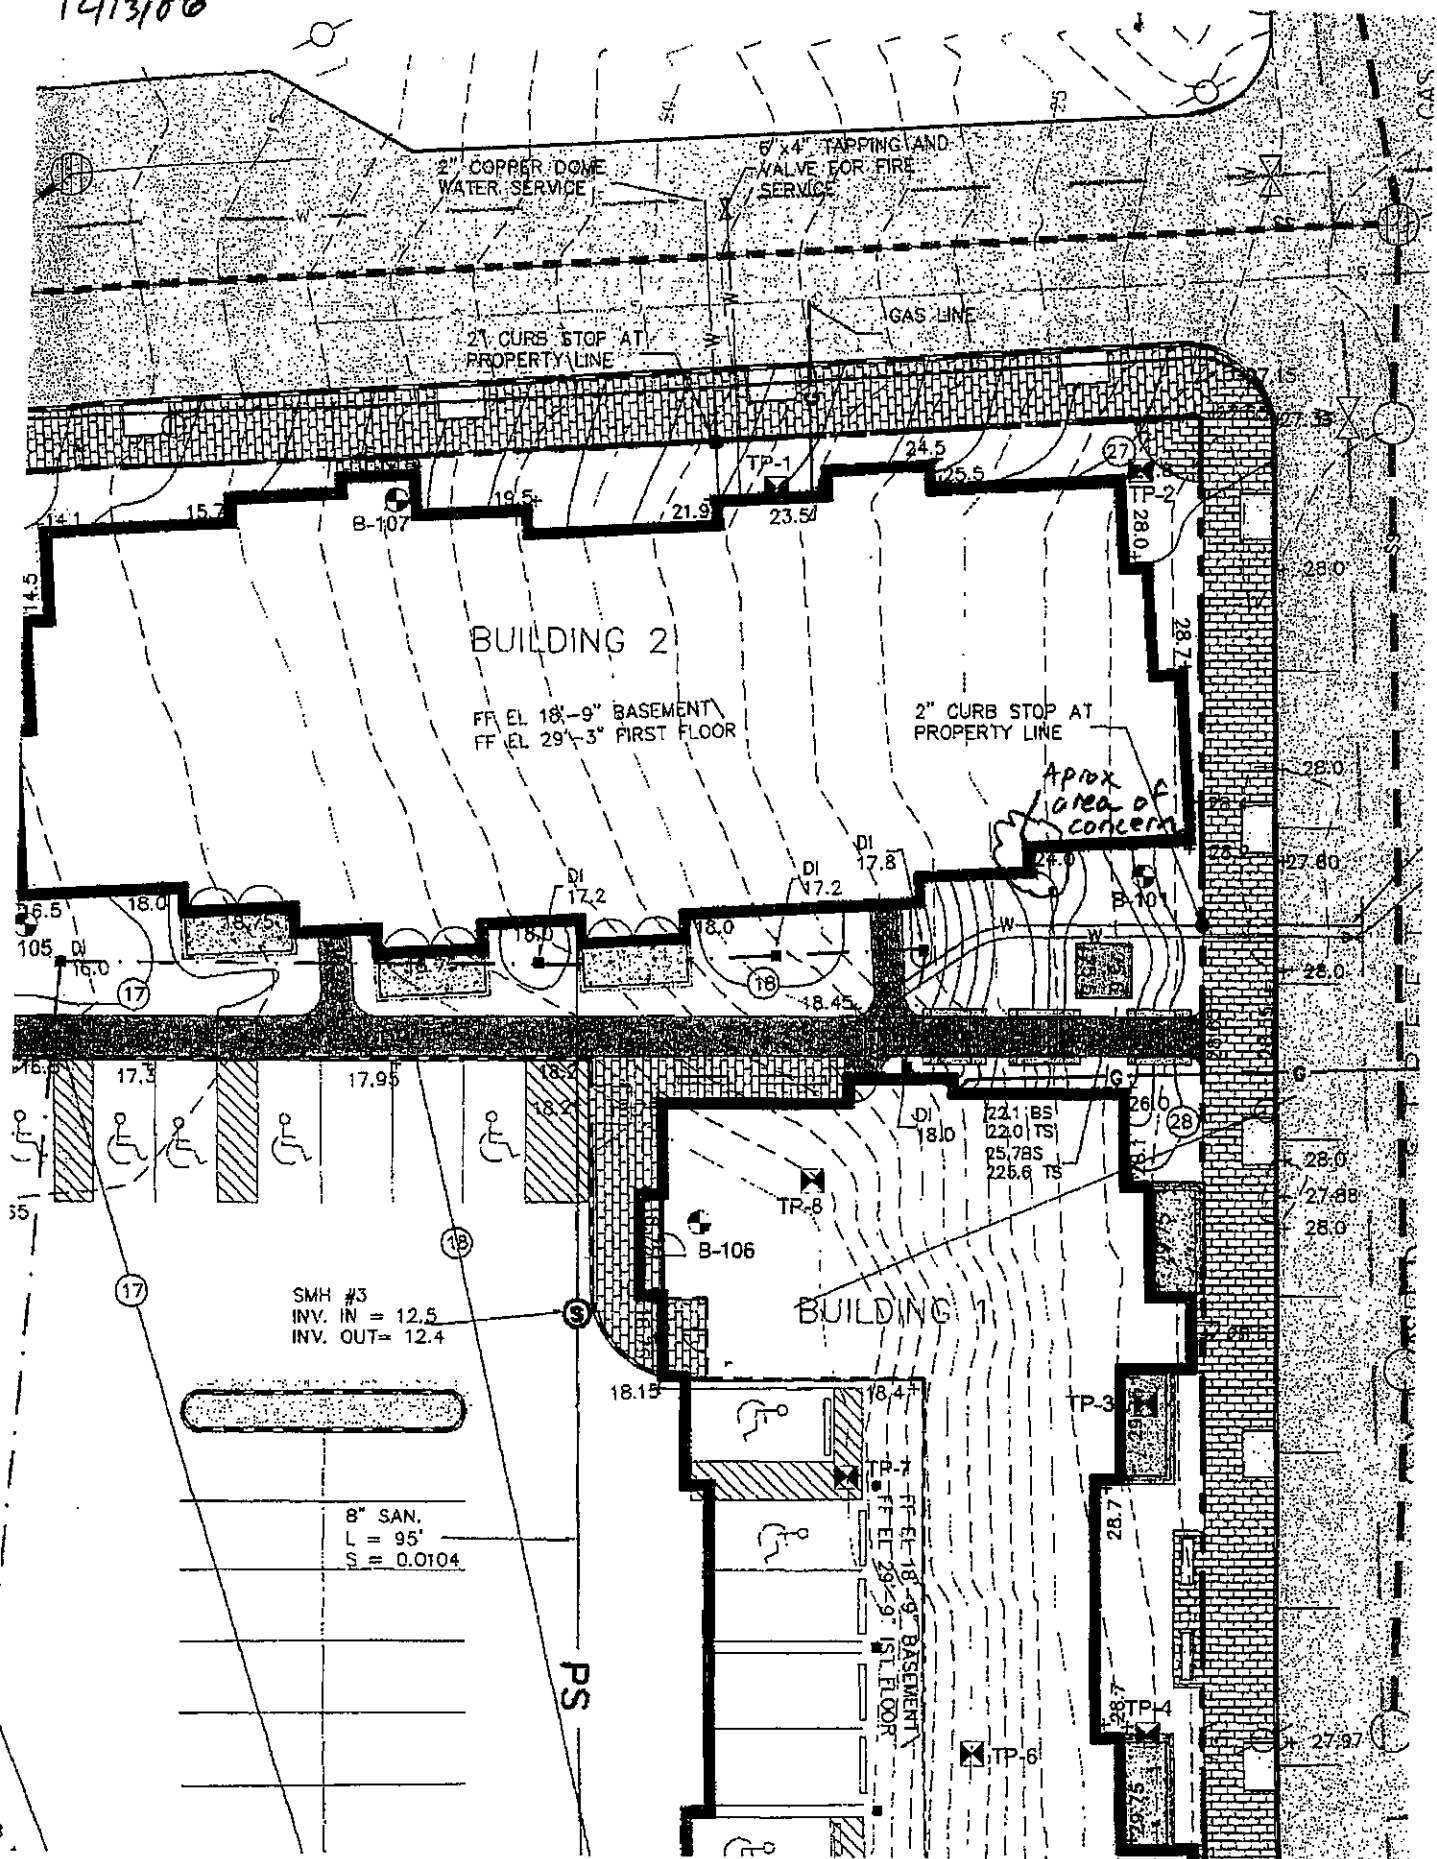
Observed vastable "spongy" soils beneath the south footing of building #2. Approximate 30' from corner of building on Oxford St. Colex was asked to over excavate and fill void with crushed stone. As of 12/13/06 this had not been done.
