BUILDING INSPECTION

416-420 Fore Street
Portland, ME 04101

Inspection No. S14-1152 - 416-420 Fore Street
Date of Inspection: 09/25/2014
Engineer: Jack Carr, P.E.

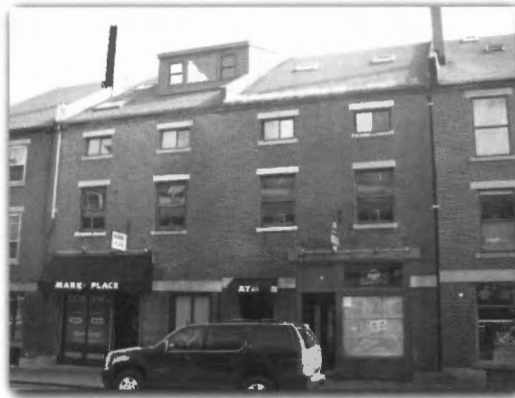
The Fore Street elevation has street level entrances for both the prior commercial tenants and a primary entrance for the apartments above.

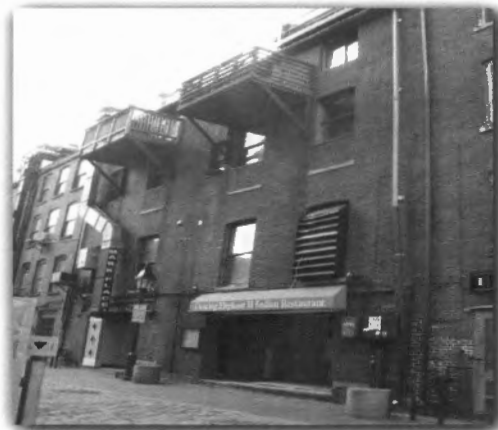
The Wharf Street entrances were used prior for restaurant tenants and are the only access to the full connected basement under the footprint of both these two attached buildings.

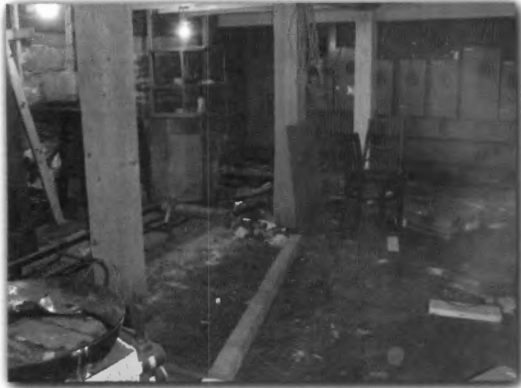
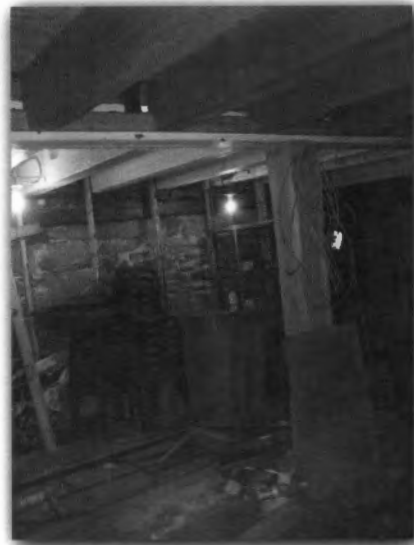
Where visible, the floor joists, girders, columns, ceiling joists, rafters, and wall framing are in good condition.

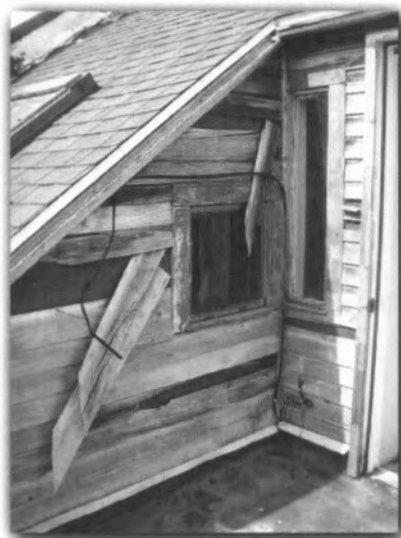
While we saw no visible evidence of any significant rot present in this structure, you should not assume that no rot exists in any of the inaccessible areas. Rot can result from moisture accumulating underneath the siding, behind trim, or within the wall cavities should the normal drying process be restricted by insulation or other obstacles. It should be noted at the rear of the building the low slope roof area had significant siding damage, which is likely allowing water infiltration into the structure. It is our understanding future renovations will incorporate enclosing this space with the extension of a dormer in the rear.

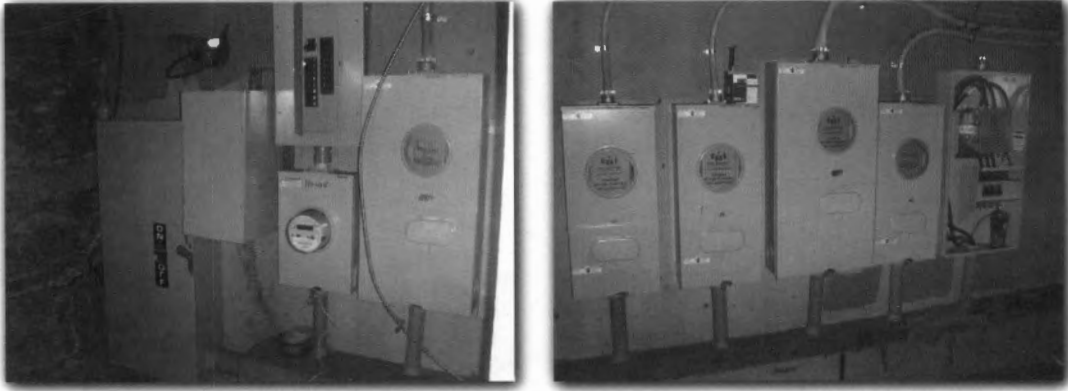
The electrical system consists of a three-wire service and separate panels, each providing 120/240 volts and an apparent 200-amperes to each of the apartments. This is adequate for this building as it now stands.

With the building under renovations the electrical wiring was not complete and most spaces were without power or controls. The tenant tavern space on the Fore Street side had electrical power with a 200 amp subpanel. The wiring and other electrical devices appeared to be of modern design and operational.

The new main electrical panel is located in the basement and has a 600 amp main switch. All tenants spaces have individual meters including the house circuit.
