Project: *Salvation Army Dining Hall V2*
Date Prepared: **October 25, 2017**

Final Report of Special Inspections (SSIC/SI 1)

Project: *Salvation Army Dining Hall Addition*
Location: *88 Preble St, Portland Me*
Owner: *Salvation Army Adult Rehab Command Center*
Owner's Address: *440 West Nyack Rd, West Nyak NY 10994*

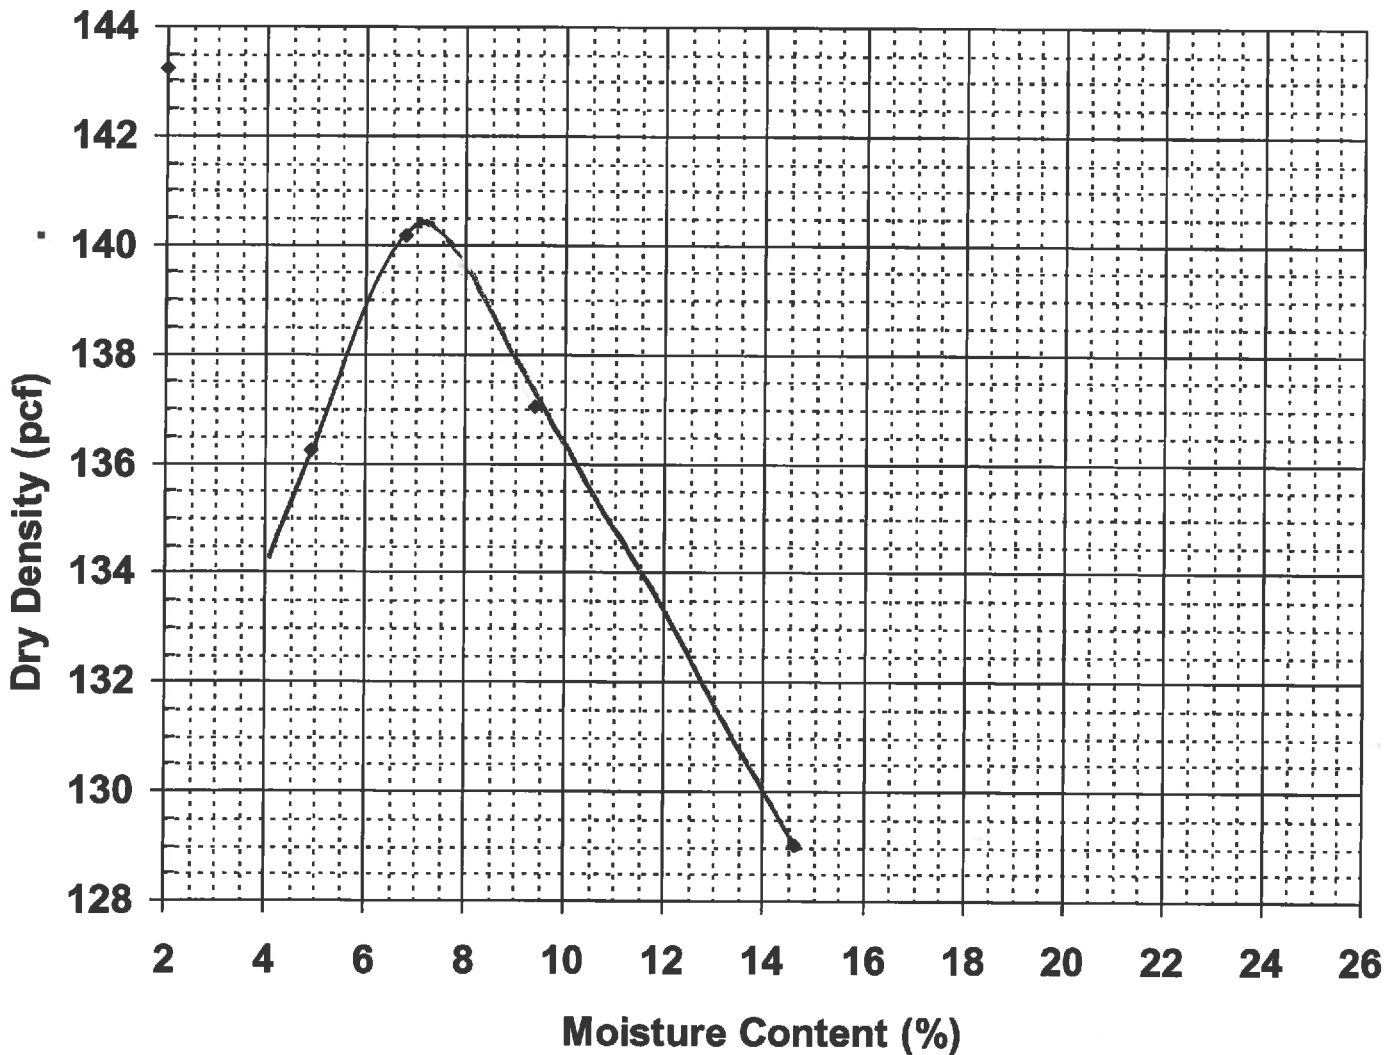
Moisture-Density Relationship Curve

Maximum Dry Density (pcf) 140.3
Optimum Moisture Content (%) 7
Percent Oversized 30.0%

Corrected Dry Density (pcf) **145**
Corrected Moisture Content (%) **5.5**
