Prepared For:  
**LAFAYETTE PROPERTIES, LLC**  
 155 LITTLEFIELD STREET  
 BANGOR, MAINE 04401

Project:  
**Holiday Inn**  
 88 Spring Street  
 Portland, ME

Date: June 30, 2017  
 Scale: As indicated  
**MASONRY REPAIR**

**BE1A**

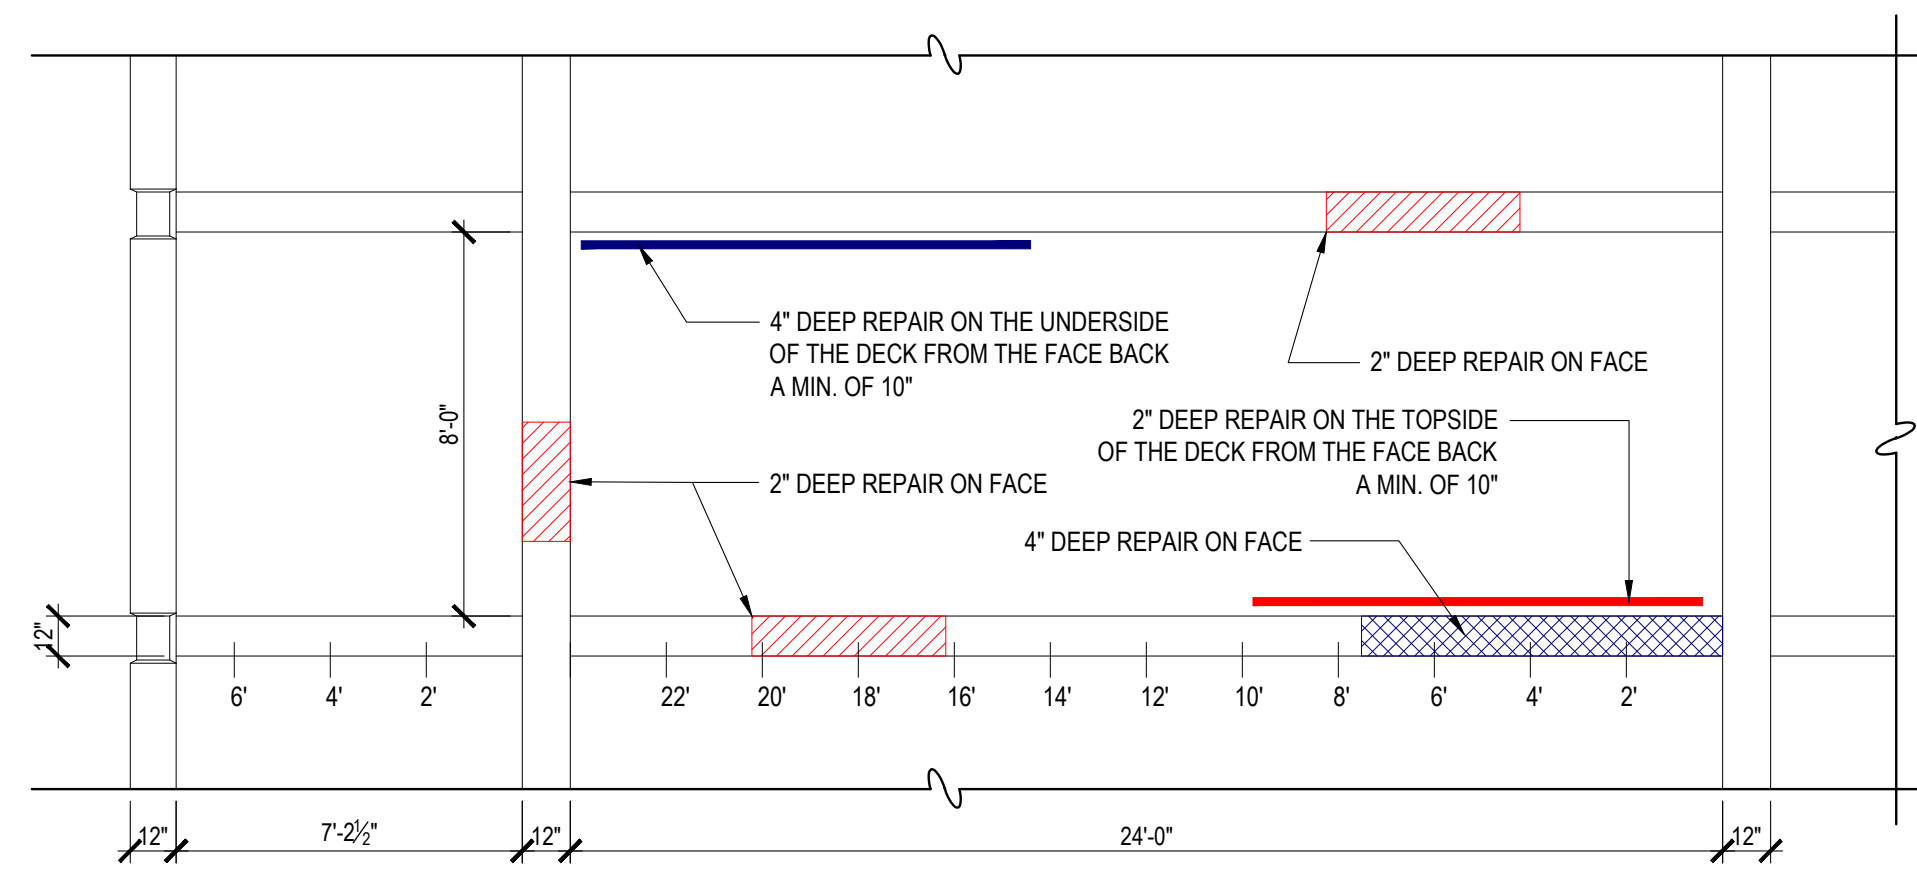
**CONCRETE REPAIR WEST ELEVATION**

**NOTE: REPAIR AREAS REPRESENTED ON THE ELEVATIONS ARE APPROXIMATE AND DETERMINED BY VISUAL OBSERVATIONS FROM GROUND**
