UST CLOSURE SITE ASSESSMENT REPORT SUMMARY COVER SHEET

Facility Name: Harborview Citgo

Location 101 York St. Portland Maine

Purpose of Site Assessment: Document removal of a gasoline UST at the site.

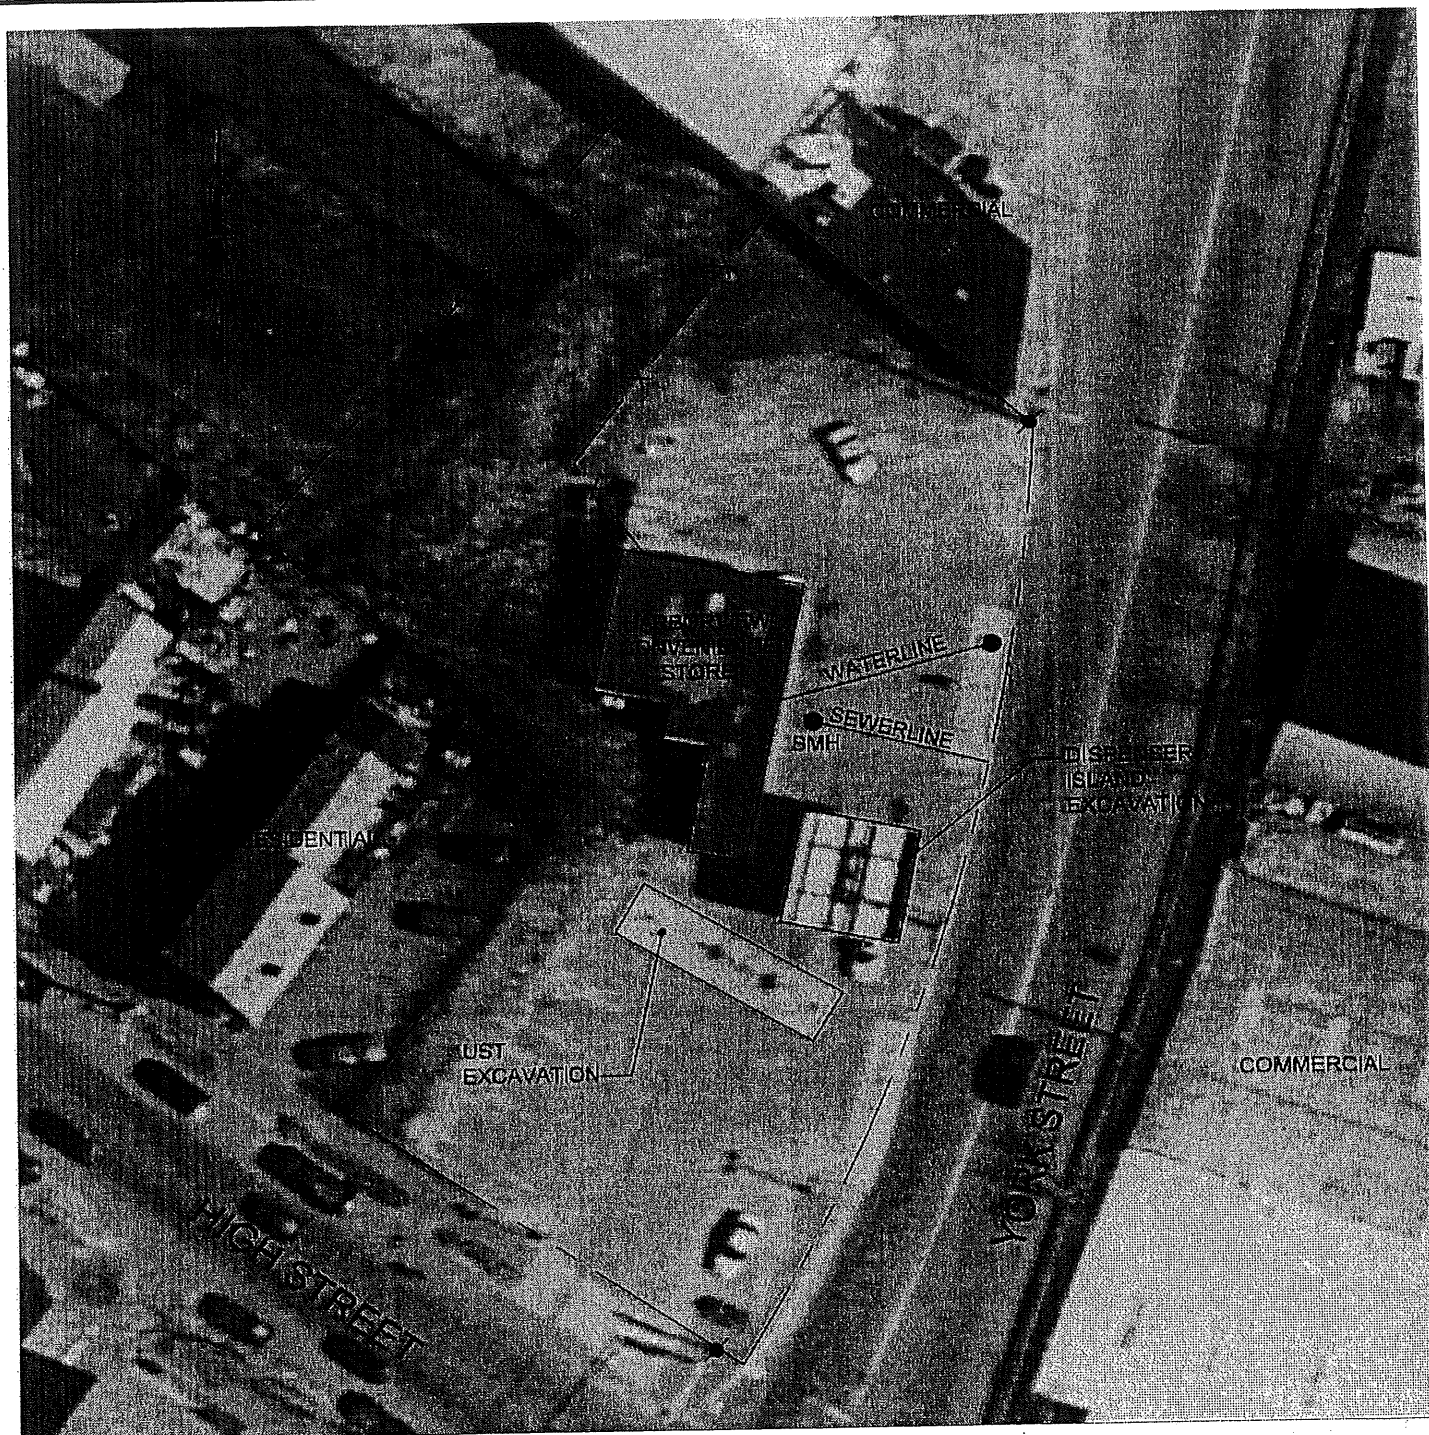
UST CLOSURE EXCAVATION MAP

Field Observations/Screening Summary: Tanks, piping, dispenser appeared to be in good condition but PID readings above 100 ppm, (see attached UST closure soil screening table), petroleum odor, and staining observed; most impacts under dispenser island (see attached Facility and Excavation Maps). Groundwater encountered at approximately 9.0'.

St.Germain observed and documented the removal of a 15,000 gallon, double walled fiberglass coated steel tank, piping, and dispenser island. Petroleum odors in the soil, coupled with PID readings ranging from 571 to 2,295 ppm, indicated a release. During the UST removal, elevated soil headspace was measured at only one location at the excavation bottom edge facing York Street. Elevated headspace was more widespread beneath the island

Recommendations: Provide additional information In Closure Report as required by Appendix P when contamination is found (see attached UST Closure Supplemental Information). Remove soil with headspace above 500 ppm encountered beneath the former dispenser island as practical, and dispose of at a licensed soil disposal facility, as agreed to by MEDEP.

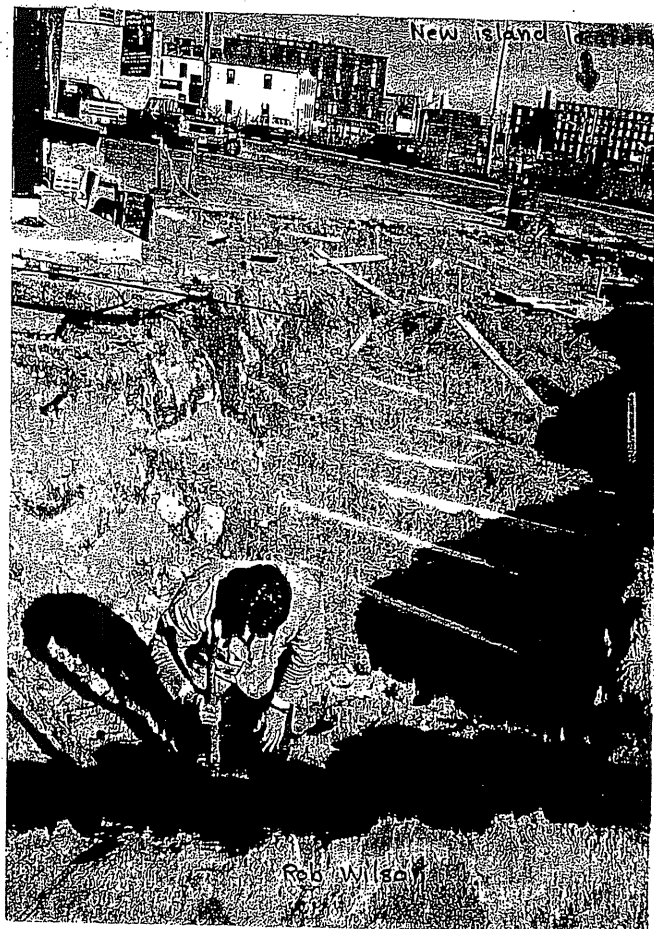
P-061-91
Photos by SGB 2/4/91

↑ Installing new product lines.
