Re: Special Inspections Final Report
645 Congress St.
Portland, Maine

Final Report of Structural Special Inspections

Project: *Renovations to 645 Congress Street*
Location: *645 Congress Street; Portland Maine*
Owner: *Bayside Maine, LLC*

Structural Design Professional in
Responsible Charge: *David A. Price, PE / Price Structural Engineers, Inc.*

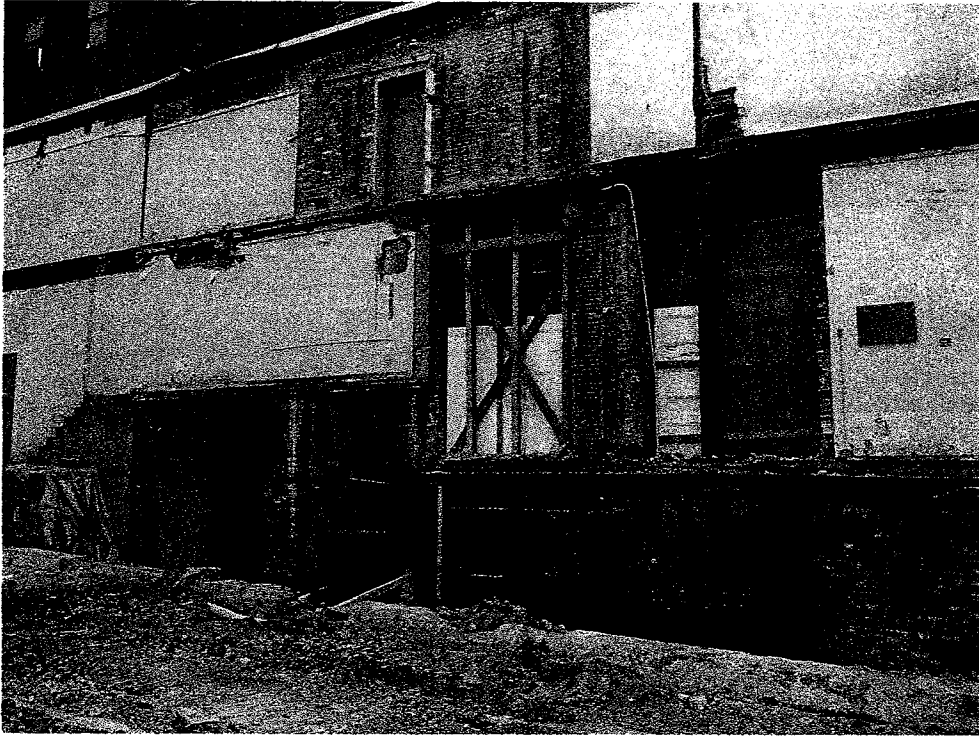
Photo # 1 – Elevation at back wall (view looking South at grid F, near grid 6)

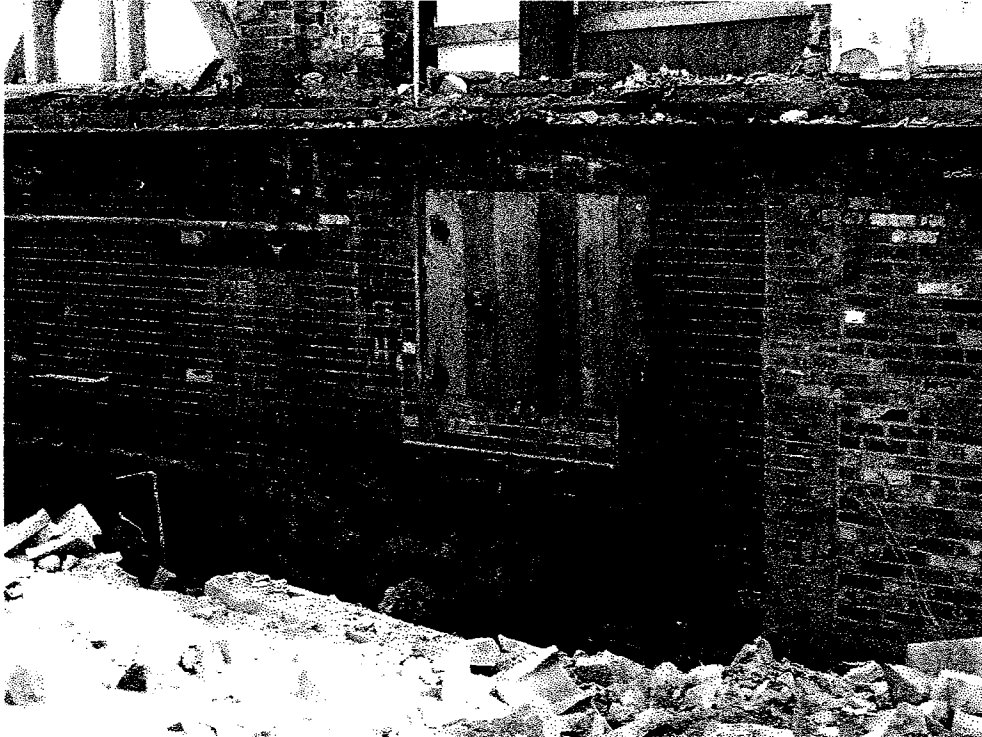
Photo # 2 – Existing window below new column and F/5.8 will need to have solid masonry infill.

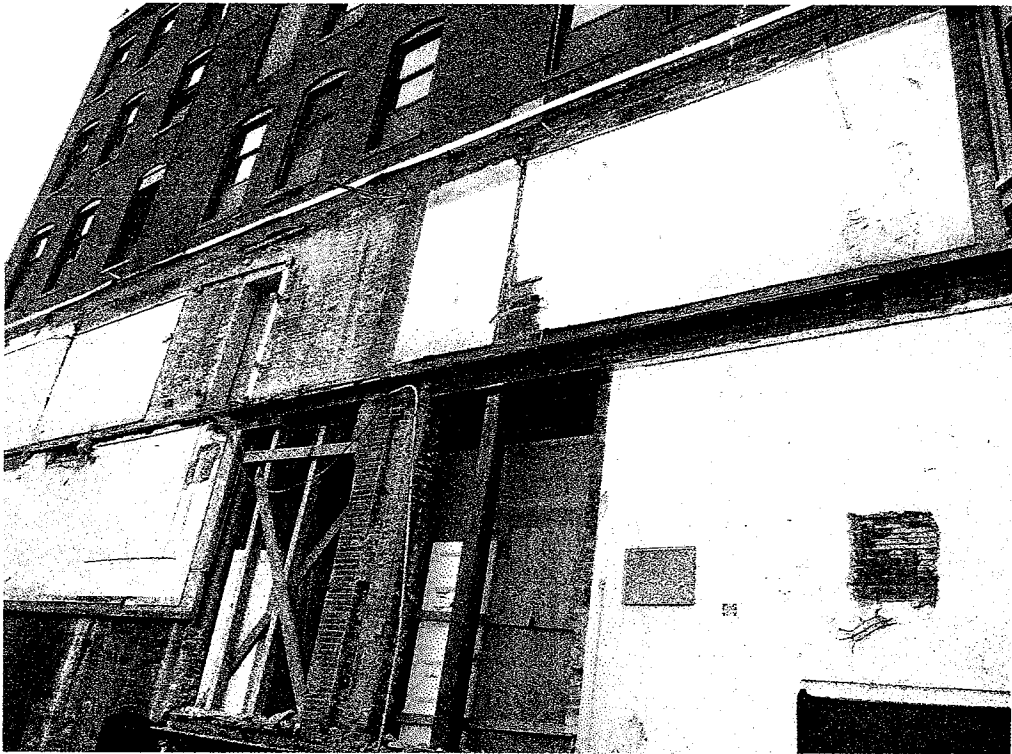
Photo # 6 – View looking South at the existing double steel beams embedded below second floor brick wall

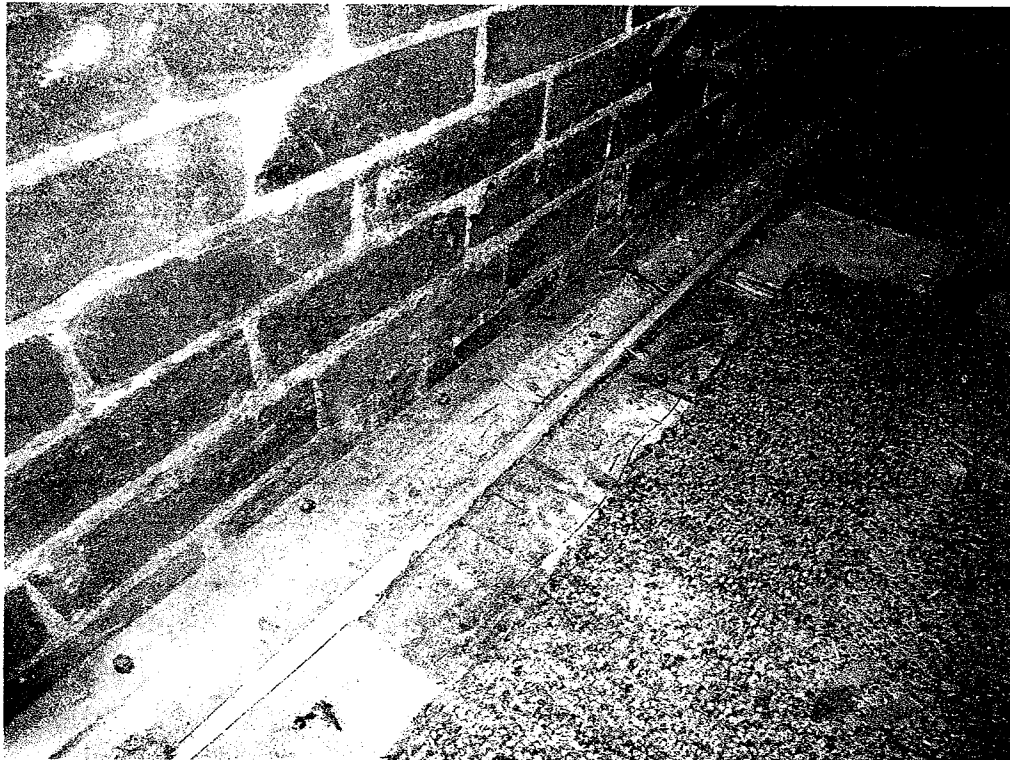
Photo # 4 - L3x3 steel angle connecting 2nd floor diaphragm to existing brick

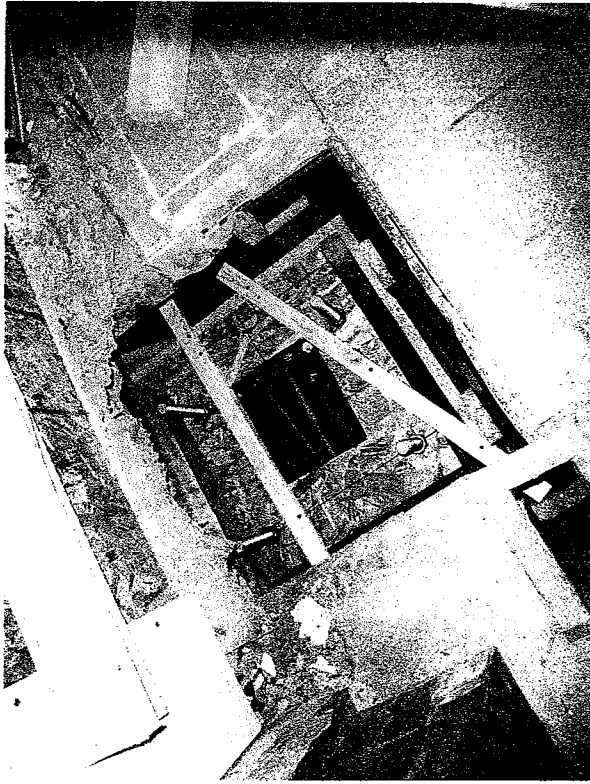
Photo #1 – Conc. Pier@ Bsmt Grid A/8.9 (Photo rotated 90 deg.)

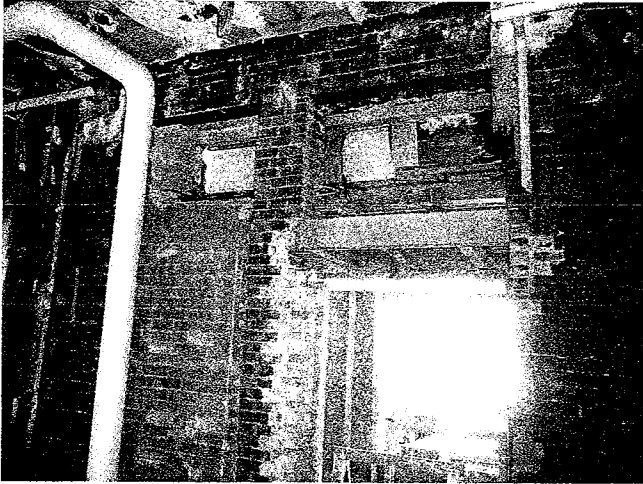
1. **URGENT** - I have a serious concern that the temporary shoring process is inadequate. At several areas in the building demolition of existing masonry load bearing walls was being performed by Hardy Pond with no temporary shoring whatsoever (see attached photos #1 and #8). When I asked Mark Leasure if he had reviewed these areas for adequate shoring he said he had not been notified by the contractor that the demolition was going to be performed. I said to Jeff Frye that it is required that Mark Leasure specify shoring requirements prior to demolition and Jeff said he would take care of it. Since Mark was on site the workmen stopped until Mark reviewed the situation. When I spoke with Mark the next day he said temporary shoring had been installed at several areas under his direction.

Photo # 1 Lack of Shoring @ 1st Floor Grid F/3.6

7. It is required that Mark Leasure specify shoring requirements prior to demolition being performed.
8. There is a severely spalled existing concrete wall near grid location F.4/9.5 adjacent to the sidewalk at the northeast corner of the building. This area of the wall will be exposed when construction is complete and although the existing wall appears to be structurally adequate I recommend that the spalled portion of the existing concrete be sawcut and removed (see photo #5). This is necessary so that it is not left as an unsightly condition when the project is complete. Therefore, the contractor needs to be a price to sawcut the wall and verify with the owner prior to proceeding with the sawcut. JL

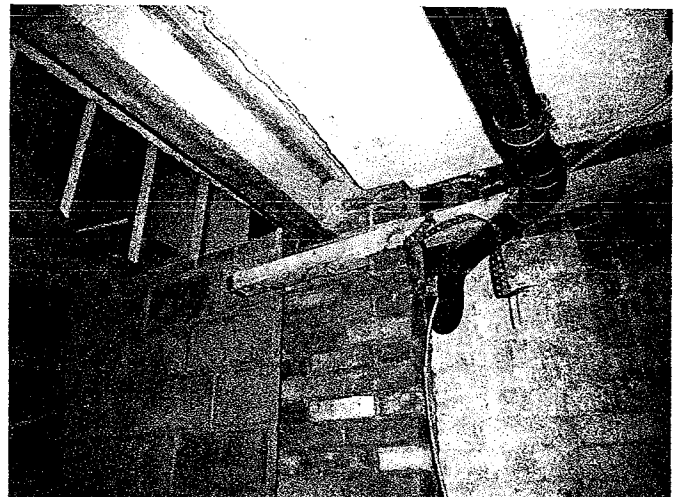
14. John also rebuilt the masonry bearing at both ends of the beam located at grid F.3/2.5 (see photo #9, # 10) to support the existing beam. The existing beam has not been checked but the rebuilt bearing points appear to be sound.

Photo # 10 - Rebuilt Bearing @ Grid F.3/2.5 (Looking NE)

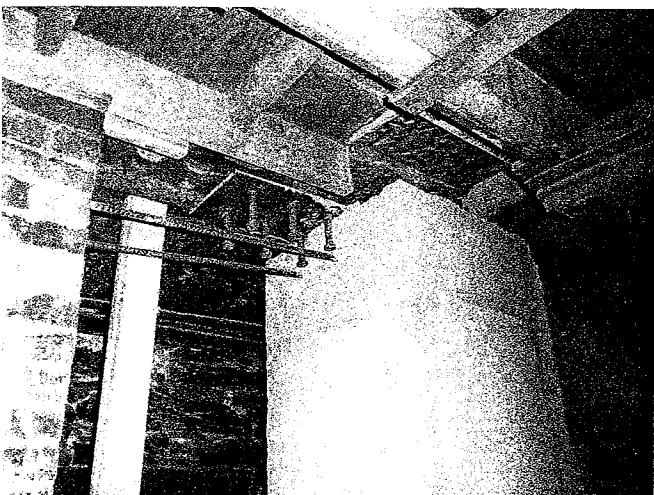
9. Mike Bisson was briefly on site from SW Cole to review the conditions at the back entrance.
 10. The basement concrete piers placed at grid A previously appears to have fairly good consolidation of concrete (see photo #11). Dave Norton said he used 4000 psi concrete for the piers.

Photo # 11 Concrete Pier @ Grid A/7.1 (Looking SW)

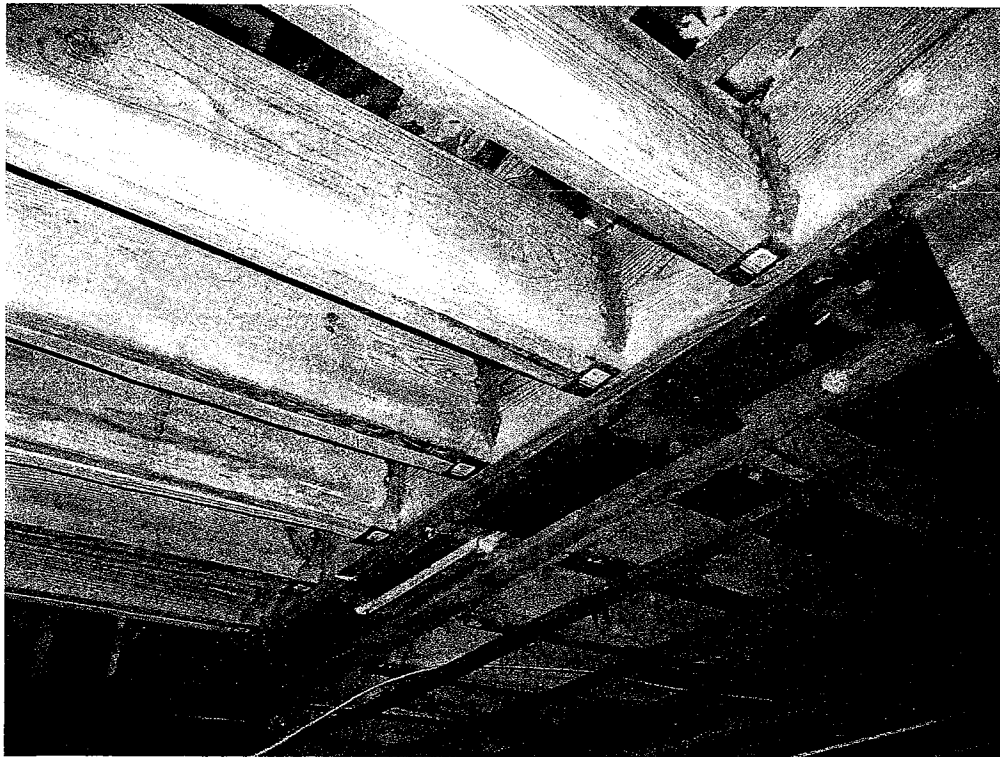
Photo # 2 – Double joists at 1st Floor Grid a.5/9.5. Header must be bolted to existing beam.

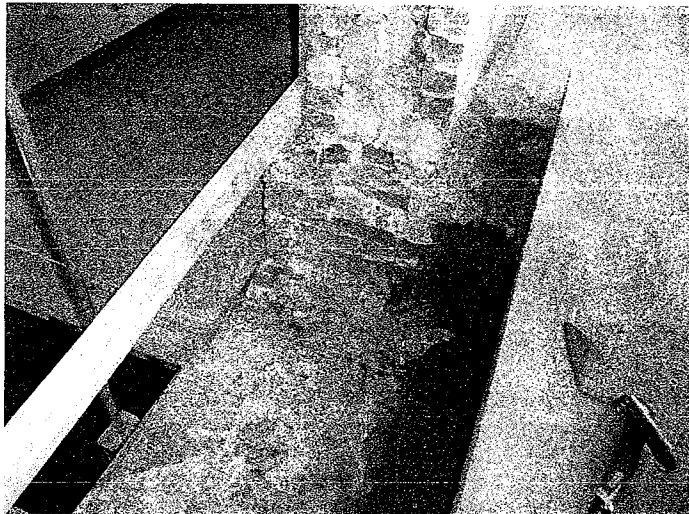
Photo # 11 - Preparation for Concrete Grade Beam at Grid A/4.2

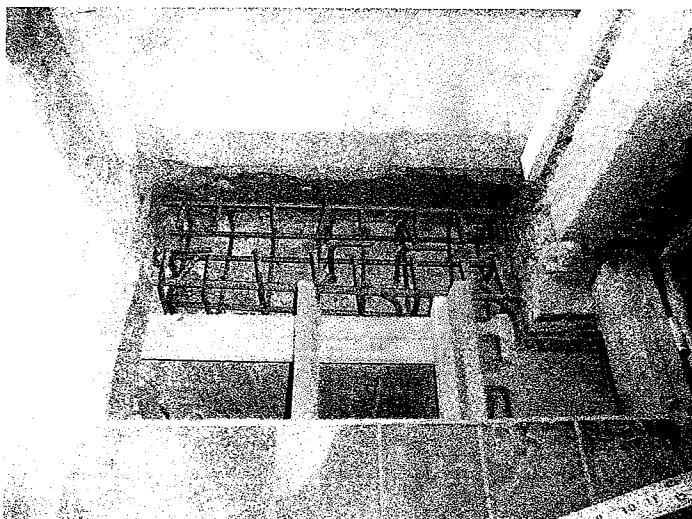
Photo # 12 - Preparation for Concrete Grade Beam at Grid A/4.9

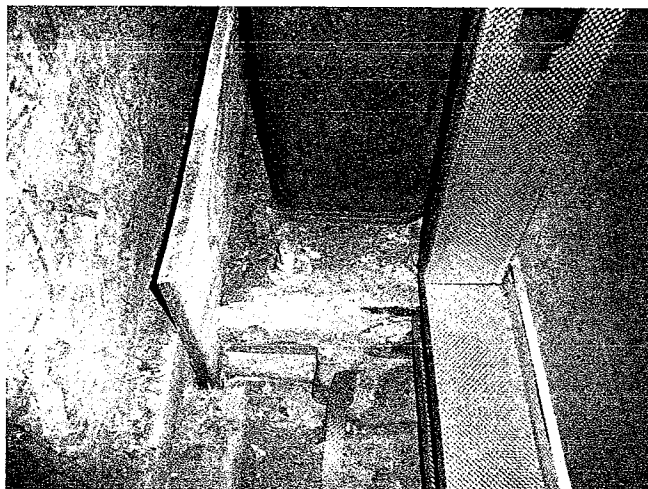
2. The column at grid F/5.8 has been grouted beneath the baseplate and anchor bolt installed (see photo #2). Also, the existing plywood embedded in the brick below the baseplate was reported as being removed and replaced with concrete masonry mortared solid to ensure adequate bearing at this location.

Photo # 2 – Column F/5.8 non- shrink grout below base plate and anchor bolts.

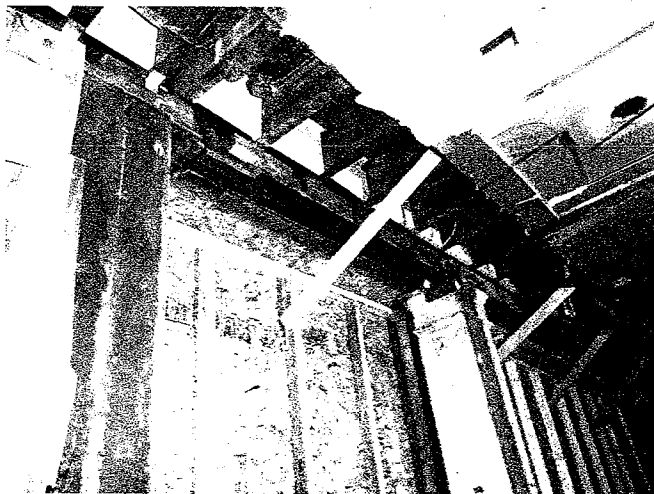
Photo # 8- Installation of cold form clips at bottom of wood joists not yet completed.

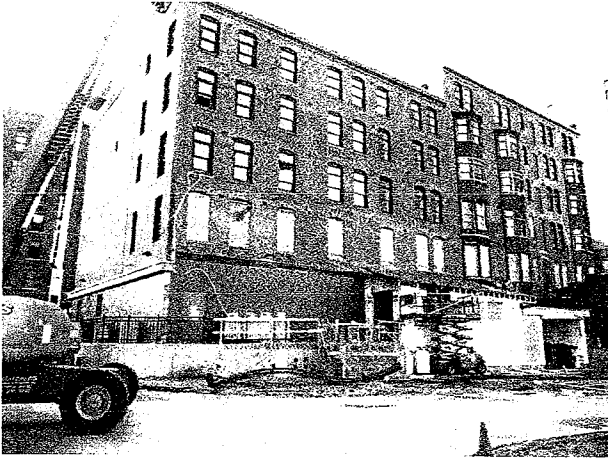
Photo # 1 – Back of building, view looking South

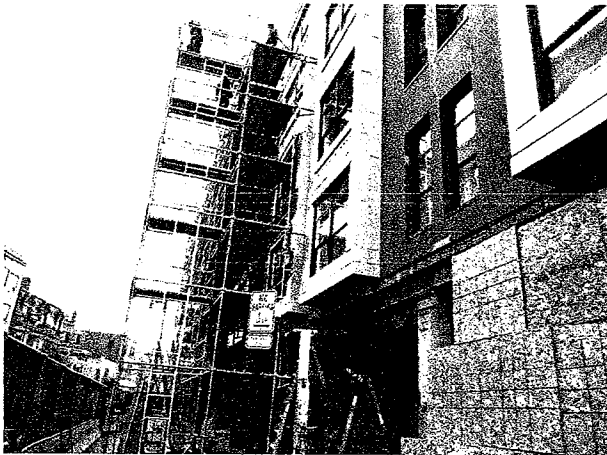
Photo # 2- Scaffolding being removed in front of building

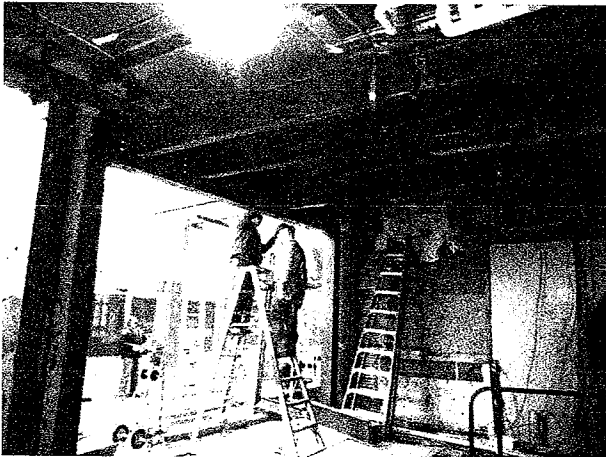
Photo # 6 – Installation of steel beams above main entrance.

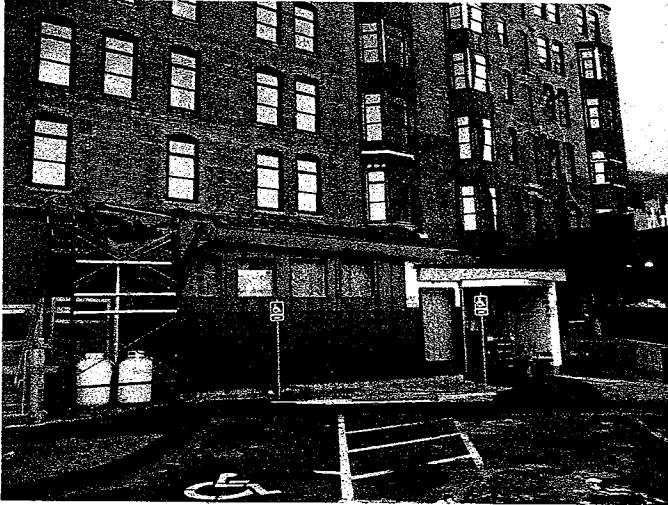
Photo # 1 Roofing and metal siding were being installed at the Back Entrance.

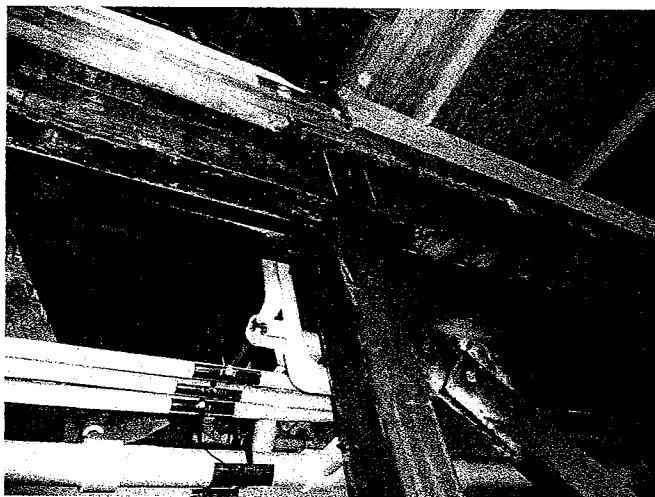
Photo # 3 Double stiffeners welded to existing steel beam above column A/2.5.

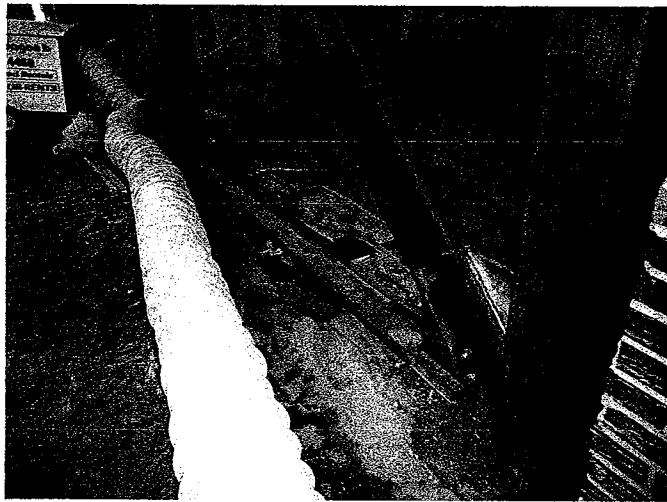
13. Tie bar at grid A/2.5 is to be embedded in concrete (see photo #8). The infill floor at this area will be installed as indicated on the original drawings using pressure treated wood framing.
14. Preparations were being made at the front entrance slab at the grid A/3.5 entrance (see photo #9).

Photo # 8 – Tie bar at grid A/2.5 to be embedded in concrete.

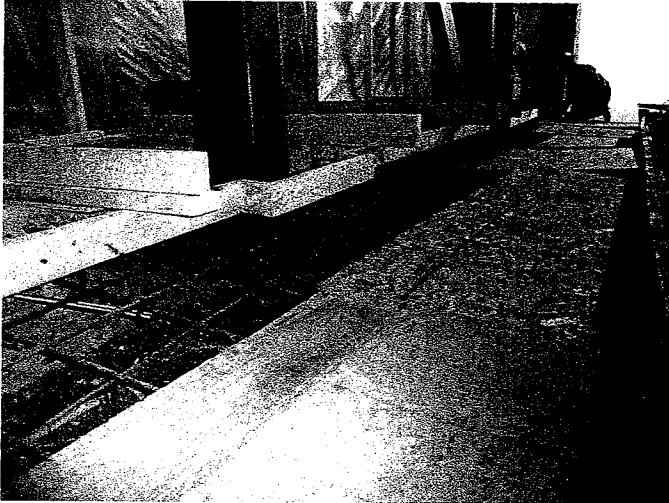
Photo # 4- Cantilevered formwork to accommodate concrete step for brick shelf.

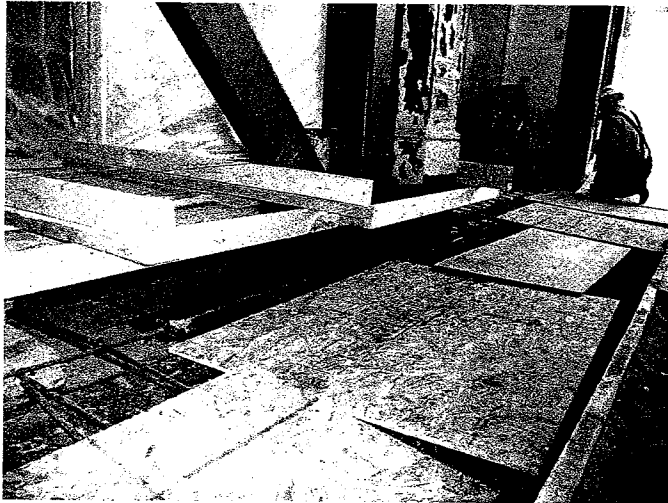
Photo # 7 – Welded anchors per detail E5/S5.5

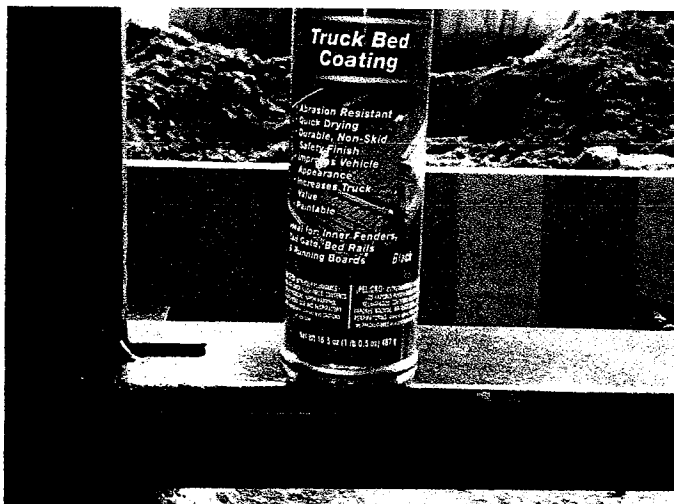
Photo # 8 – Contractor coated embedded steel with a Napa “Dupli-Color” truck-bed coating

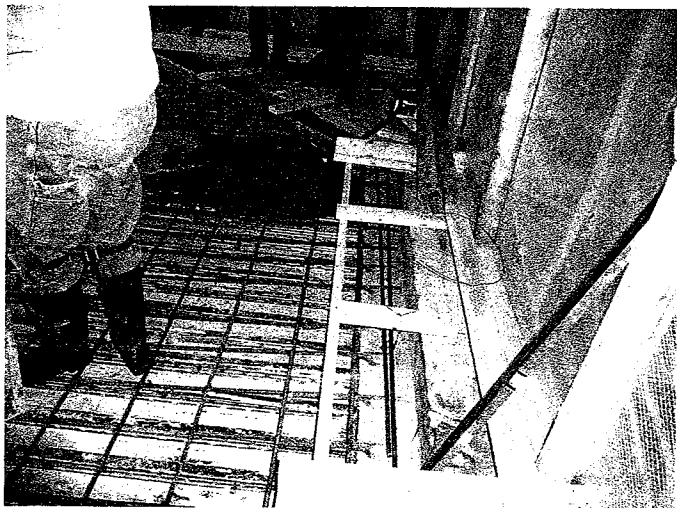
Photo # 9 – Concrete supported by both metal deck and also extends onto masonry wall (this differs from original detail)
