# **ATTACHMENT 3: VALLEY STREET TRAIL ASSESSMENT**

TO: Al Green, MMC  
FROM: David Senus, PE and Craig Sweet, PE  
DATE: August 17, 2018  
RE: MMC Staff Parking Garage | Valley Street Trail Condition Assessment

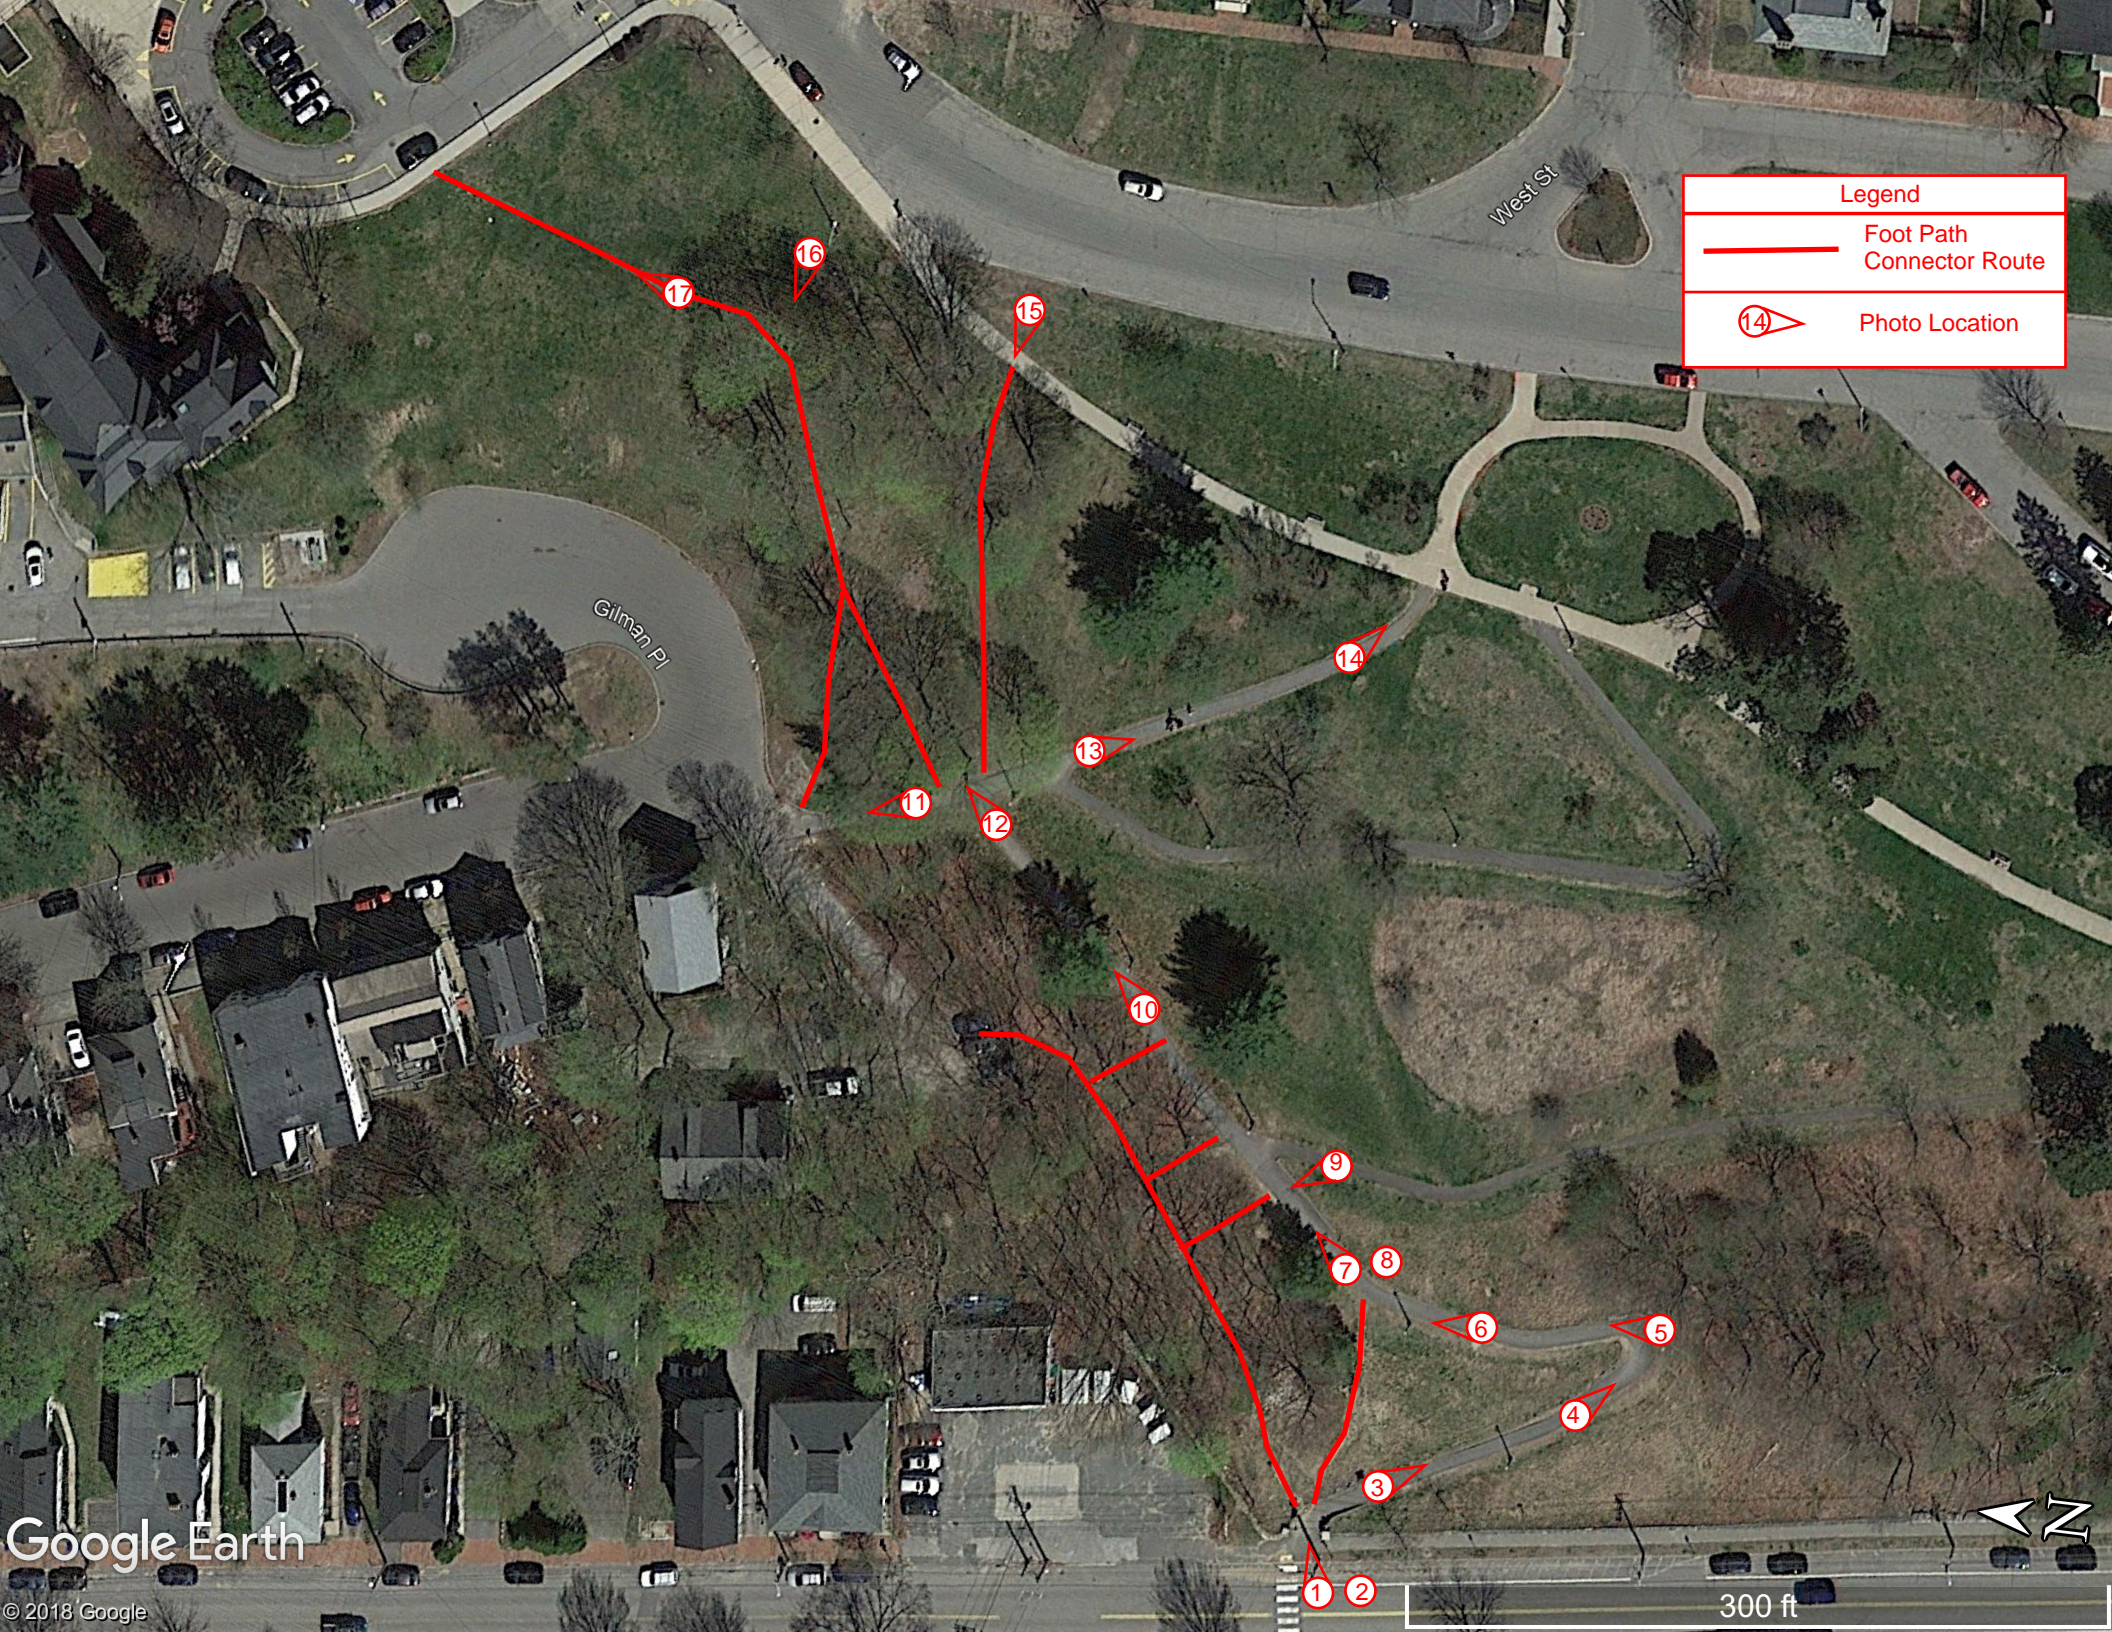
During the visual inspection, multiple informal gravel foot paths were observed along the Valley Street Trail, the general location of these paths are shown on the attached figure. As previously noted, at the Valley Street Trail and Valley Street connection, retaining wall endcap blocks were removed and placed as makeshift “steps” for users (Photographs 1 & 2). Pedestrians who utilize these steps either continue east on a gravel path towards the Valley Street Trail avoiding the first trail switchback or northeast on a gravel path and enter the woods adjacent to the trail. From the woods, the foot path continues to a driveway and parking area for 4 Gilman Street. Three other informal gravel foot paths were observed along the Valley Street Trail that connect to this section.
