BUILDING PERMIT

Location/Address of Construction: <u>696 CONGRESS STREET</u>		
Total Square Footage of Proposed Structure/Area <u>1,814 sq ft</u>	Square Footage of Lot <u>0.78 ACRES</u>	Number of Stories <u>3</u>
Tax Assessor's Chart, Block & Lot Chart# <u>55</u> Block# <u>E</u> Lot# <u>32</u>	Applicant * <u>must be owner, Lessee or Buyer</u> * Name <u>MGO PROPERTIES LLC</u> Address <u>PMB 299 SO MARKET ST</u> City, State & Zip <u>S. PORTLAND 04106</u>	Telephone: <u>207-799-7502</u>
Lessee/DBA (If Applicable)	Owner (if different from Applicant) Name Address City, State & Zip	Cost Of Work: \$ <u>20,000⁰⁰</u> C of O Fee: \$ _____ Total Fee: \$ <u>220⁰⁰</u>
Current legal use (i.e. single family) <u>MIXED / OFFICE</u> Number of Residential Units <u>FOUR</u>		
If vacant, what was the previous use? _____		
Proposed Specific use: <u>SAME</u>		
Is property part of a subdivision? _____ If yes, please name _____		
Project description: <u>REPAIRS TO INTERIOR / EXTERIOR DUE TO VEHICLE COLLISION. EGRESS CHANGES PER PFD.</u>

Subject: Building located at 696 Congress Street, Portland, Maine
Damage to Building Resulting from Automobile Accident

designed by: JHL	696 CONGRESS STREET PORTLAND, MAI

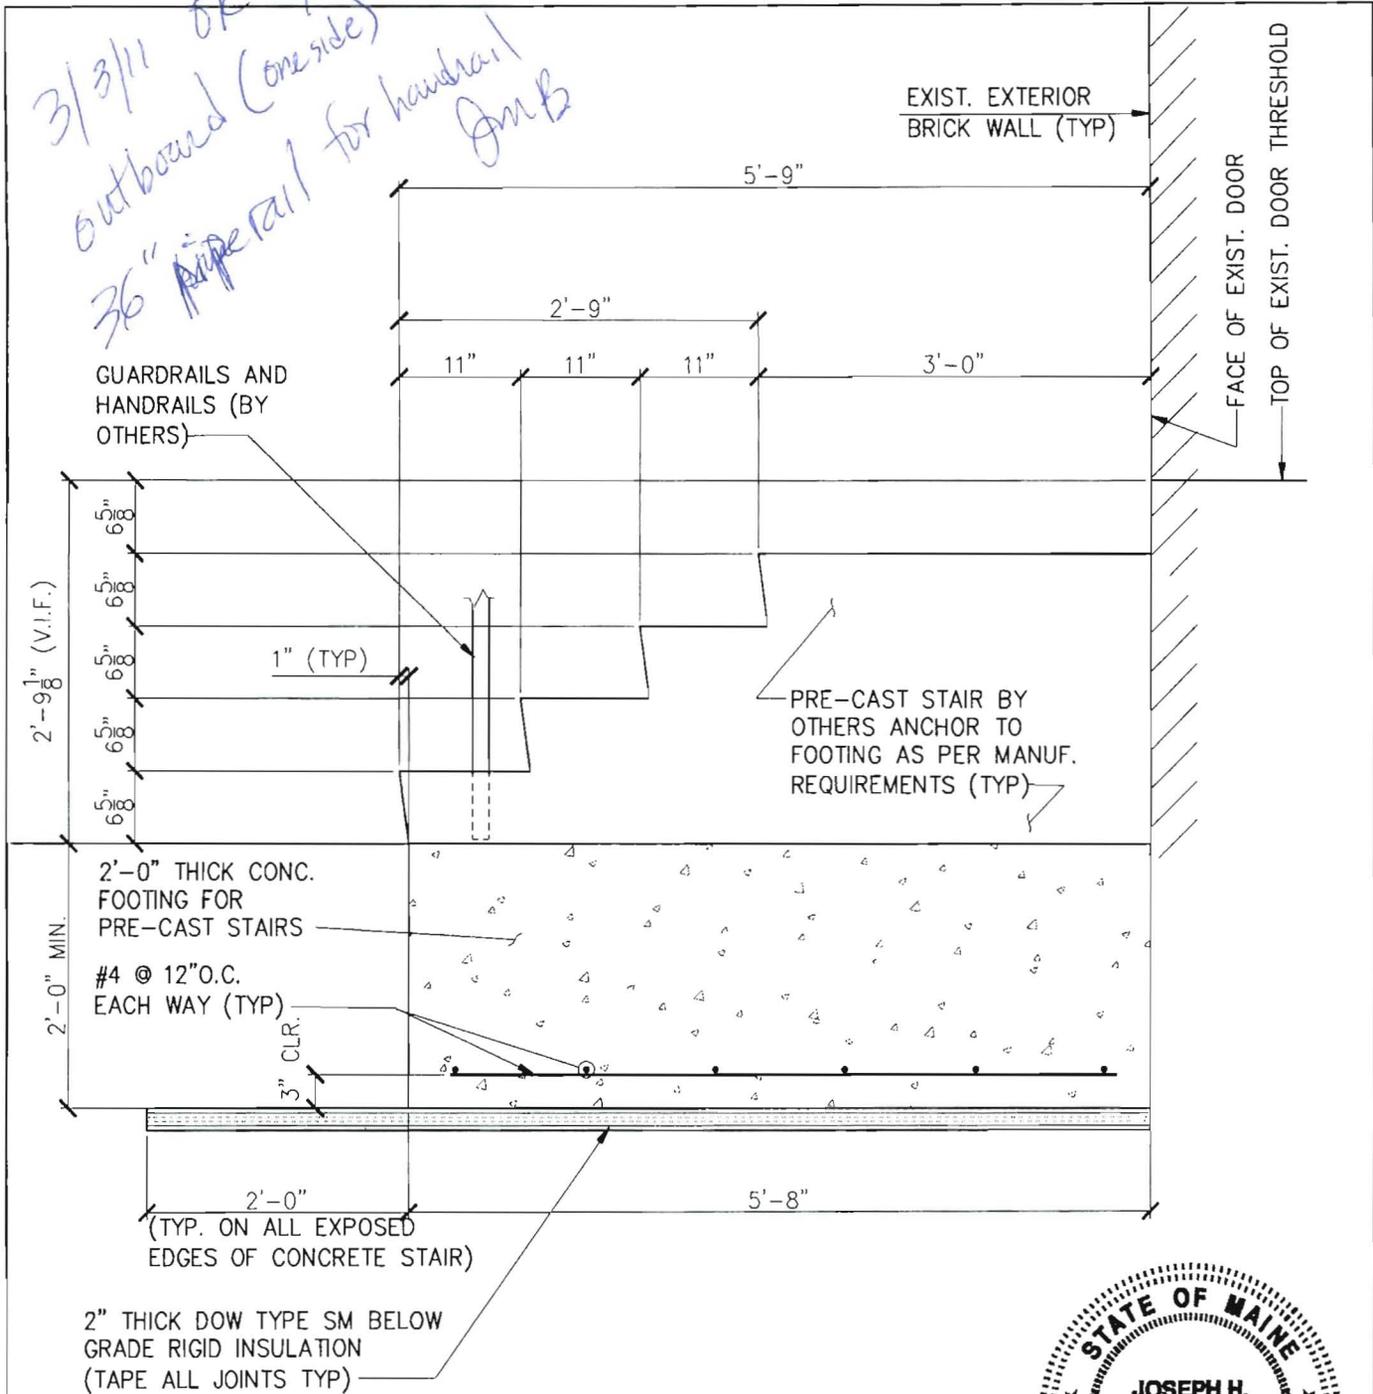
REAR ENTRY STAIR-SECTION 1
 3/4" = 1'-0" S5

*3/3/11 OK w/ Deb A.
outboard (one side)
36" Pipe rail for handrail
Am B*
