# General Building Permit Application

Re: 696 Congress Construction /Repairs due to Accident.

Subject: Building located at 696 Congress Street, Portland, Maine  
Damage to Building Resulting from Automobile Accident

designed by: JHL	696 CONGRESS STREET PORTLAND, MAINE  FRONT ENTRY STAIR REPAIR AND NEW REAR ENTRY STAIR  GENERAL NOTES	L & L STRUCTURAL ENGINEERING SERVICES, INC. SIX Q STREET SOUTH PORTLAND, MAINE 04106  PHONE: (207) 767-4830 FAX: (207) 799-5432	S1
drawn by: AKB			
checked by: JHL			
scale: NONE			
date: 10-28-10

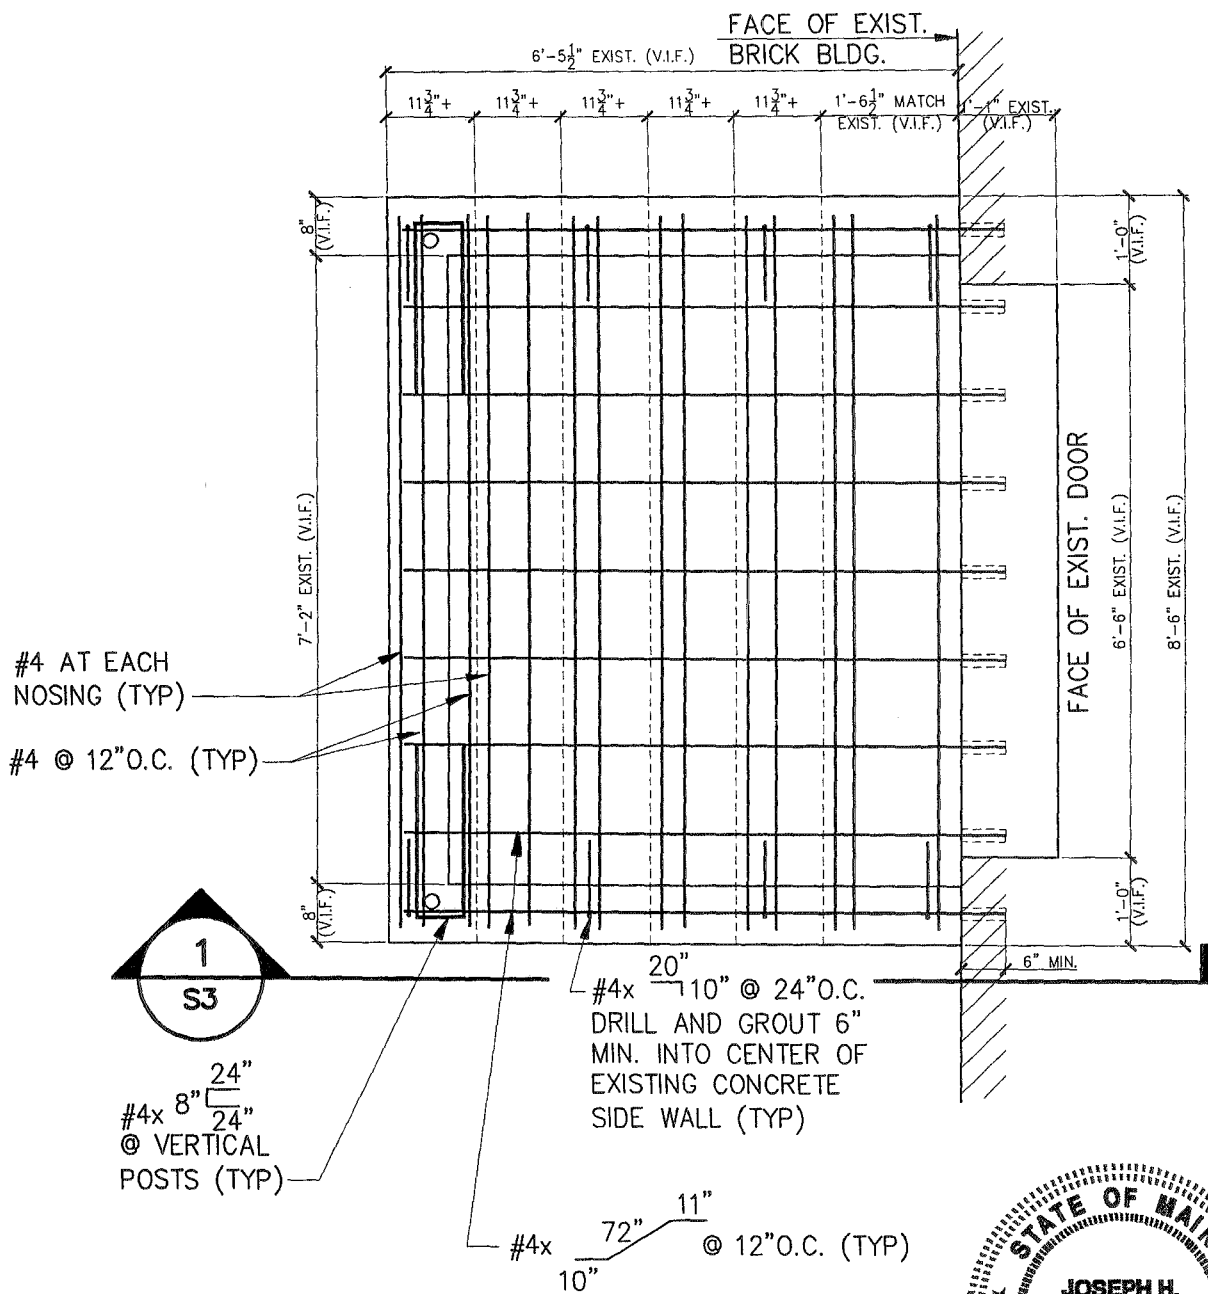
# FRONT ENTRY STAIR-CONCRETE PLAN

2. The existing concrete stair and steel railings at the front of the building has been compromised. Some of the concrete treads and portions of the concrete side walls have been cracked, completely broken or shifted laterally or rotated from the original position. In addition, the steel side rails have been bent and dislodged from the concrete embedment that structurally supported the railings. The original concrete stair and steel railings do not meet the current building code requirements for an egress stair entry. The entire stair system shall be either replaced or the effected concrete treads, concrete side walls and steel railings shall be repaired or replaced. In either case, the reconstruction of the stair to meet the current building code requirements would violate the standards of the Maine Historic Society and force the stair system to be located over the property line into the existing sidewalk. This is obviously unacceptable. Hence, a variance from the City of Portland shall be pursued to repair and/or replace the stair system to match the original condition. In addition, the repair and/or replacement of the "historic" steel handrails on both sides of the stair, which do not currently meet the building code requirements, may potentially be modified to enhance the safety by installing a bottom rail and balusters which will violate the standards of the Maine Historic Society. This shall be pursued with the City of Portland Building Department and the Maine Historic Society. The replacement of the entire stair system shall be implemented utilizing a reinforced concrete stair and side wall construction that matches the original stair to be designed upon your request. Otherwise, the compromised concrete treads shall be replaced with concrete treads reinforced with 3-#5 reinforcing bars longitudinally (one located near the stair nosing and two located at the center of the depth) and doweled into the repaired concrete side walls at both ends with 2-#4 hooked L-shaped bars drilled and grouted vertically 6" minimum into the repaired concrete side walls and embedded 15" minimum into the center of the new concrete stair tread. In addition, 2-#4 U-shaped reinforcing bars shall be installed at the end of the treads where the repaired steel vertical posts of the railings shall be embedded. The U-shaped bars shall be installed at the top and bottom of the treads at the ends wrapped around the vertical steel post (with 2" minimum concrete cover around the vertical steel post and around the reinforcing bar on all sides) and extend 15" minimum into the tread longitudinally. The steel side rails shall be repaired and /or replaced to match the original rails, potentially modified as previously discussed, and anchored as previously anchored.

The front steps will be rebuilt according to engineering plans, and the railings, stored in the basement, will be re-installed.
