Final Report of Special Inspections

Project: *Addition and Renovations*
Location: *214 Danforth Street, Portland, ME*
Owner: *Shalom House, Inc.*
Owner's Address: *106 Gilman Street*
Portland, ME 04102

JOB NAME: 214 Danforth Street
JOB NO.: 14005
DATE OF VISIT: Sep 09, 2014
TIME: 1:00 P.M.
WEATHER: 70°, clear
CLIENT: Shalom House
OBSERVERS: David Tetreault, SDC

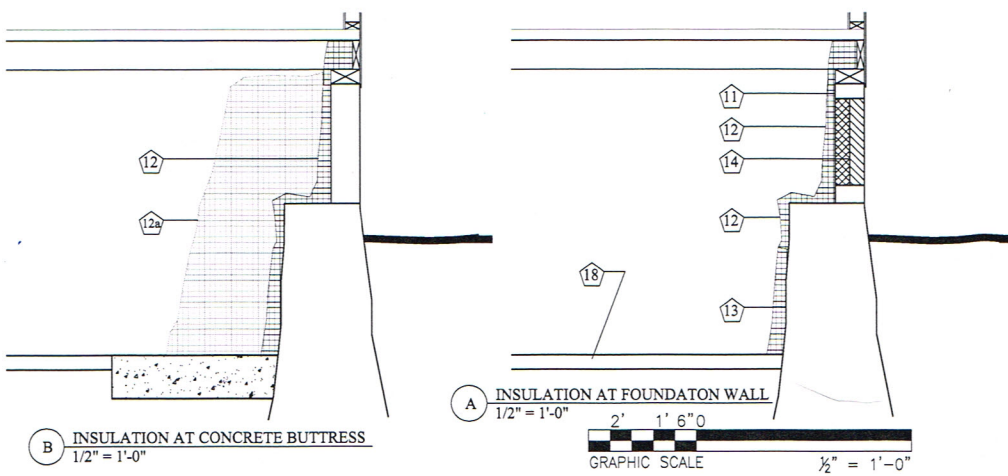
1 BASEMENT PLAN
1/4" = 1'-0"

Demolition of finishes has been substantially completed. Several areas that have been exposed in the basement require revisions from the Contract Documents. See the attached Basement Plan.

The foundation at the west side has been exposed. Loose bricks and granite pieces must be removed prior to placing concrete for the buttress detailed on sheet ST-1a. A 1st floor beam is supported on the foundation approximately 13 feet south of the rear wall. This beam must be temporarily shored before removing loose brick and granite.
