**Aquion Energy**

**Abuse Testing**

**TEST REPORT**

**MGA REPORT NO.:** C14T1-010  
**TESTS PERFORMED ON:** December 5, 2013 - March 3, 2014  
**TEST DESCRIPTION:** Abuse Testing  
**ITEM DESCRIPTION\*:** Salt Water Batteries  
**PROCEDURE NUMBER:** TP002-02, TP007-08, TP016-10, TP018-11, TP020-09,  
TP027-05, TP030-02, TP031-03, TP032-06, TP033-04

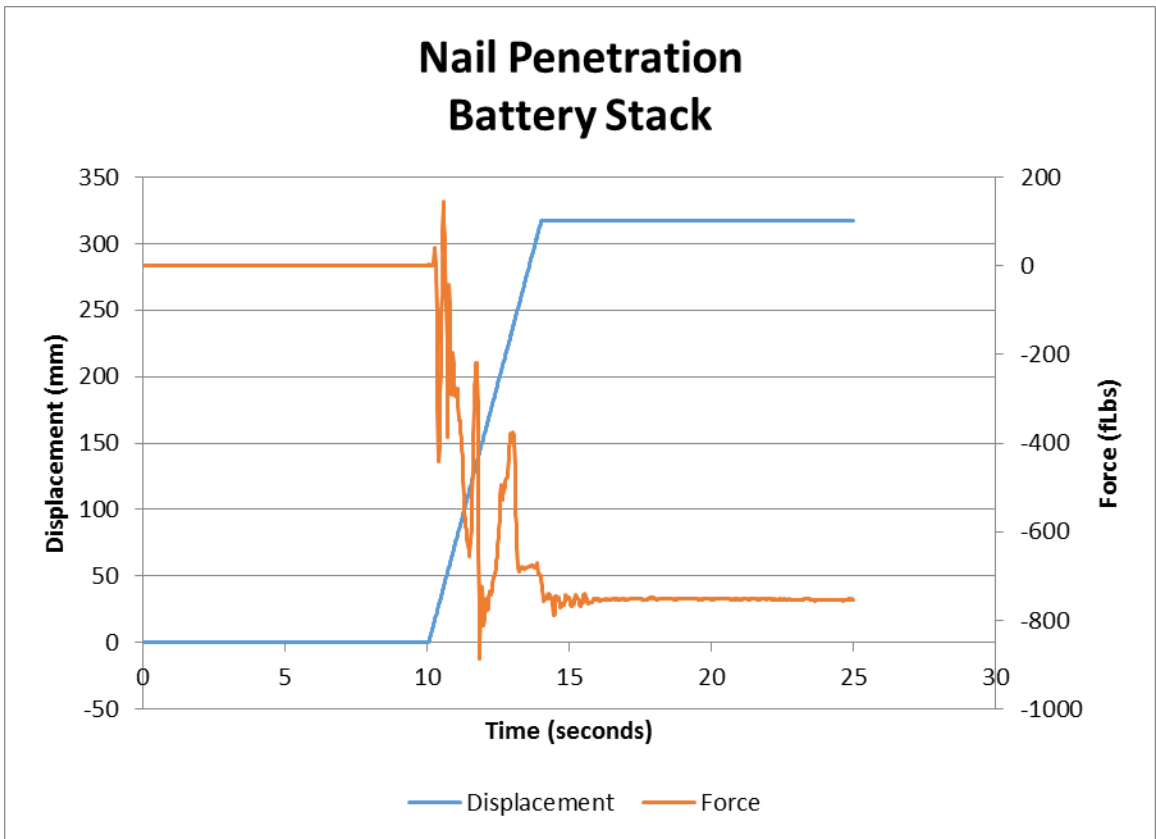
## Nail Penetration Battery Stack

During penetration, the nail bent inside the battery stack and protruded from the side of the third cell. Both the battery stack and the nail experienced slight leaking and significant voltage loss as a result of the penetration.
