PROJECT: New Portland Service Building
Five (5) Foot East Truck Bay Building Addition
Punch List
Portland, Maine
DATE: Thursday, December 29, 2011

PUNCH LIST ITEMS

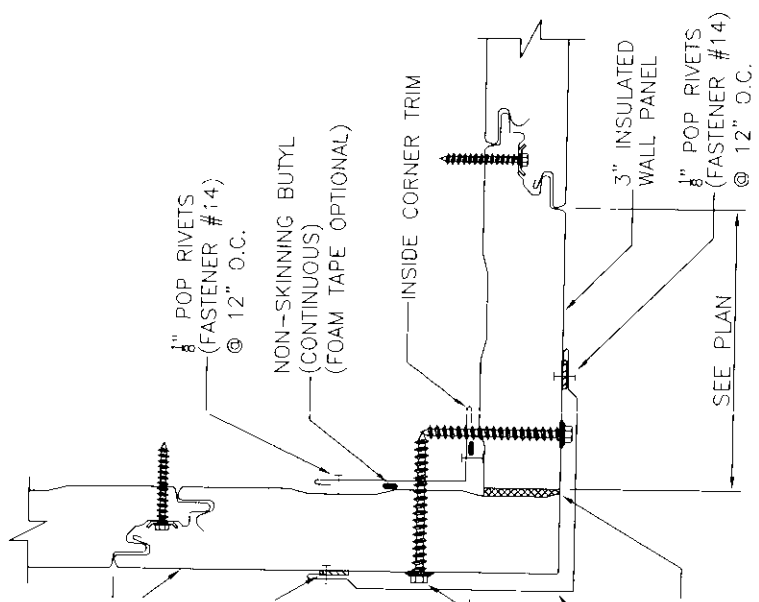
METAL WALL PANEL
OUTSIDE CORNER DETAIL

THE EXISTING WINDOW TRIM WHICH WAS EXTENDED HAS A VERTICAL GAP BETWEEN SECTIONS WHICH IS NOT SEALED
