Slope Reconstruction

Back Cove Estates

2013-097

Subject: Geotechnical Consultation Services  
Back Cove Estates Condominiums  
East Road Slope Repair  
Portland, Maine

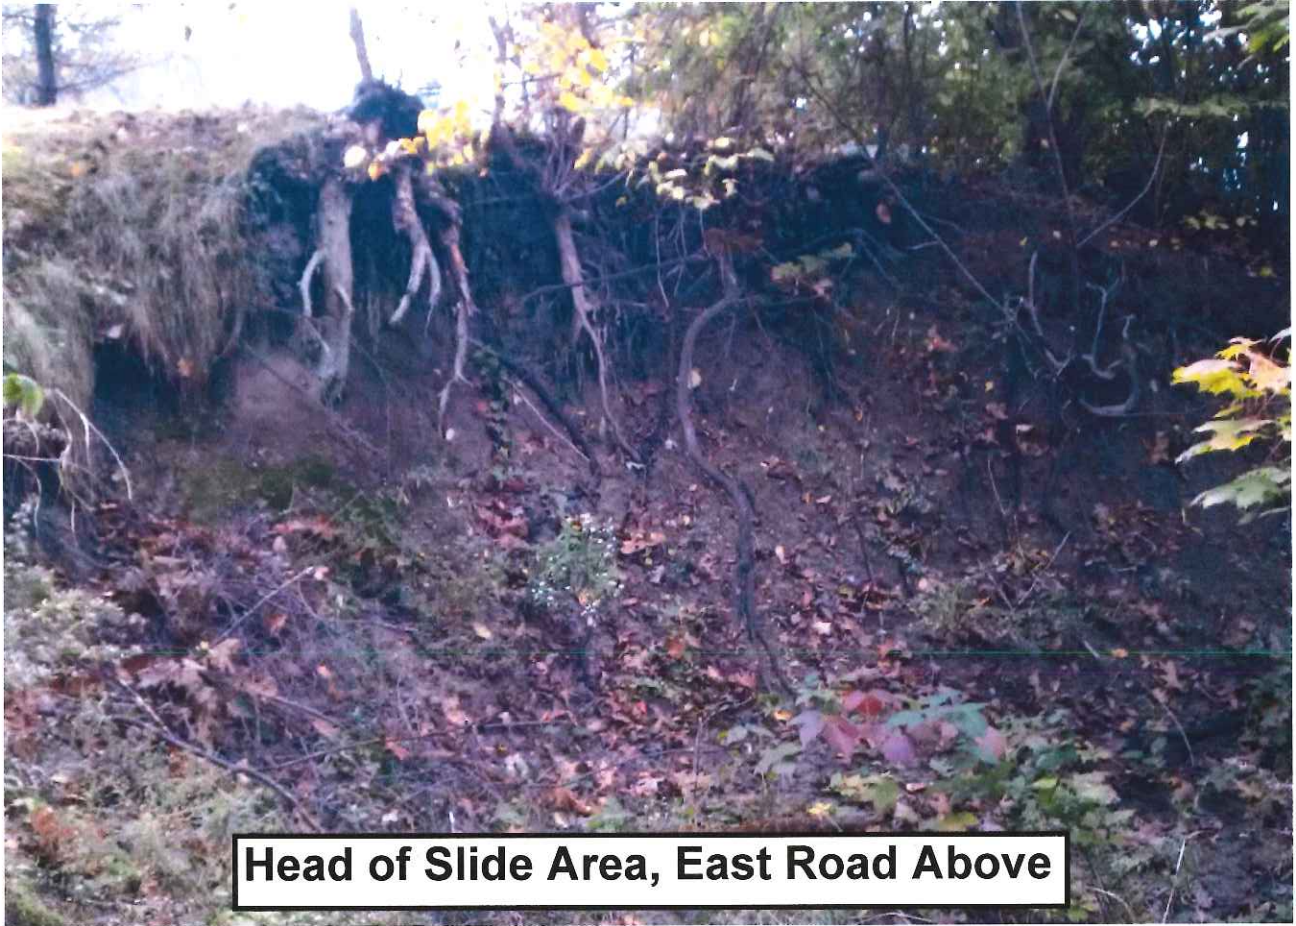
Surficial Conditions: The stream bed conditions vary from sand and gravel with boulders to exposed bedrock, see photos attached as Sheet 2. The stream bank conditions vary from exposed bedrock to native clay, see photos attached as Sheet 3. The soils in the slope failure area (slide area) consist of disturbed clay with organics (slide debris) overlying a relatively stiff undisturbed native clay exposed at the head of the slide area, see photos attached as Sheet 4. We did not observe tension cracking or faulting upslope of the head scarp of the slide area.

Based upon visual observations and subsurface findings at the hand boring locations, the slide plane of the failure area appeared to be relatively shallow and on the order of 5 feet below the surface of the slide debris. The stream bank upstream and downstream of the failure area consists of erodible native clay and the stream bed consists of relatively stable sand and gravel or bedrock. Considering the visible surface conditions and subsurface findings, it is our opinion the slope failure was likely due to toe erosion that undermined the stream bank and caused a shallow surface failure.

**Head of Slide Area, East Road Above**

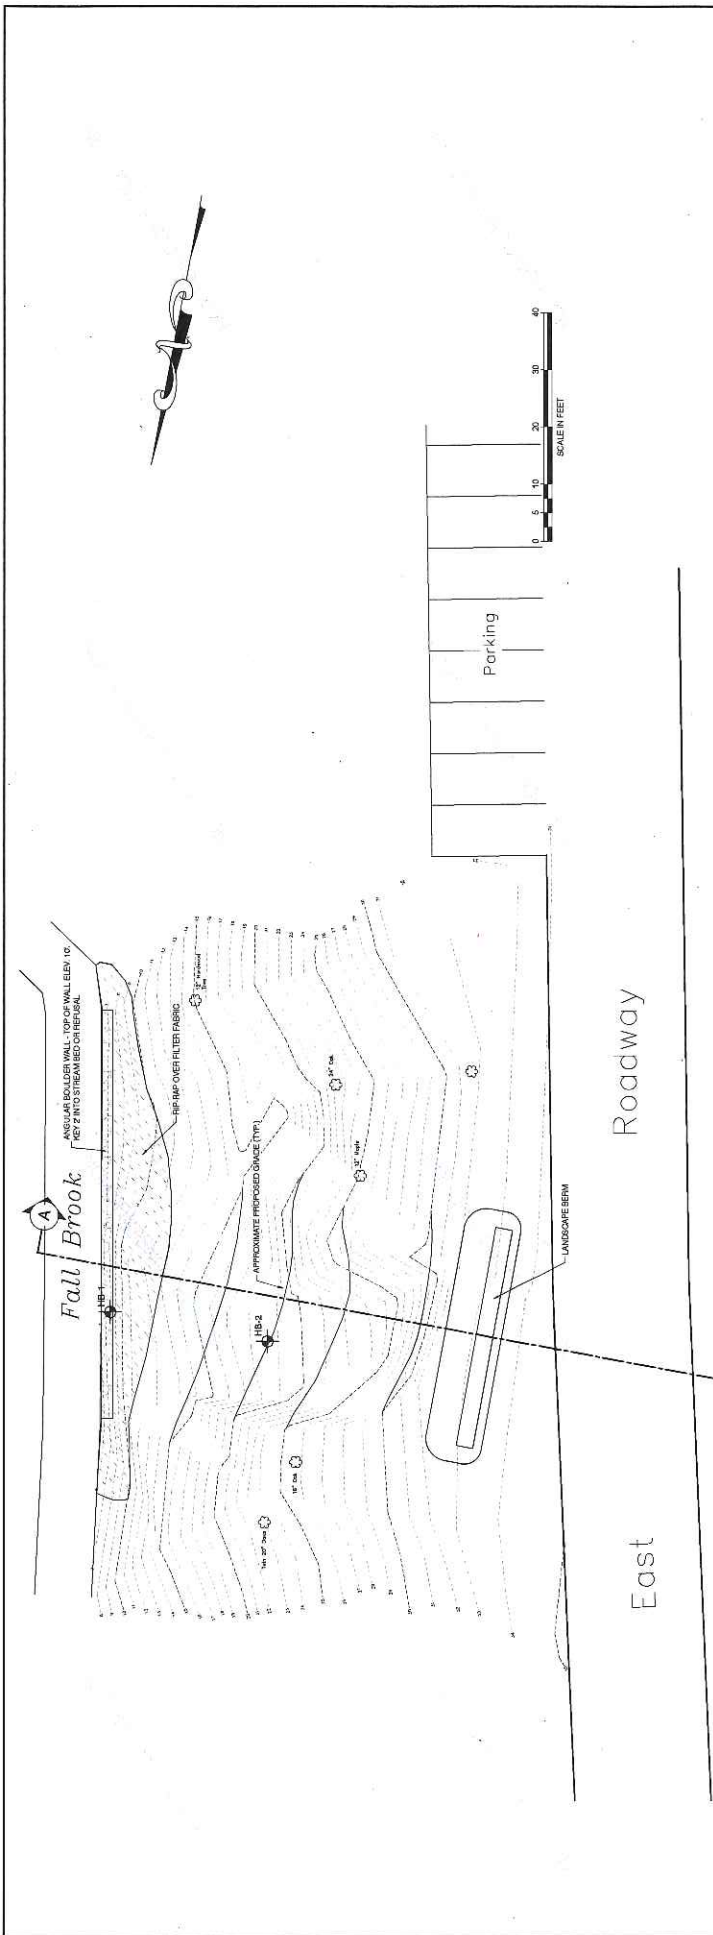
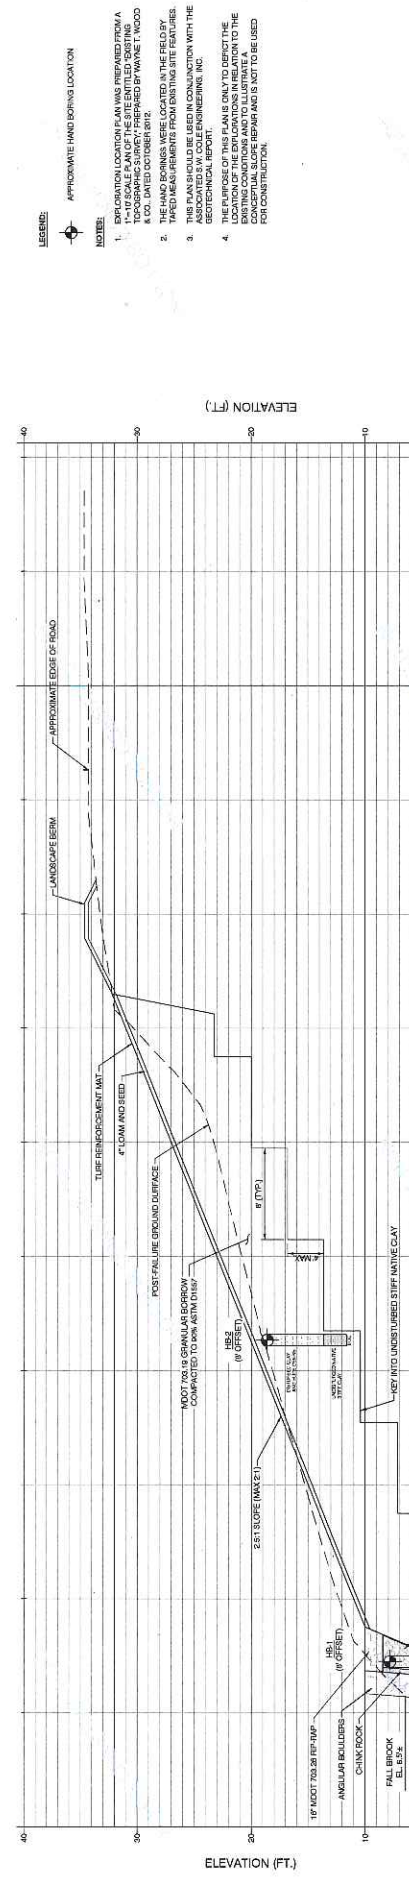
Job No: 120074  
Date: 10/12/2012  
Scale: As Noted  
Sheet: 1

The site is located along the west bank of Fall Brook along the East Road of the Back Cove Condominiums off Ocean Avenue in Portland, Maine. The slope failure area is generally bounded by Fall Brook at the toe (east), East Road at the head (west) and undisturbed, vegetated, slope areas to the north and south. The site area and existing topography are shown on the "Exploration Location Plan" attached as Sheet 1.

**SW COLE**  
ENGINEERING, INC.  
EXPLORATION, DESIGN AND  
CONCEPTUAL SLOPE REPAIR  
BACKCOURSE EXISTES  
POSTULATED FAILURE

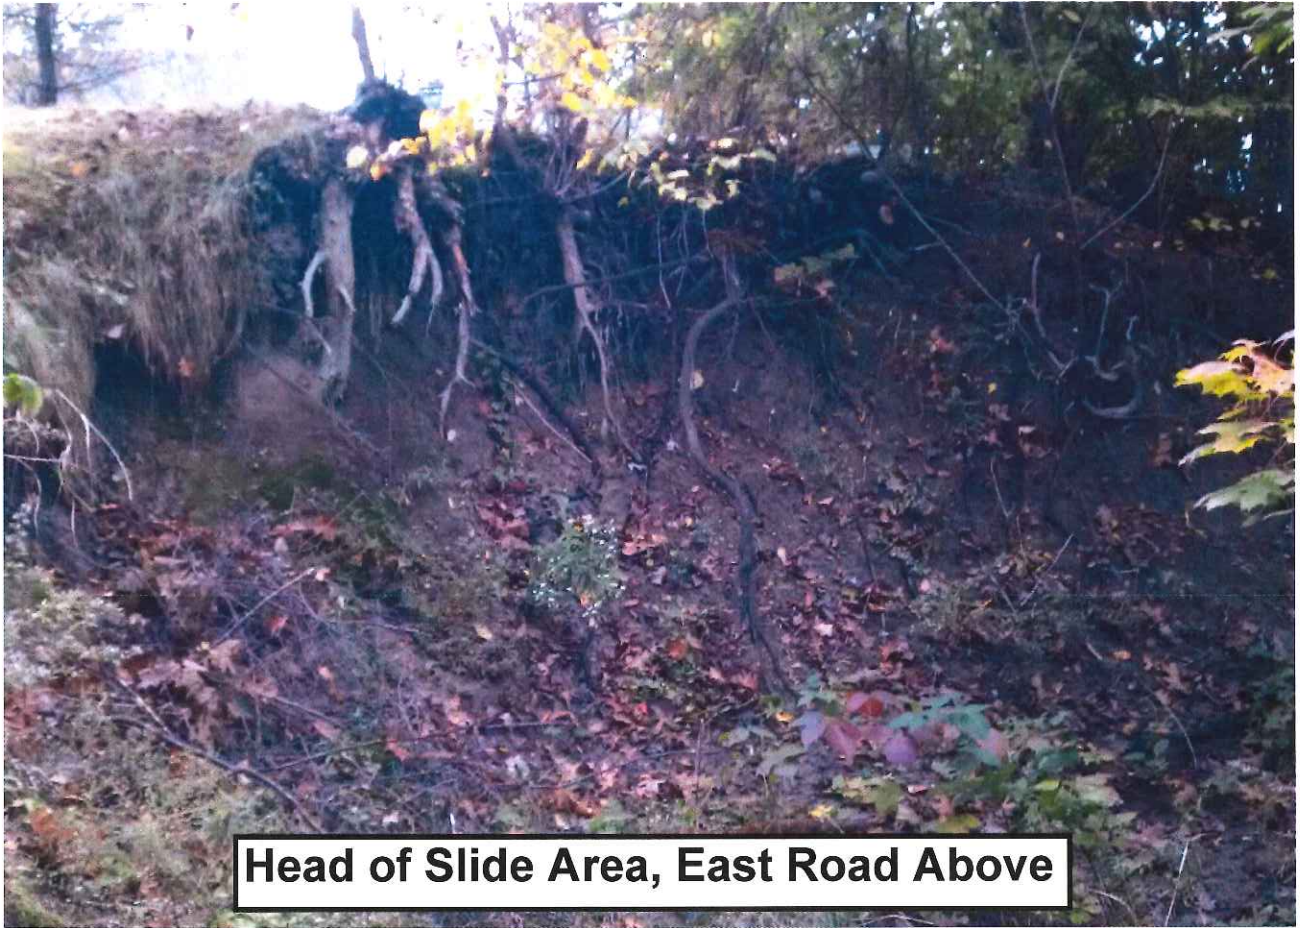
**Head of Slide Area, East Road Above**
