STORMWATER MANAGEMENT PLAN

Proposed Condominium Development

218 Washington Avenue
Portland, Maine

STORMWATER & EROSION CONTROL PLAN
218-220 WASHINGTON AVE. CONDOMINIUMS
218 WASHINGTON AVENUE
PORTLAND, MAINE

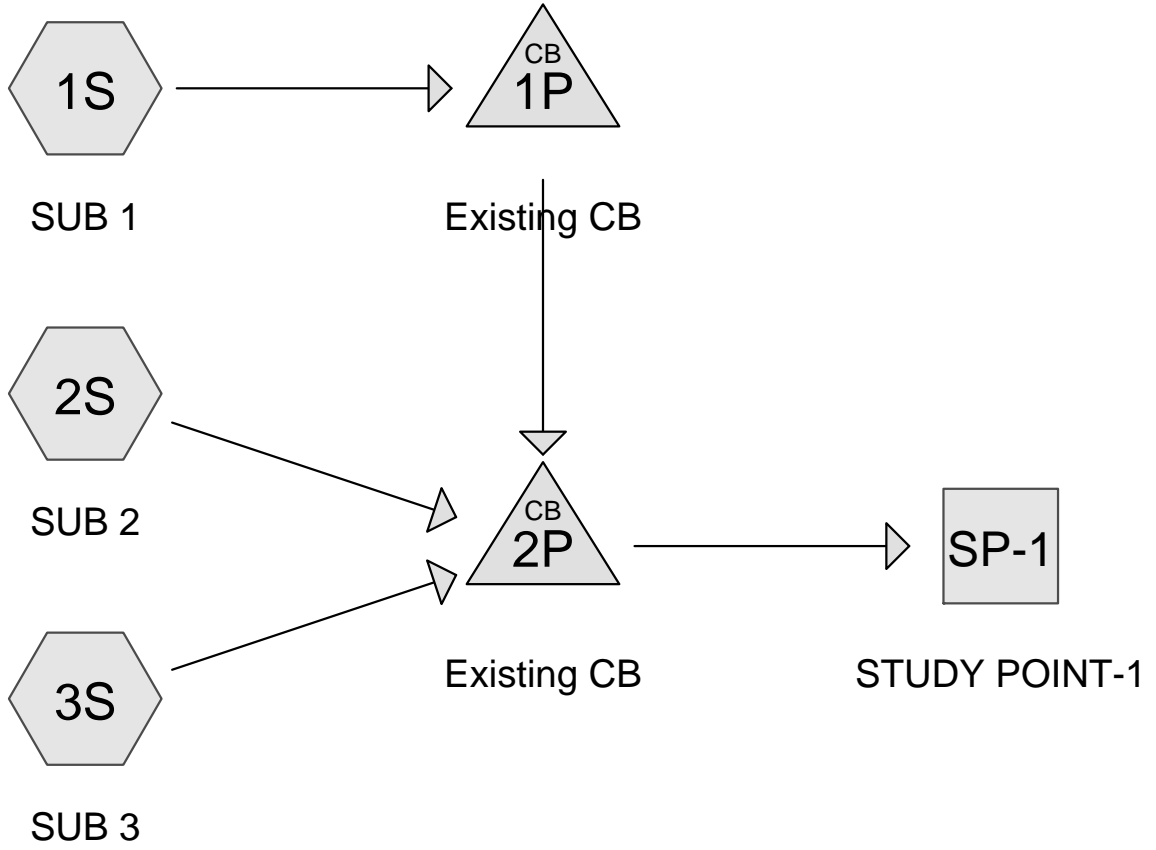
Pre Development

Subcat

One watershed point of analysis (POA1) was established to evaluate the pre-development and post-development peak runoff conditions for compliance with the City Stormwater Compliance.

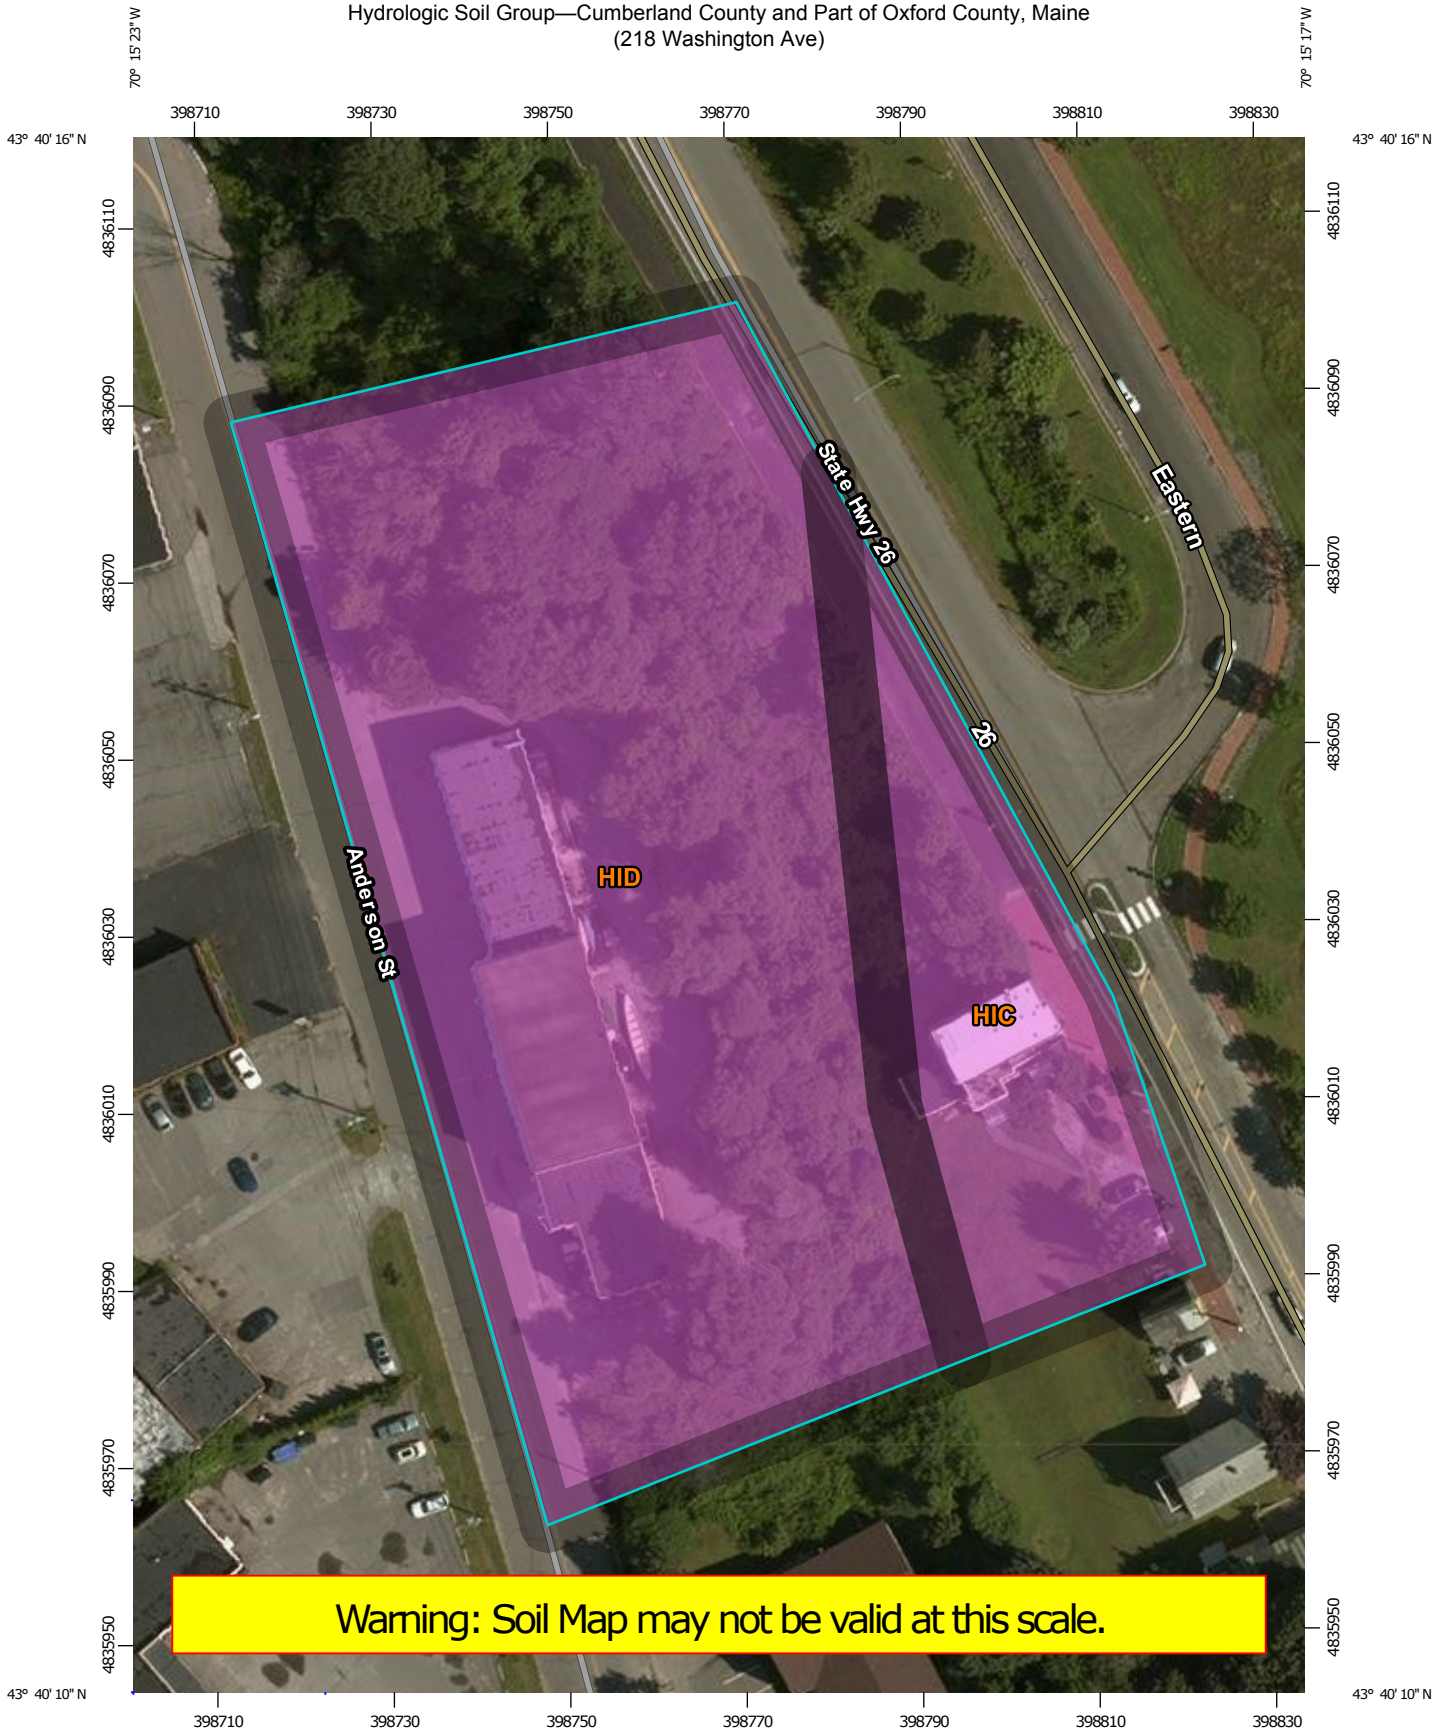
Hydrologic Soil Group—Cumberland County and Part of Oxford County, Maine
(218 Washington Ave)

Warning: Soil Map may not be valid at this scale.
