WALL TYPES

229 Congress St Apartments

Portland, Maine

13116 Project Number Drawing Scale AS NOTED SHEET NAME

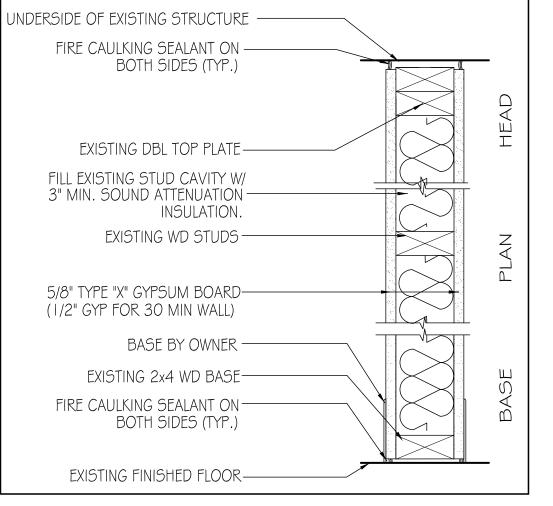
INTERIOR WALL (2 x 4 WD STUD) U.L. #U305 (1-HR. RATED, BRG. WALL) INTERIOR WALL (2 x 4 WD STUD) U.L. #U319 (30-MIN. RATED, BRG. WALL)

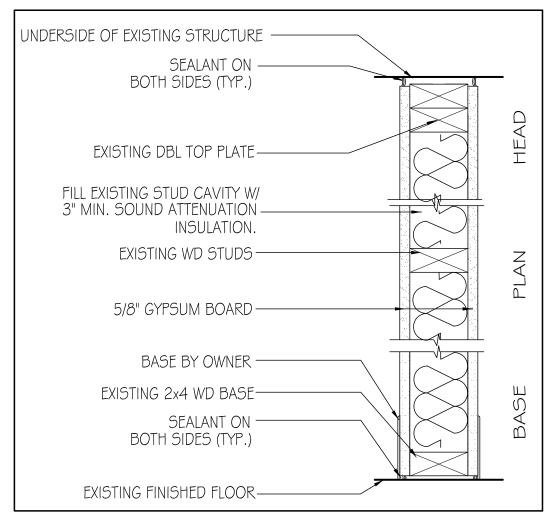
INTERIOR WALL (2 x WD STUD) (WALL NOT REQ'D. TO BE FIRÉ-RATED

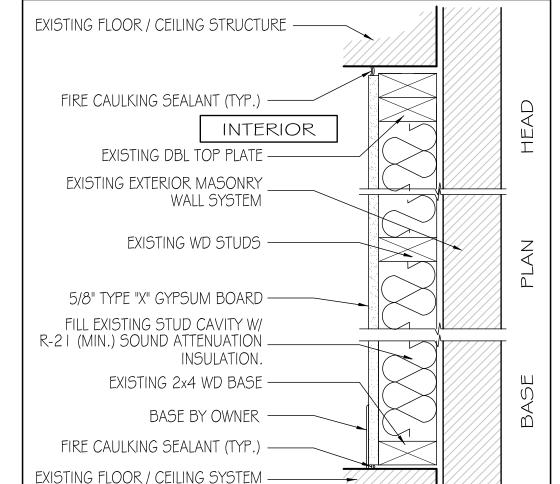
EXTERIOR WALL (MOD. BRICK W/ 2 x 4 WD. STUD BACK-UP)
