1 FLOOR PLAN - FOURTH FLOOR
SCALE: 1/4" = 1'-0"

229 Congress St Apartments

Portland, Maine

Date Issued Nov 20, 2013
Project Number 13116
Drawing Scale AS NOTED
SHEET NAME

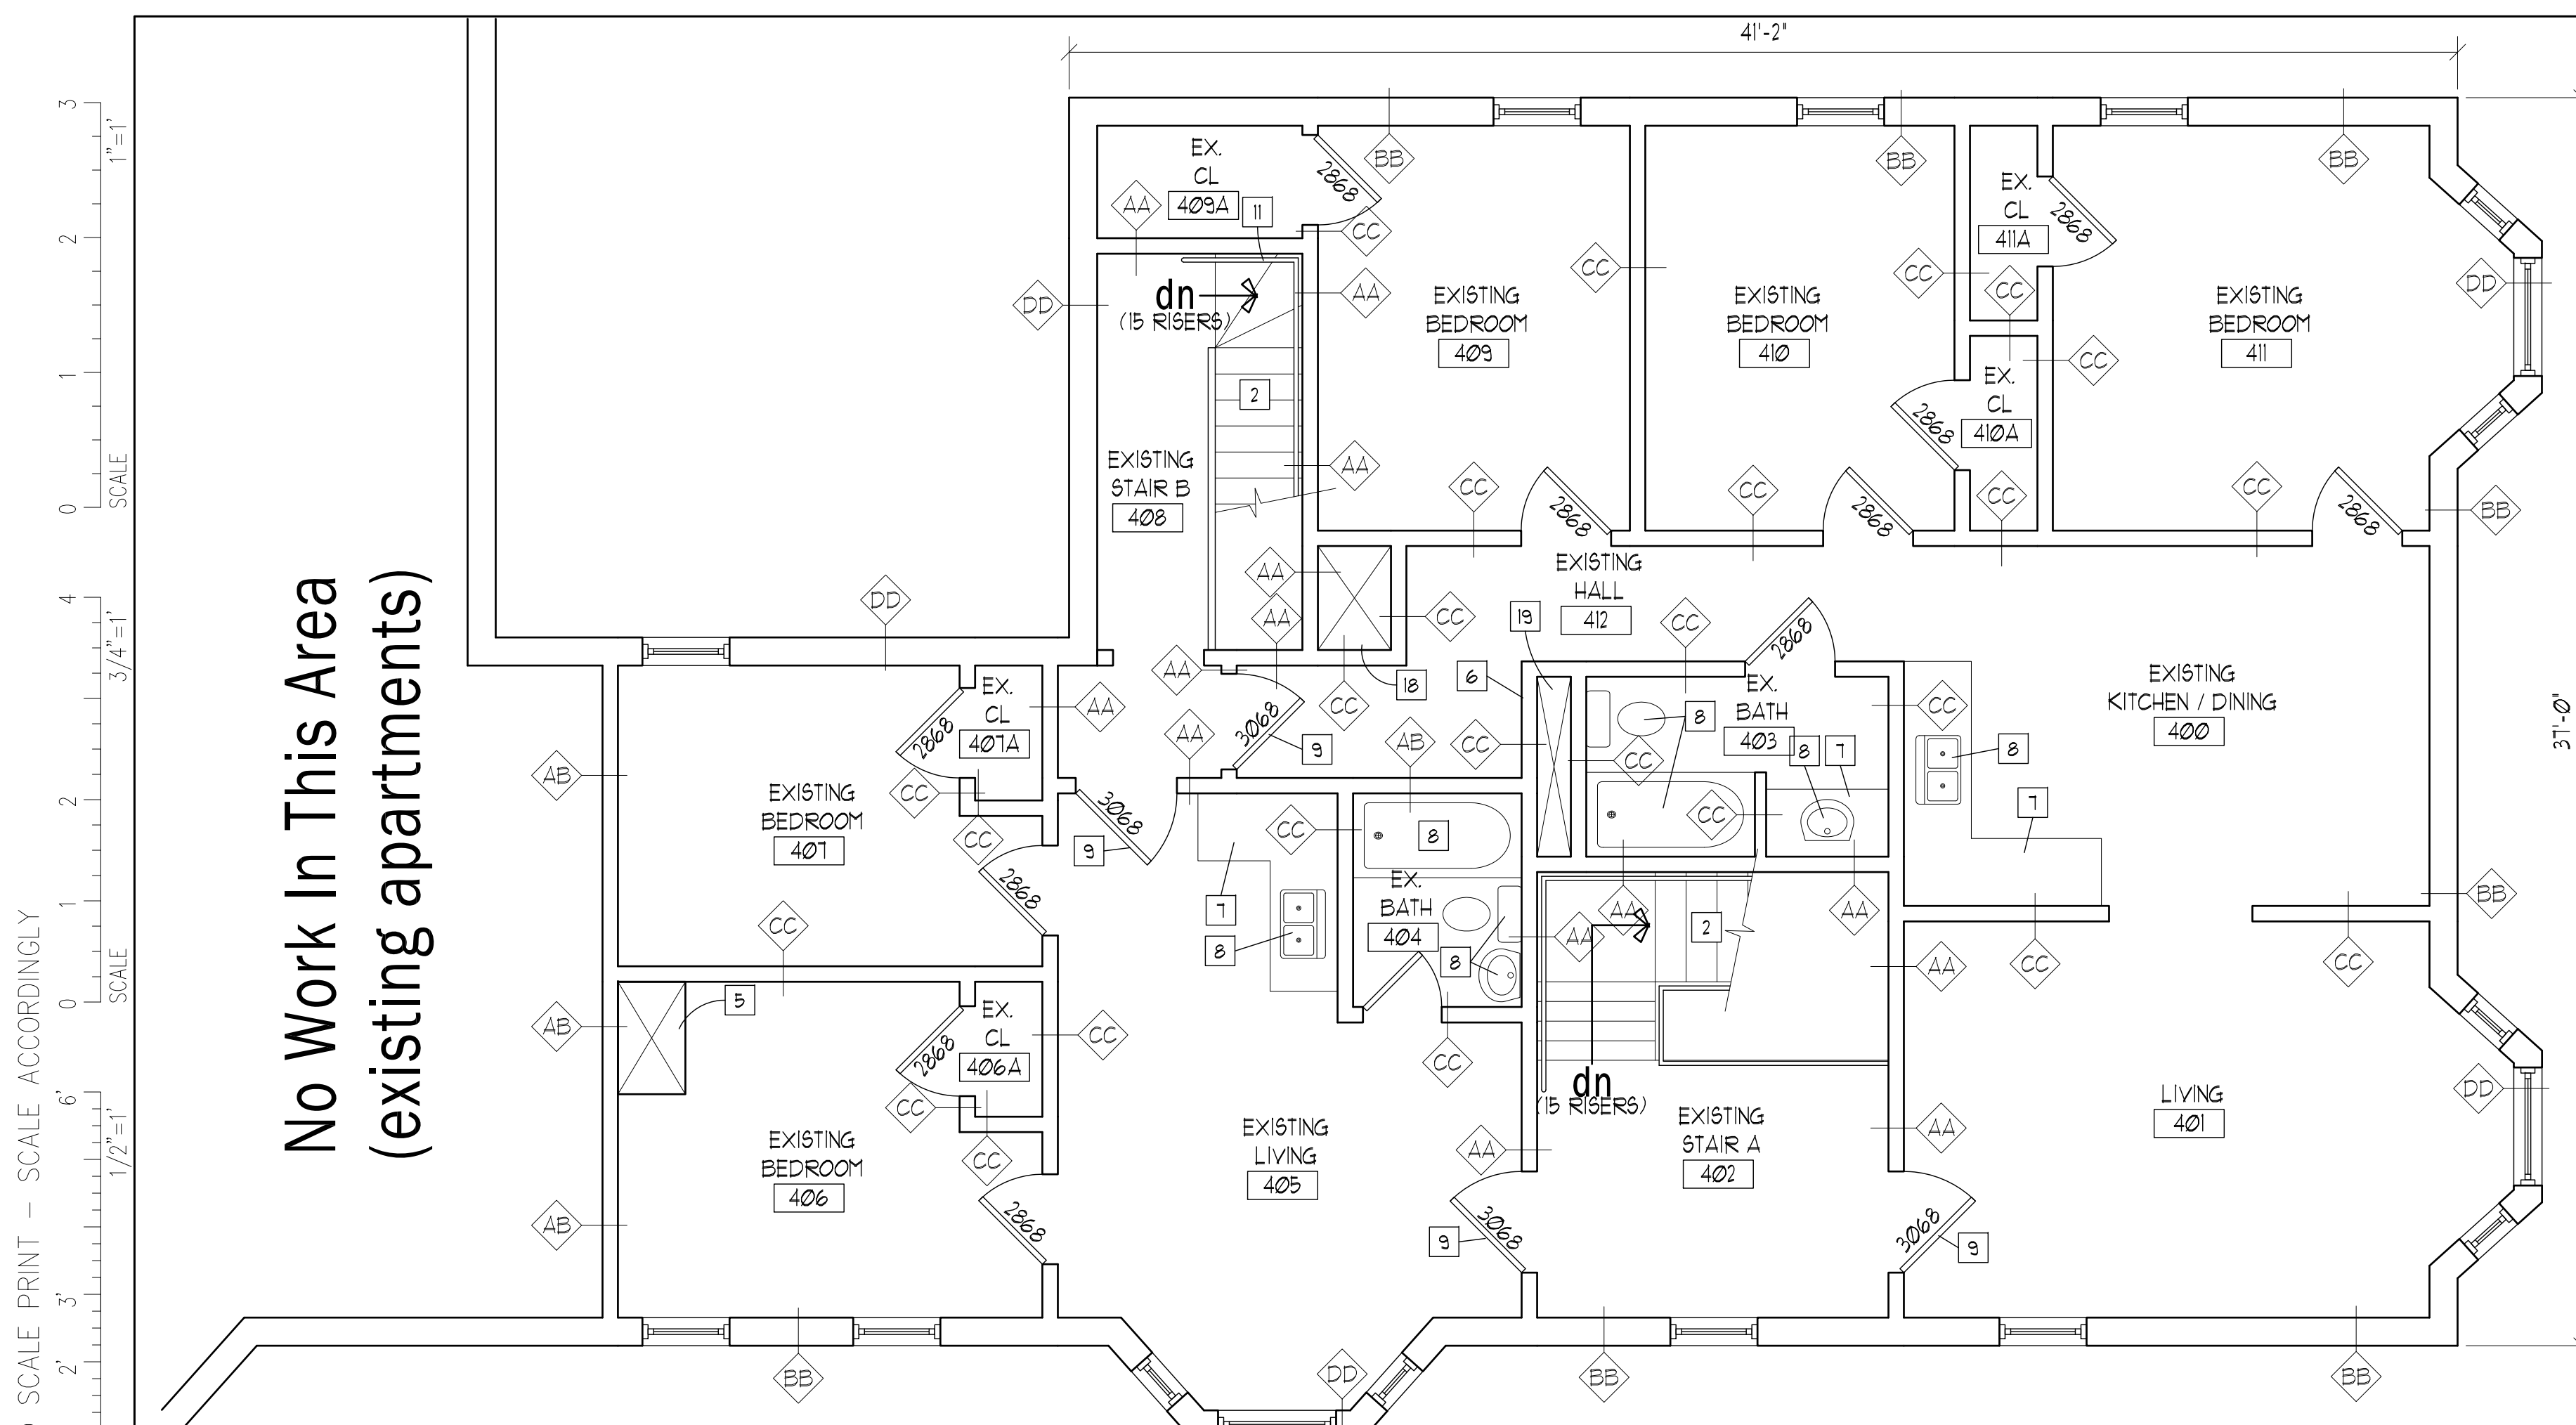
- 1 EXISTING ACCESS DOOR IN FLOOR TO BASEMENT
- 2 EXISTING STAIR TO REMAIN.
- 3 EXISTING FINISH FLOOR OF THIS UNIT IS APPROX. 5' HIGHER THAN THE VESTIBULE FINISH FLOOR.

- 4 EXISTING PLUMBING FIXTURE TO REMAIN (PROTECT AS REQUIRED)
- 5 EXISTING MASONRY CHIMNEY IS INACTIVE AND SHALL BE REMOVED DUE TO STRUCTURAL INTEGRITY ISSUES. THE FLOOR/CEILING SYSTEM SHALL BE INSTALLED AT EACH LEVEL TO ELIMINATE THE CHASE LEFT BY THE REMOVED CHIMNEY.

- 6 EXISTING ELECTRICAL PANEL TO REMAIN
- 1 MILLWORK BY OWNER
- 8 PLUMBING FIXTURE BY OWNER
- 9 DOOR TO BE 1-HOUR (60 MINUTE) FIRE-RATED
- 10 APPROX. LOCATION OF EXISTING STL. COLUMN

- 11 PROVIDE AND INSTALL HANDRAIL AS SHOWN PER DETAIL 3, SHEET A12
NOTE: THE HANDRAIL ON THIS SIDE OF THE STAIR WAS REMOVED AND IS BEING REPLACED. THERE IS HANDRAIL AND BALLUSTER SYSTEM ON THE OTHER SIDE OF THE STAIR THAT IS EXISTING AND IS NOT BEING REMOVED.

- 12 PROVIDE AND INSTALL HANDRAIL AS SHOWN PER DETAIL 3, SHEET A12
- 13 PROVIDE AND INSTALL NEW WD. STUD WALL AS SHOWN IN APPROX. LOCATION OF EXISTING STUD WALL THAT WAS REMOVED

- 14 PROVIDE AND INSTALL HANDRAIL / GUARDRAIL (SEE 3, SHT A12, S1M)
NOTE: THE HANDRAIL ON THIS SIDE OF THE STAIR WAS REMOVED AND IS BEING REPLACED. THERE IS A HALF-WALL ON THE OTHER SIDE OF THE STAIR THAT IS EXISTING AND IS NOT BEING REMOVED. THE GYP BOARD ON THE HALF-WALL HAS BEEN REMOVED AND IS BEING REPLACED. THERE WAS NO EXISTING HANDRAIL ON THE EXISTING HALF-WALL.

- 15 OWNER TO CONFIRM EXISTING DOOR IS 60 MIN RATED (MIN.). REPLACE IF REQUIRED.
- 16 INFILL MASONRY FOUNDATION WALL TO MATCH EXISTING
- 17 PROVIDE AND INSTALL 5/8" TYPE 'X' GYP OVER EXISTING FLOOR JOISTS AS REQUIRED TO PROVIDE A 1-HOUR FIRE-SEPARATION FROM THE APARTMENT USE ABOVE. ASSEMBLY TO BE U.L. L513 (SEE 3, SHT A12).

- SEE STRUCTURAL DRAWINGS FOR ITEMS TO BE REBUILT, REPAIRED, OR STRENGTHENED AS REQUIRED.
- 18 EXISTING MASONRY CHIMNEY TO REMAIN, PROTECT AS REQUIRED. PER SECTION 1082 - EXCEPTION 6 (2009 IBC), A SHAFT ENCLOSURE IS NOT REQUIRED. THE ANNULAR SPACE BETWEEN THE MASONRY AND THE WALL SURROUNDING THE CHIMNEY SHALL BE FIRE-BLOCKED AS REQUIRED PER SECTION 717.5 AT EACH FLOOR/CEILING LEVEL.

- 19 INDICATED SPACE IS NOT A CHASE AND DOES NOT REQUIRE A SHAFT ENCLOSURE. THIS SPACE IS SEPARATED AT EACH FLOOR LEVEL WITH THE TYPICAL FLOOR/CEILING ASSEMBLY. ANY PENETRATIONS THROUGH THE FLOOR/CEILING WILL REQUIRE TO BE FIRE-BLOCKED WITH THE USE OF SEALANTS, BARRIER DEVICES, COLLARS, OR OTHER PRODUCTS AS REQUIRED BY THE AUTHORITY HAVING JURISDICTION.
