Proposed Renovations  
@ 34 Howard St.,  
Portland, ME  
August 27, 2014

BUILDING SECTIONS  
A6

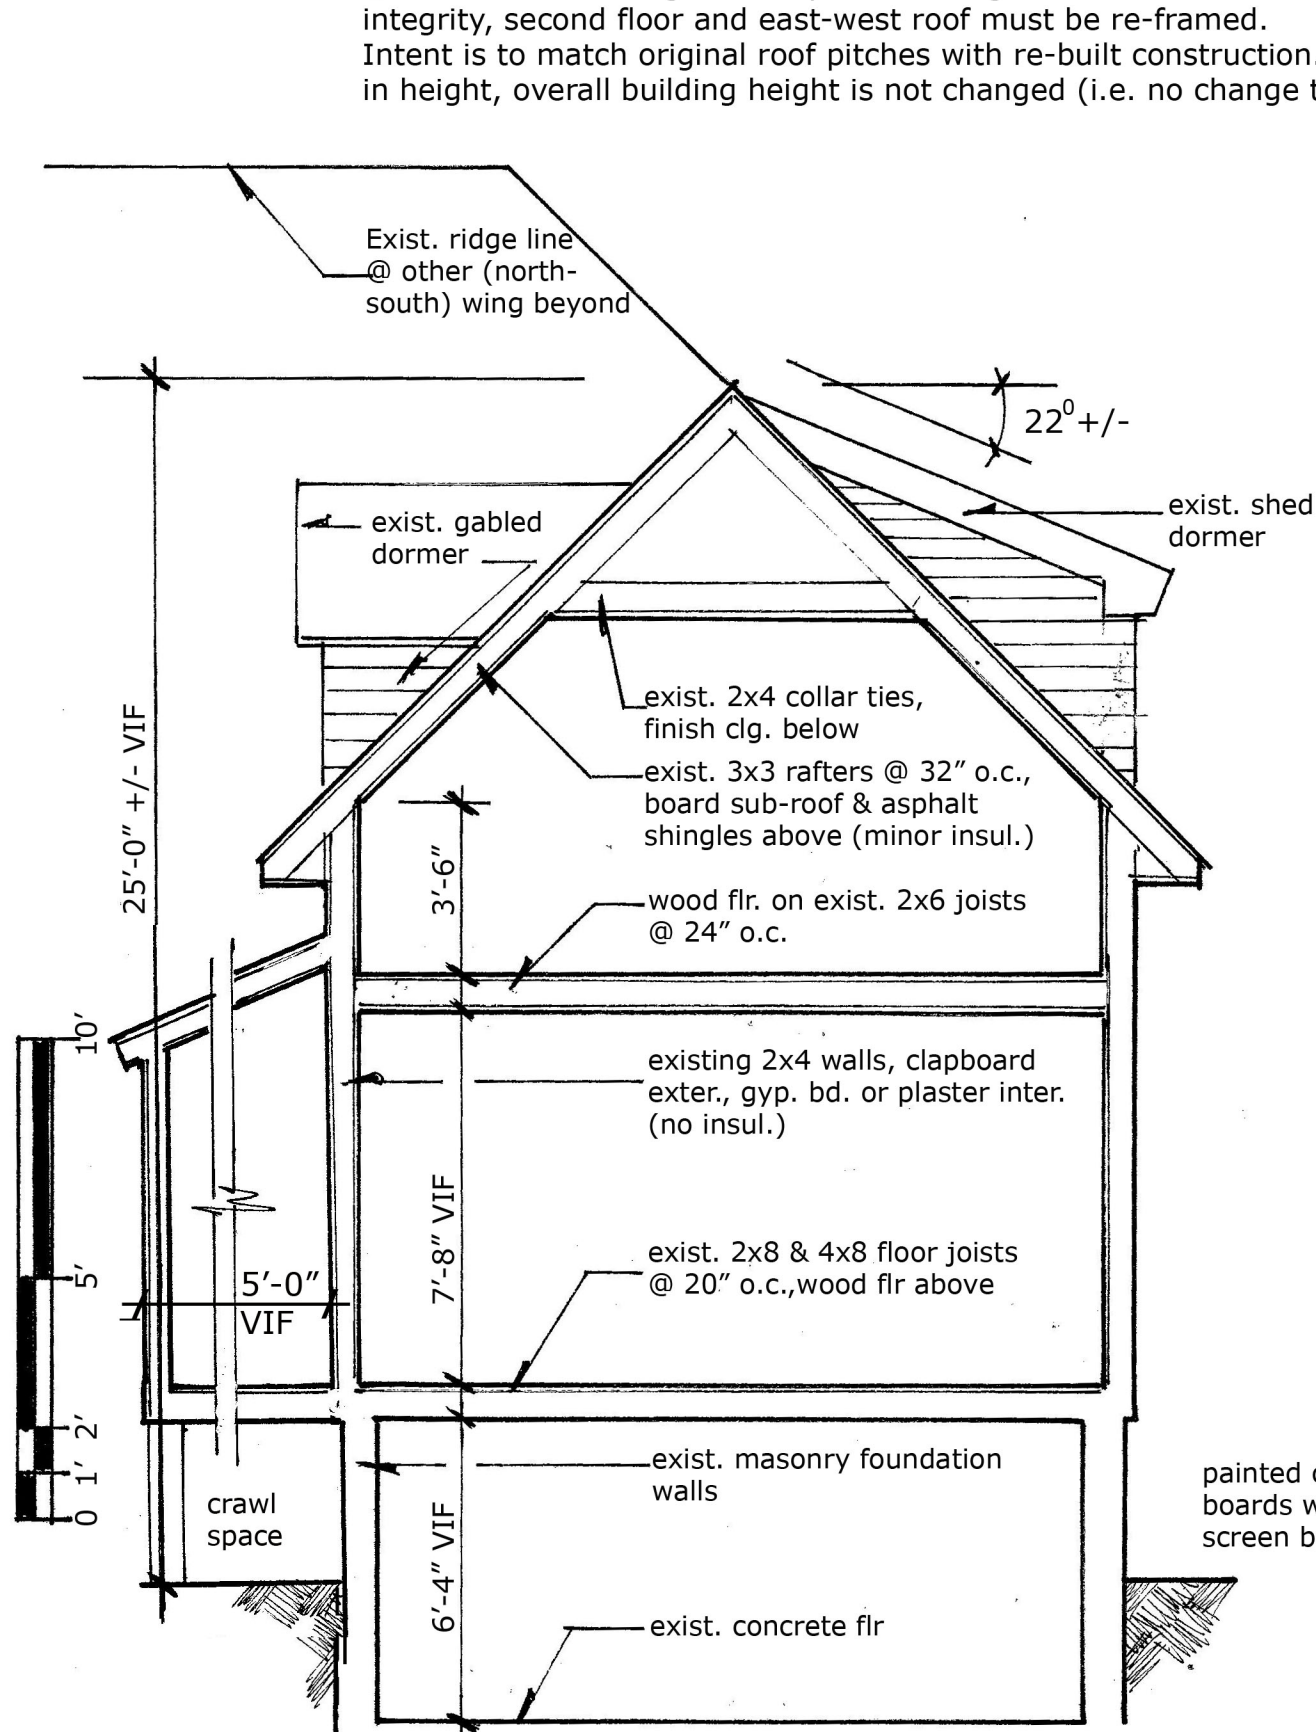
NOTE: Exploratory removals indicate solid, sound construction at basement level, first floor floor framing, exterior walls, & roof @ "north-south" wing. Inadequate framing is found at east-west roof and second floor floor framing. For structural integrity, second floor and east-west roof must be re-framed. Intent is to match original roof pitches with re-built construction. While re-built east-west roof will have minor increase in height, overall building height is not changed (i.e. no change to north-south roof, the higher roofline).

1 EXISTING BUILDING SECTION  
1/4" = 1'-0"

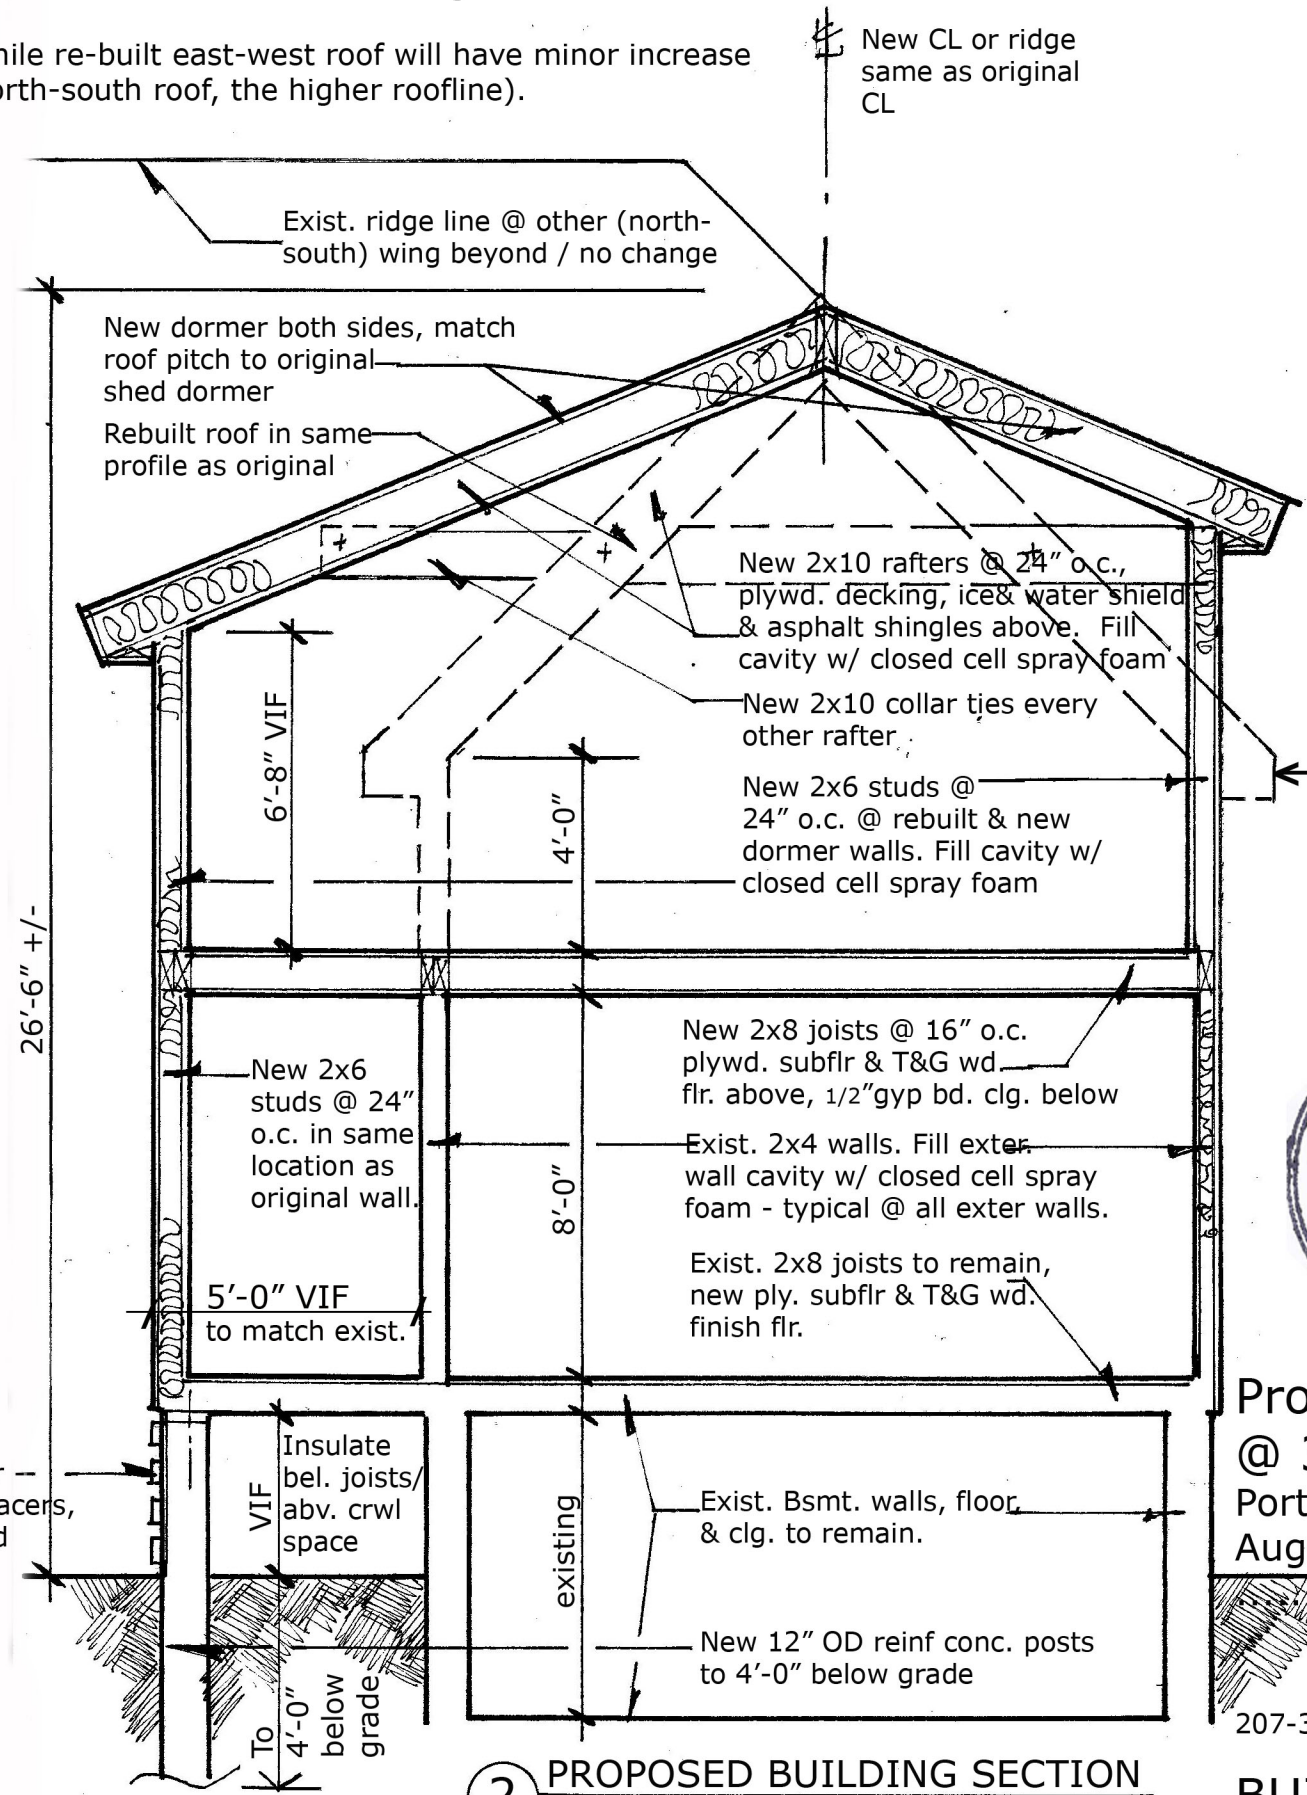
2 PROPOSED BUILDING SECTION  
1/4" = 1'-0"

Note: Profile facing street is gabled with 1:1 pitch, same as existing. See roof plan & exterior elevations
