Project:
GRAND TRUNK BUILDING
 1 INDIA STREET
 PORTLAND, ME

Date: **MAR 10 2016**
 Scale: **As indicated**
ELEVATION, NOTES AND KEY PLAN

BE1

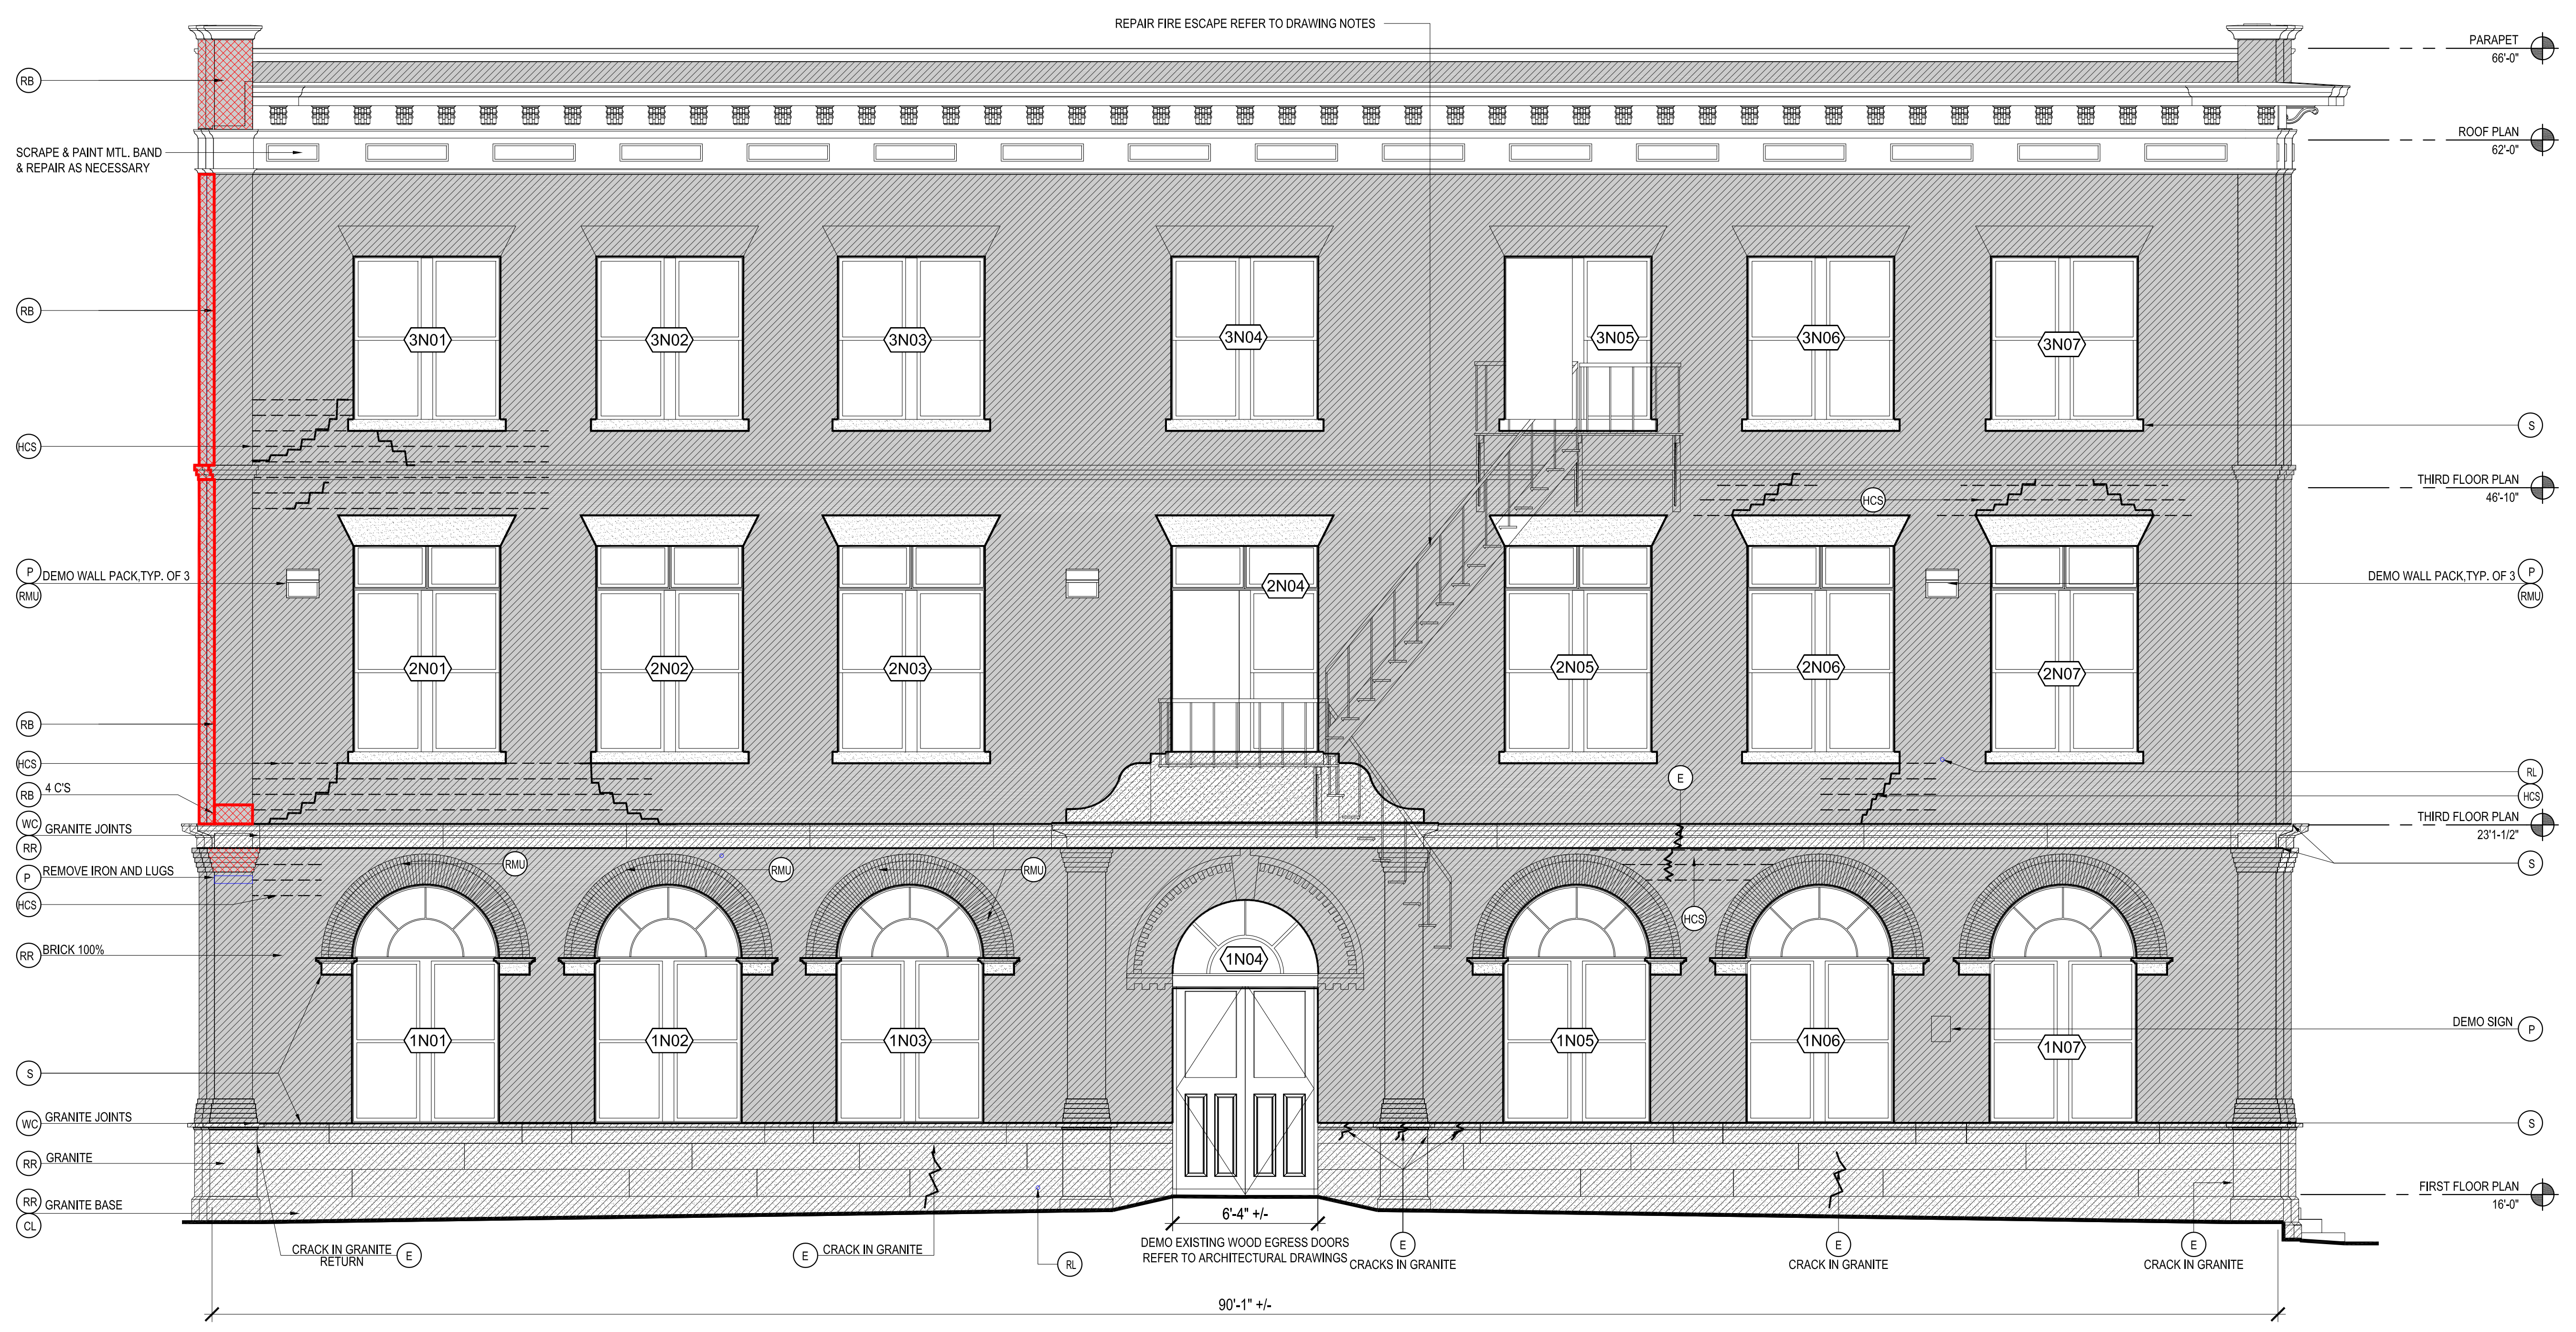
1 NORTH ELEVATION

<p>RAKE OUT AND RE-POINT</p> <p>RAKE OUT & RE-POINT: RAKE OUT ALL JOINTS TO A MINIMUM DEPTH OF 1" UNLESS OTHERWISE NOTED. RE-POINT JOINTS IN MASONRY WITH A PROPORTIONALLY MIXED BY VOLUME POINTING MORTAR. DO NOT LET HARDEN ON THE SURFACE OF MASONRY. MORTAR MUST CURE A MINIMUM OF 7 TO 14 DAYS PRIOR TO FINAL WASHING. WASH MASONRY WITH SPECIFIED PRODUCT LISTED IN THESE DOCUMENTS. ADDITIONAL WASHES MAY BE NECESSARY TO OBTAIN THE DESIRED APPEARANCE.</p> <p>POINTING MORTAR RECIPE: AS NOTES ON SHEET A0</p>	<p>REBUILD</p> <p>REBUILD: REMOVE AND REBUILD INDICATED MASONRY 1 WYTHE DEEP (UN), REBUILD USING EXISTING MATERIALS IF POSSIBLE. OTHERWISE, MATCH EXISTING MATERIALS, RESEMBLE TO MATCH ORIGINAL CONFIGURATION AT ALL LOCATIONS. LAY NEW MASONRY VENEER TRUE AND PLUMB WITH PROPORTIONALLY MIXED MORTAR TO MATCH EXISTING IN COLOR, POINTING PROFILE AND SAND SELECTION. REMOVE RESIDUAL MORTAR FROM ADJACENT MATERIAL IMMEDIATELY. DO NOT LET HARDEN ON MASONRY FACE. MORTAR MUST CURE FOR AT LEAST 14 TO 30 DAYS PRIOR TO FINAL WASH (CURING TIME MAY VARY DEPENDING ON WEATHER CONDITIONS). WASH MASONRY WITH SPECIFIED PRODUCT LISTED IN THESE DOCUMENTS. ADDITIONAL WASHES MAY BE NECESSARY TO OBTAIN THE DESIRED APPEARANCE.</p> <p>IN ALL AREAS MARKED AS REBUILD INSTALL (HWT) 6MM HELICAL WALL TIES AS PER THE DETAILS IN THIS DRAWING SET. FINAL POINTING OF THE ARE WILL ALSO BE REQUIRED. REFER HELICAL WALL TIE NOTES AND DETAIL 5/64</p>	<p>HELICRAL WALL TIE</p> <p>HELICRAL WALL TIES: INSTALL IN AREAS INDICATED 6MM HELICAL WALL TIES BY HELIFIX CORP. THRU THE FACE BRICK MORTAR JOINTS INTO THE BACKUP MATERIAL AS INDICATED IN THE DRAWINGS AND DETAILS. ALSO REFERENCE THE MANUFACTURER'S SPECIFICATION FOR DEPTH OF PENETRATION INTO BACK UP AND DEPTH OF HELICAL WALL TIE HEAD BEHIND MORTAR JOINT. AREAS WHERE WALL TIES ARE INSTALLED, THE ENTIRE FIELD IS TO BE RAKED OUT AND REPOINTED AS THE ABOVE "RR" NOTE INDICATES.</p>	<p>HELICRAL CRACK STITCH</p> <p>HELICRAL CRACK STITCH: INSTALL 4MM S.S. HELICAL ANCHORS BY HELIFIX CORP. AS PER MANUFACTURER'S RECOMMENDATIONS. THE DIGIT IN THE KEYNOTE SYMBOL REPRESENTS THE NUMBER OF STITCHING ANCHORS RECOMMENDED WITHIN THE DEFINED AREA OF REPAIR. PLACE STITCHINGS AS INDICATED IN THE DRAWINGS AND DETAILS.</p>	<p>BACKER ROD AND SEALANT</p> <p>SEALANT: INSTALL NEW CLOSED CELL FOAM BACKER ROD AS REQUIRED AFTER RE-POINTING. INSTALL SEALANT PER THE DETAILS AND MANUFACTURER'S SPECIFICATIONS. CONTRACTOR WILL COORDINATE A FULL TEST APPROVAL WITH SEALANT MANUFACTURER'S REP FOR WARRANTY PURPOSES AND SUBMIT A COPY TO BES. ALL SEALANT JOINTS TO BE SANDED TO MATCH MORTAR.</p>	<p>EPOXY CONTRACTOR WILL APPLY</p> <p>EPOXY: CONTRACTOR WILL APPLY THE 2-PART EPOXY RESIN TO REPAIR MASONRY ELEMENTS, IF MATERIAL IS FRACTURED INTO LOOSE PIECES. DRILL AND EPOXY 3/16" S.S. THREADED ANCHORING PINS INTO ELEMENTS AS PART OF THE REPAIR. IF THE CAUSE OF CRACKING IS DUE TO STRUCTURAL LOADING, CONTACT BUILDING ENVELOPE SPECIALISTS FOR ADDITIONAL REPAIR MEASURES. IF SECTION OF STONE IS LOOSE, REMOVE, CLEAN, AND EPOXY IN ORIGINAL LOCATION</p>	<p>PATCH MASONRY</p> <p>PATCH: REMOVE LOOSE, SCALING OR SPALLING MASONRY. PATCH WITH PRODUCT INDICATED IN THIS DRAWING SET SPECIFIC TO THE MATERIAL BEING PATCHED.</p>	<p>REPLACE MASONRY UNITS</p> <p>REPLACE MASONRY UNITS: REMOVE THE BROKEN SPALLED OR DAMAGED MASONRY UNITS AND REPLACE WITH MATCHING MASONRY.</p>	<p>WEATHER CAP</p> <p>WEATHER CAP - INSTALL WEATHERCAP LEAD STONE FLASHING STRIPS IN ALL LOCATIONS LOCATION WHERE TEE'S ARE INDICATED ON DRAWINGS. USE SIZE OF STRIPS AS RECOMMENDED BY MANUFACTURER AND COMPATIBLE WITH STYLE AND CONFIGURATION OF EXISTING. STRIPS SHOULD BE OF SUFFICIENT SIZE TO COVER THE SEALANT JOINT WIDTH, PLUS A PERCENTAGE ALLOWANCE FOR ANTICIPATED. IN ALL LOCATIONS WHERE THERE IS A LUG AS PART OF THE MASONRY THE WEATHERCAP WILL LAP UP AND OVER THE TOP OF THE LUG.</p>	<p>EXISTING GRANITE</p> <p>EXISTING BRICK</p>
