DATE: 22 FEB 2007  
 SCALE: AS NOTED  
 PROJECT NO.: 05-032

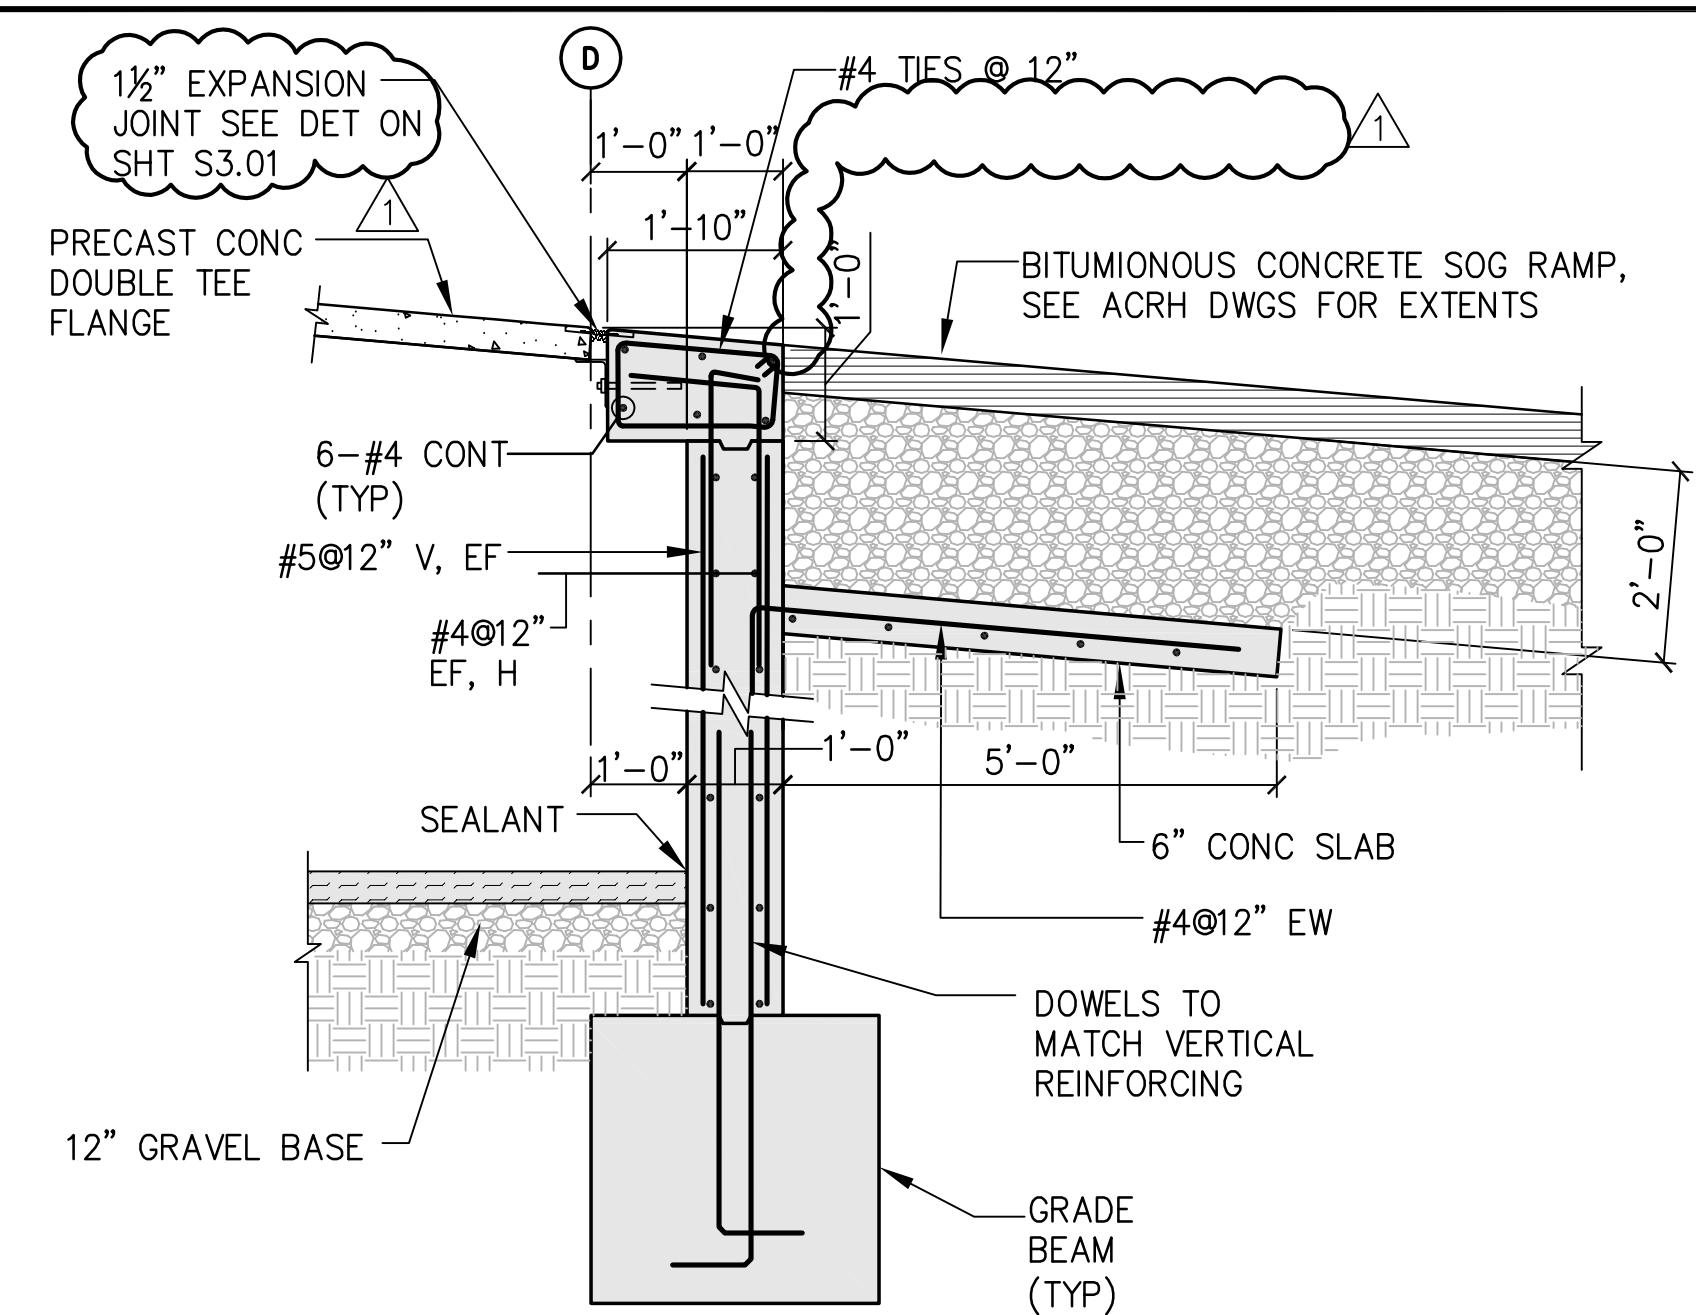
SECTION 1  
1/2"=1'-0"  
S1.00, S1.01, S1.02

NOTE: PLACE UPPER PORTION AFTER DOUBLE TEE IS IN PLACE
