This is to certify that BOODILLY LLC / E.W. Littlefield, Inc. & Sonshas permission to Change of use from Church restaurant interior exterior renovations/restorationAT 17 CHESTNUT ST

CITY OF PORTLAND, MAINE
HISTORIC PRESERVATION BOARD

On June 18, 2008, the City of Portland's Historic Preservation Board reviewed your proposal for exterior alterations and repairs to the former Chestnut Street Church at 17 Chestnut Street. The proposal, prepared by architect Dean Bingham and preservation consultant Amy Cole-Ives, included revisions to previously-approved plans for alterations at the rear of the church as well as additional exterior work. Following deliberations, the Historic Preservation Board voted 6-0 (Oldham absent) to approve the project, based on findings that the proposed scope of work met the historic preservation ordinance's Standards for Review of Alterations.

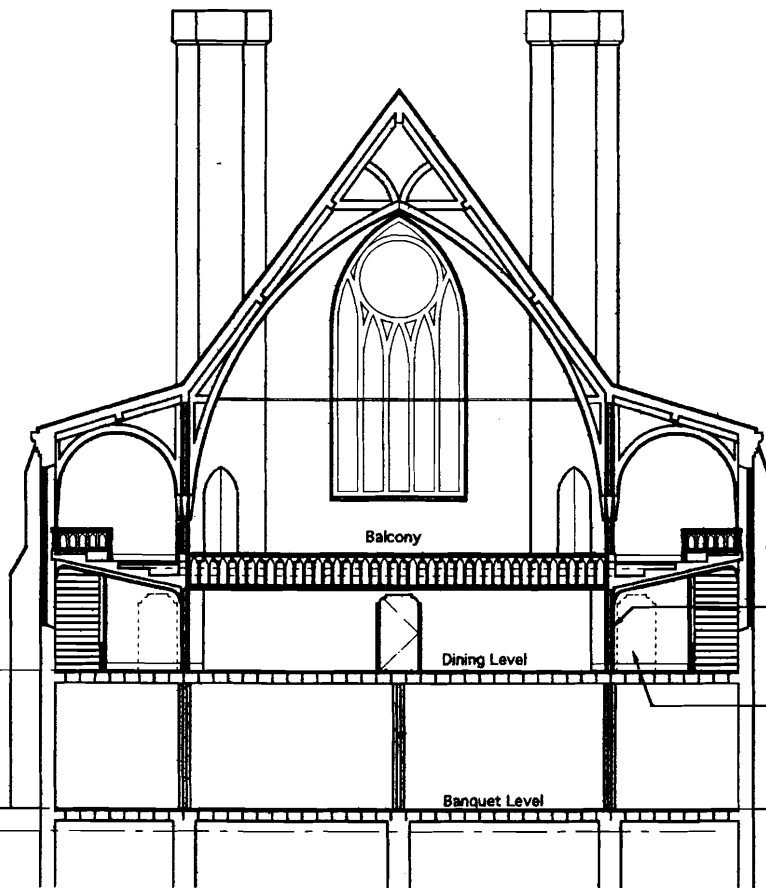
Cross Section
(looking toward entry)

New 'flying' stair, with solid stringers, risers and treads, cable handrail with wood cap to match guard at balcony.

Wood column, and beam below balcony, to remain exposed. New drywall to die into face of column and beam. Typical both sides.

New bath walls to extend to underside of balcony only.

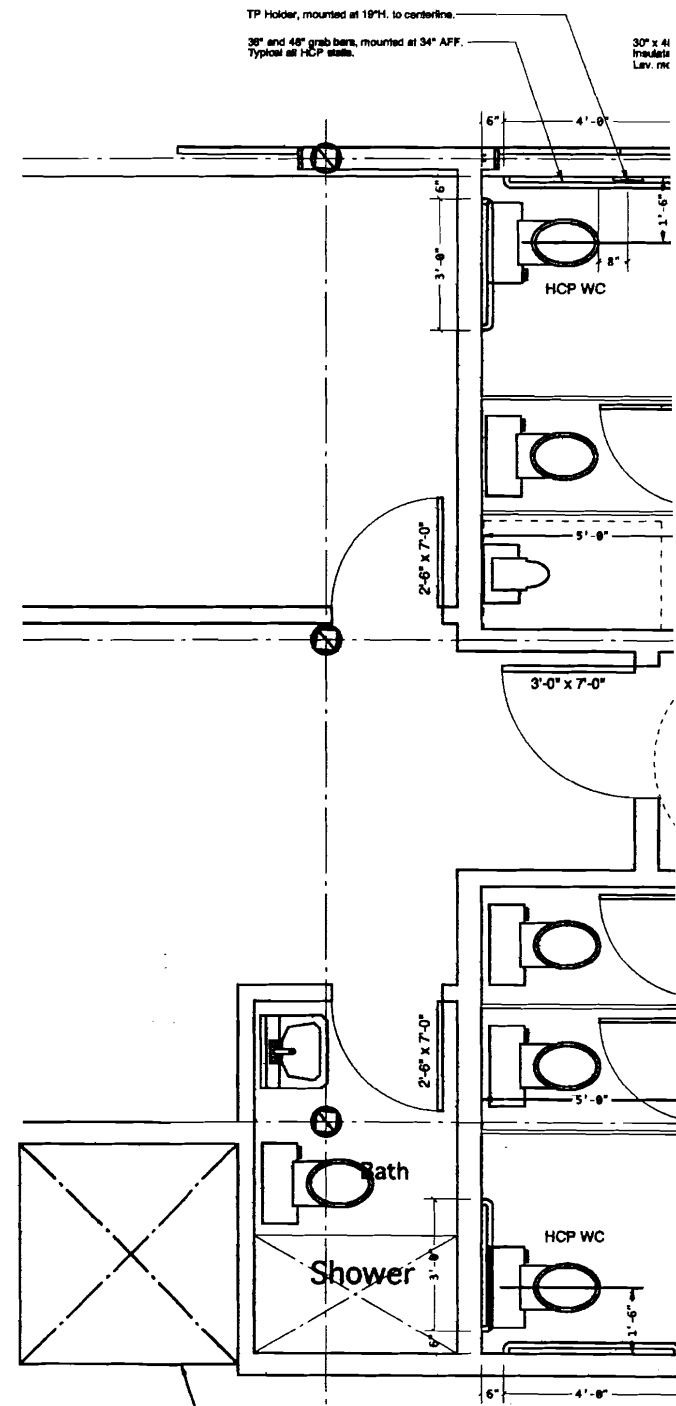
Ground Floor Men's & Women's HCP Bathrooms
Scale: 1/2" = 1'-0"

TP Holder, mounted at 19" H. to centerline.
36" and 48" grab bars, mounted at 34" AFF.
Typical at HCP stalls.

30" x 48" Transfer Lav. rkt

HCP 911 in Main Entry, above.
Adjust basement bath location as necessary
to clear 911.

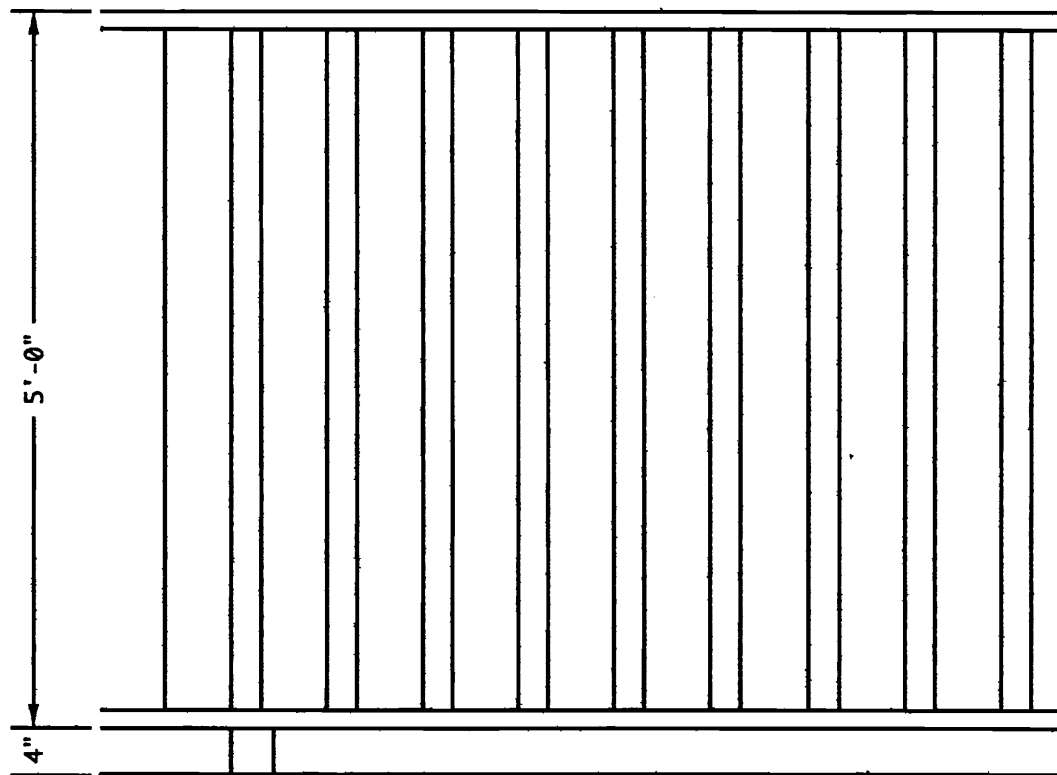
Fence Elevation

Mechanical Screen Fence Details

1. All exposed lumber to be Western Red Cedar, with weathering grey stain finish.
2. All framing lumber to be pressure treated southern yellow pine.
3. Connection to roof to be determined, dependent on final roof construction.
4. All exposed fasteners to be stainless steel.

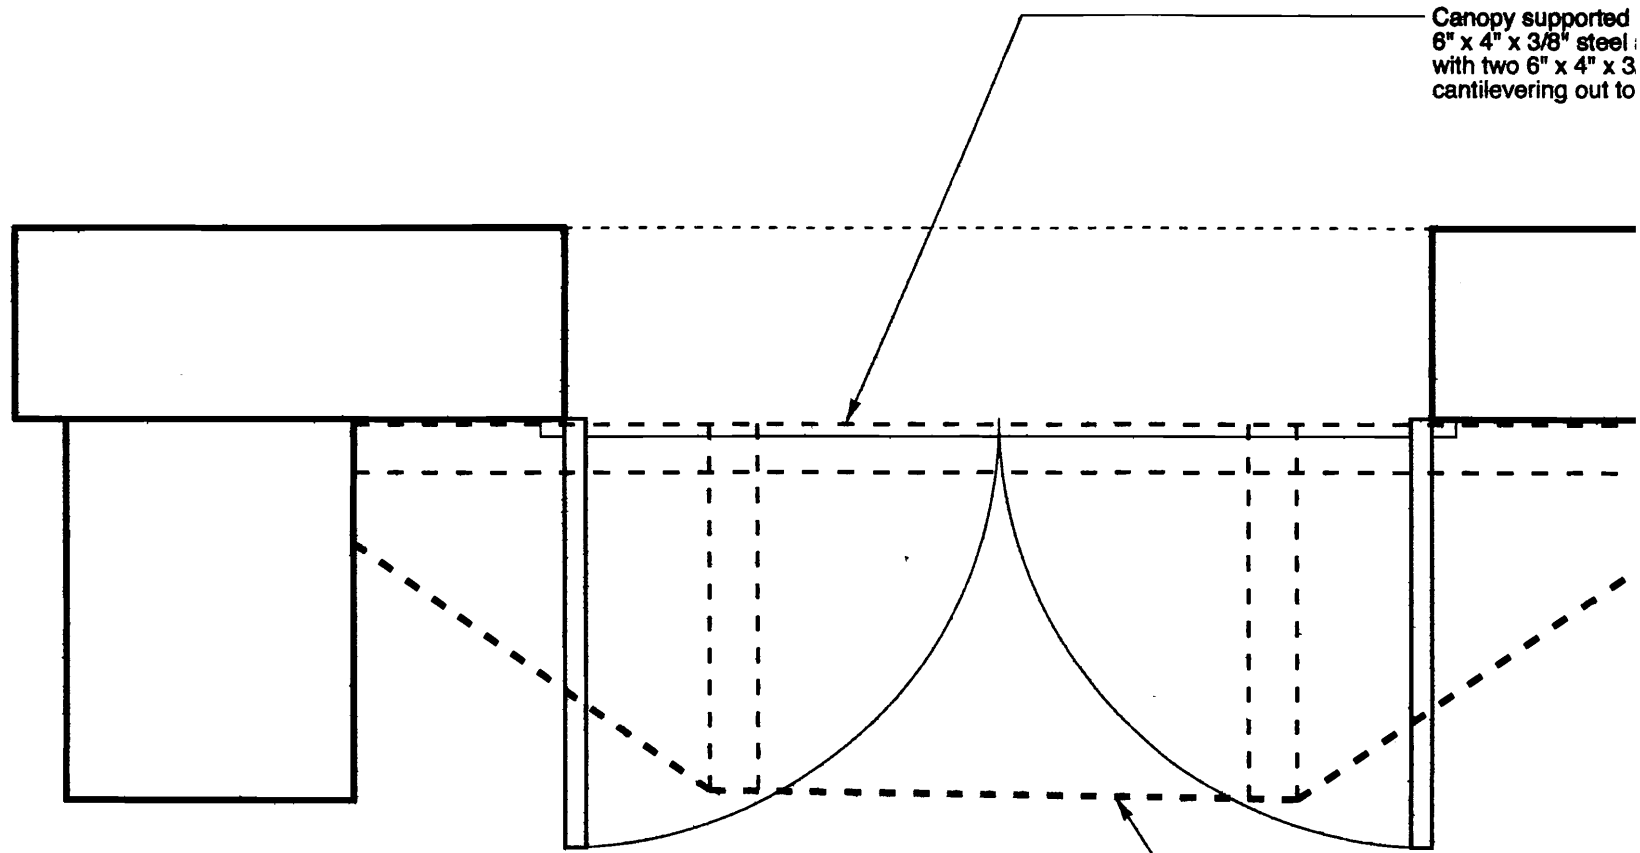
Plan of New Canopy Roof at Function Room Entrance
(see SK3 for elevation and section)

Face of masonry wall.

Outside face of brick pilaster.

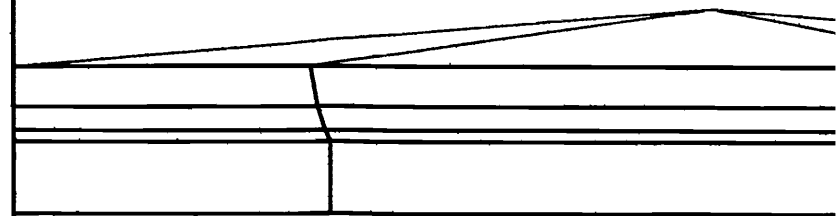
Section Through Function Room Entrance/Canopy

Existing brownstone lintel to be removed and
opening raised to accommodate new 3' x 7'
4-panel entrance door, with power assisted operator.
Patch brick in area where brownstone removed.

Adjust grade and paving at door to create flat landing
at entrance. Slope away from landing area at
maximum 1:20 pitch to meet existing grade.
