# Solar Glare Hazard Analysis Report

Analysis name	Fore St Garage
PV array axis tracking	none
Orientation of array (deg)	150.0
Tilt of solar panels (deg)	5.0
Rated power (kW)	193.63
Vary reflectivity	True
PV surface material	Smooth glass with ARC

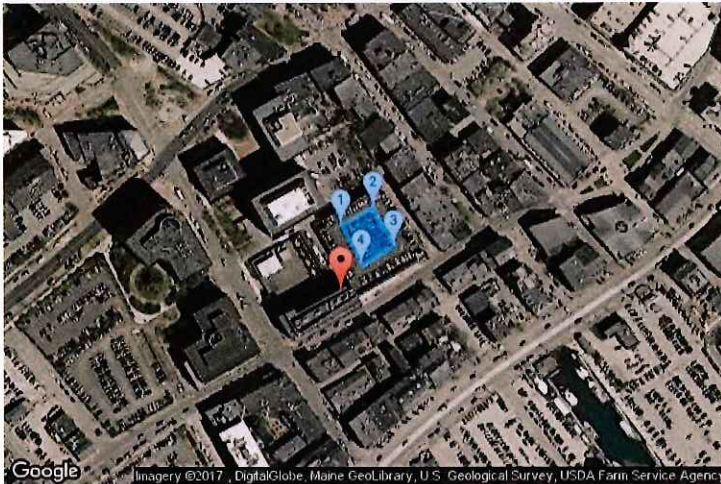
No glare found

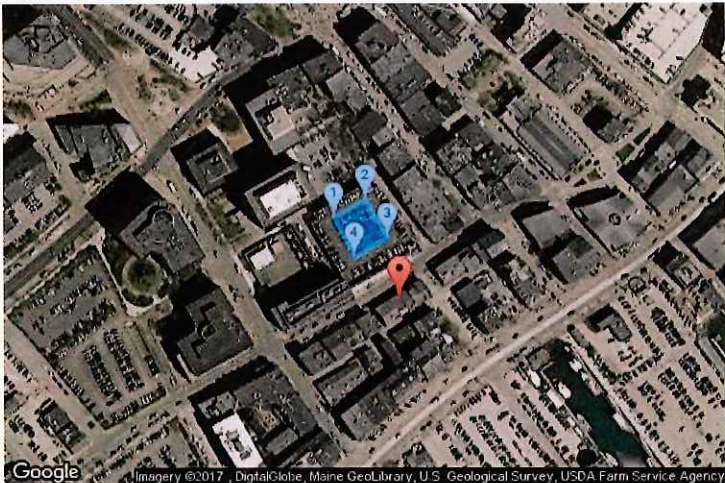
No glare found

Analysis name	Fore St Garage
PV array axis tracking	none
Orientation of array (deg)	150.0
Tilt of solar panels (deg)	5.0
Rated power (kW)	193.63
Vary reflectivity	True
PV surface material	Smooth glass with ARC

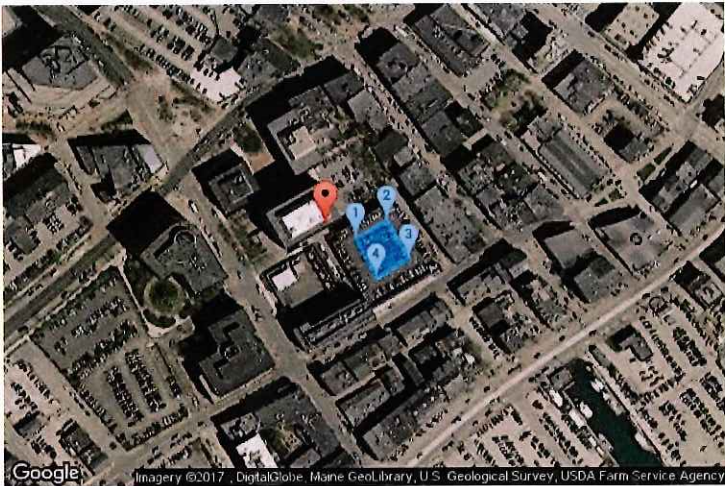
## Glare found

Analysis name	Fore St Garage
PV array axis tracking	none
Orientation of array (deg)	150.0
Tilt of solar panels (deg)	5.0
Rated power (kW)	193.63
Vary reflectivity	True
PV surface material	Smooth glass with ARC
