DEVELOPMENT

MIXED

RESIDENCE WINDOW DETAILS

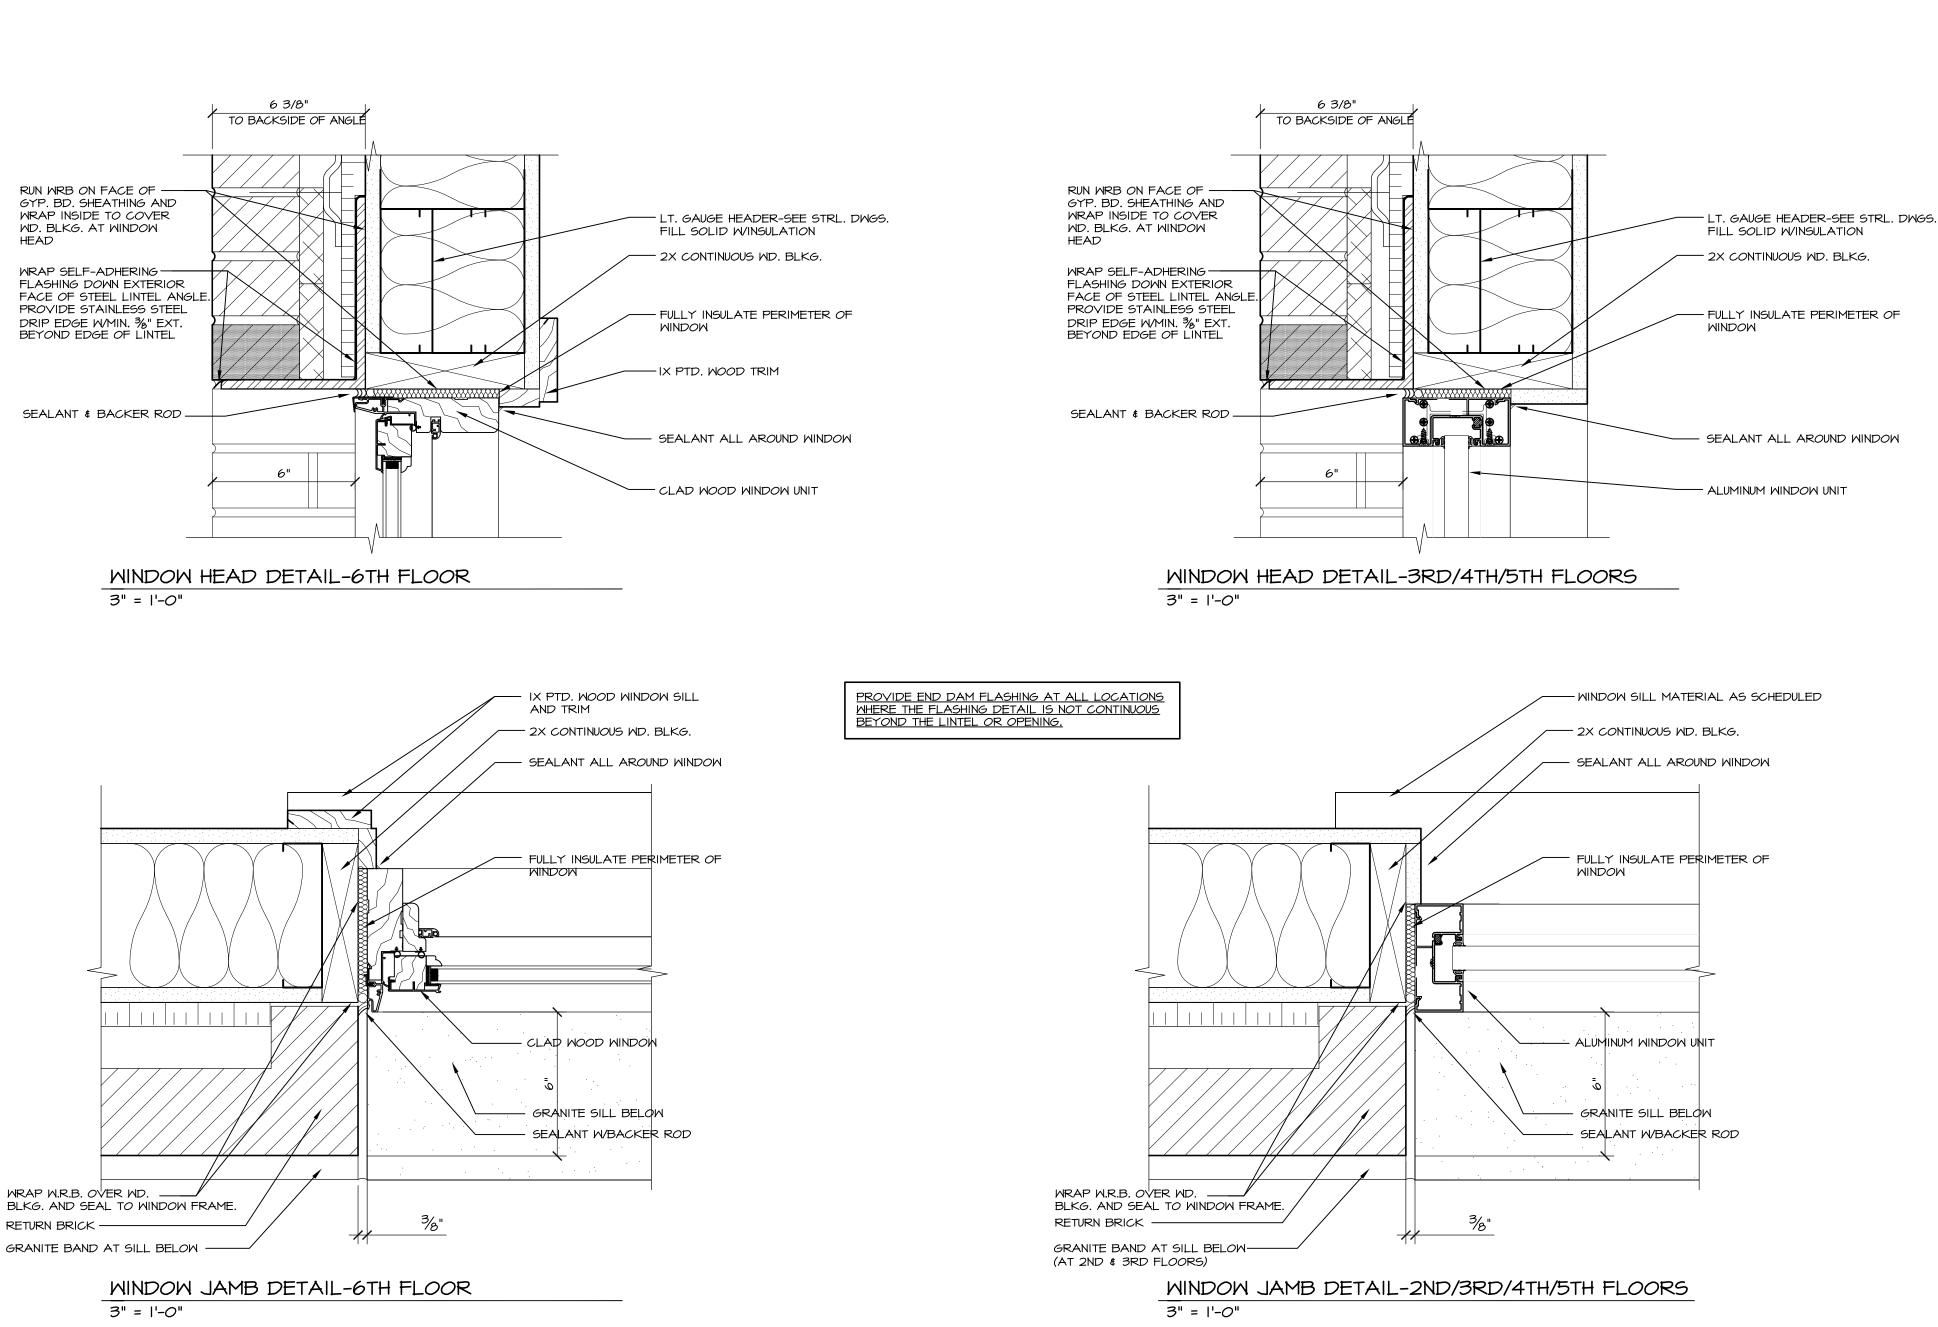
- CLAD WOOD WINDOW UNIT

---- 2X CONTINUOUS WD. BLKG.

- IX PTD. WOOD WINDOW SILL

- SEALANT ALL AROUND WINDOW

- MD. BLOCKING, SET IN SEALANT

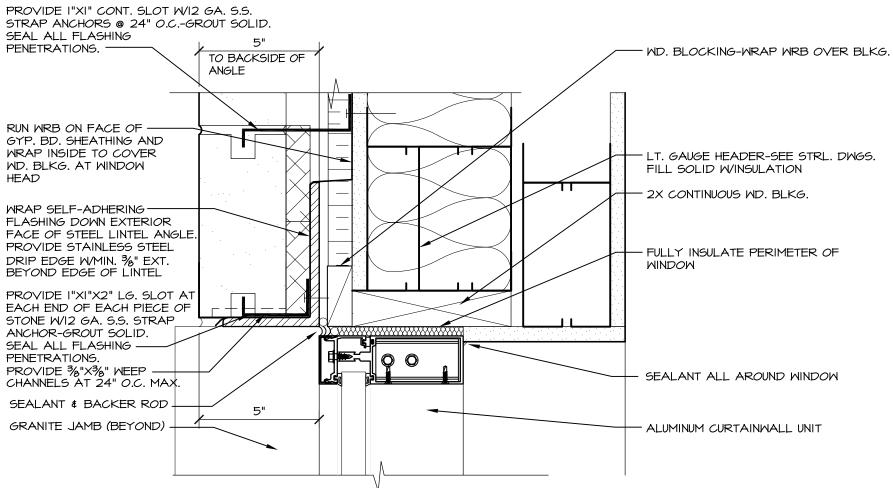
HEAD DETAIL-STONE LINTEL 3" = I'-0"

SEAL ALL FLASHING

SEALANT & BACKER ROD.

GRANITE JAMB (BEYOND) -

PENETRATIONS. —
