# LEARNINGWORKS

## 181 BRACKETT STREET, PORTLAND, MAINE

### DETAILED PHASING PLAN & DESCRIPTION OF WORK

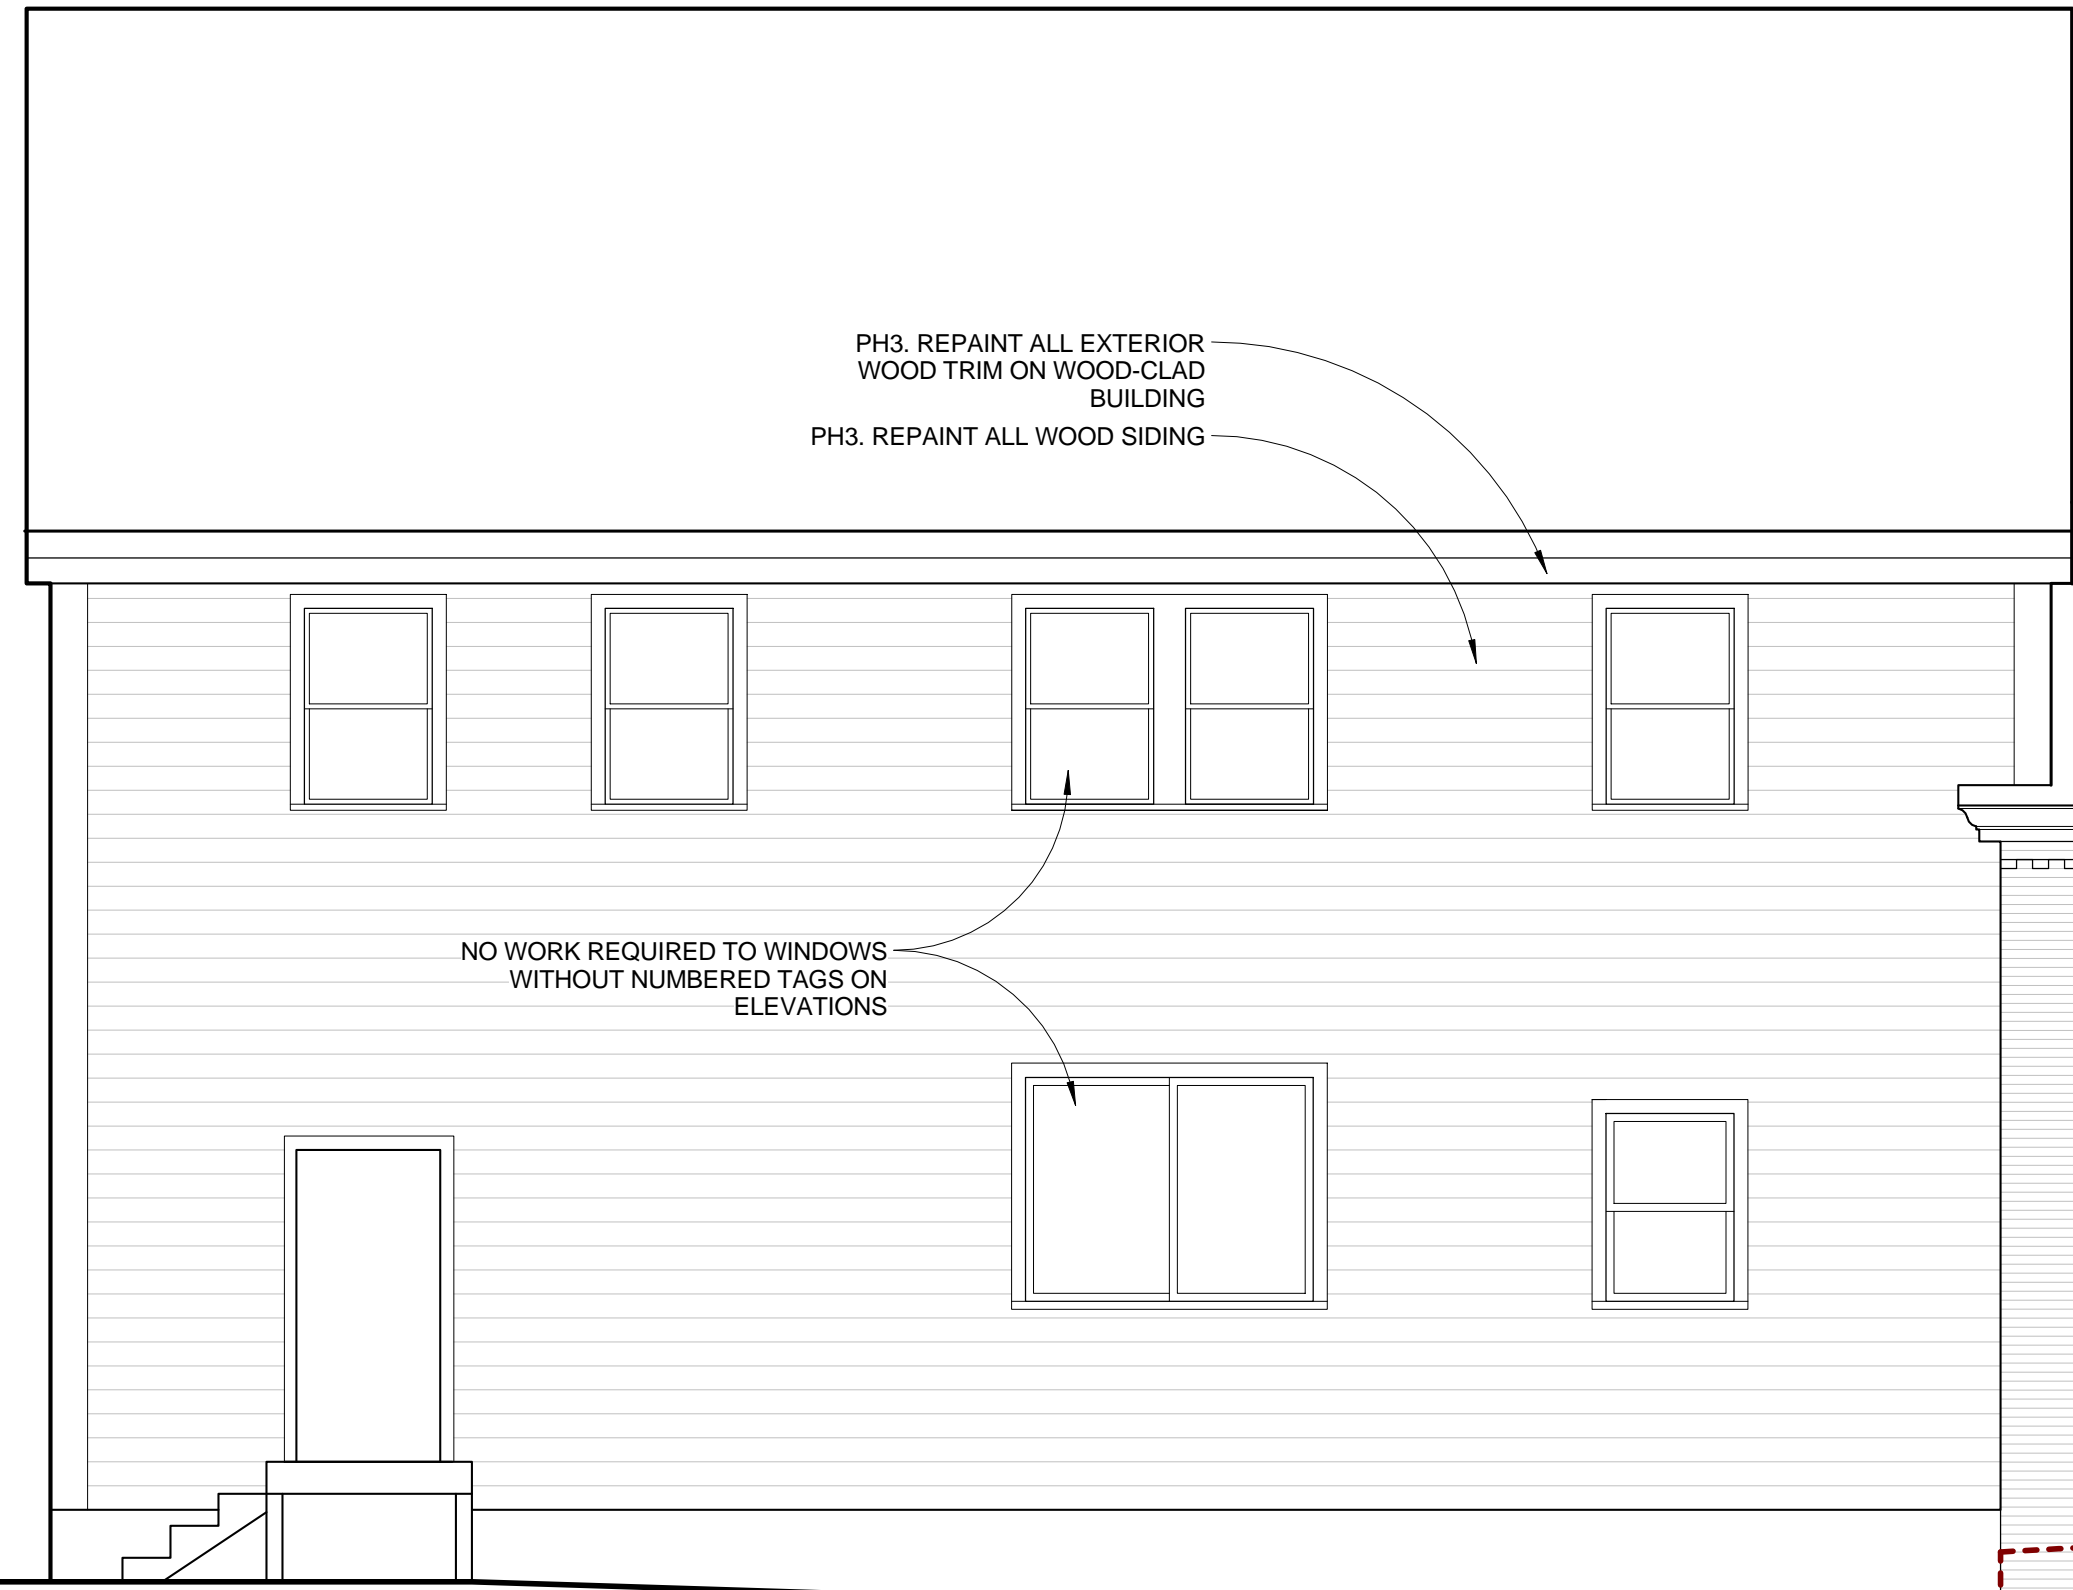
2 NORTH ELEVATION  
1/4" = 1'-0"

WALL AREA WITH 10' SEPARATION DISTANCE FROM ADJACENT BUILDING: 2,190 SF  
ALLOWABLE EXTERIOR WALL OPENING AREA 15% (PER IBC TABLE 705.8): 328.5 SF  
EXISTING WINDOW AREA: 222 SF  
PROPOSED AREA OF NEW WINDOWS: 58 SF  
TOTAL WINDOW AREA (EXISTING + NEW): 280 SF - 12.75%

- CREATE (4) NEW WINDOW OPENINGS ON NORTH SIDE OF 2-STORY BUILDING. INSTALL (4) NEW WINDOWS TO MATCH REPLACEMENT WINDOWS. REFER TO STRUCTURAL DRAWINGS/SPECIFICATIONS. NEW OPENINGS TO ALIGN WITH BRICK COURSING AND MATCH DIMENSIONS OF EXISTING MASONRY OPENINGS ADJACENT. TOOTH-IN SALVAGED BRICKS AT JAMBS TO AVOID EXPOSURE OF CUT BRICK ENDS. MODIFY INTERIOR FINISHES AS REQUIRED. PROVIDE NEW PAINTED WOOD TRIM AT INTERIOR.

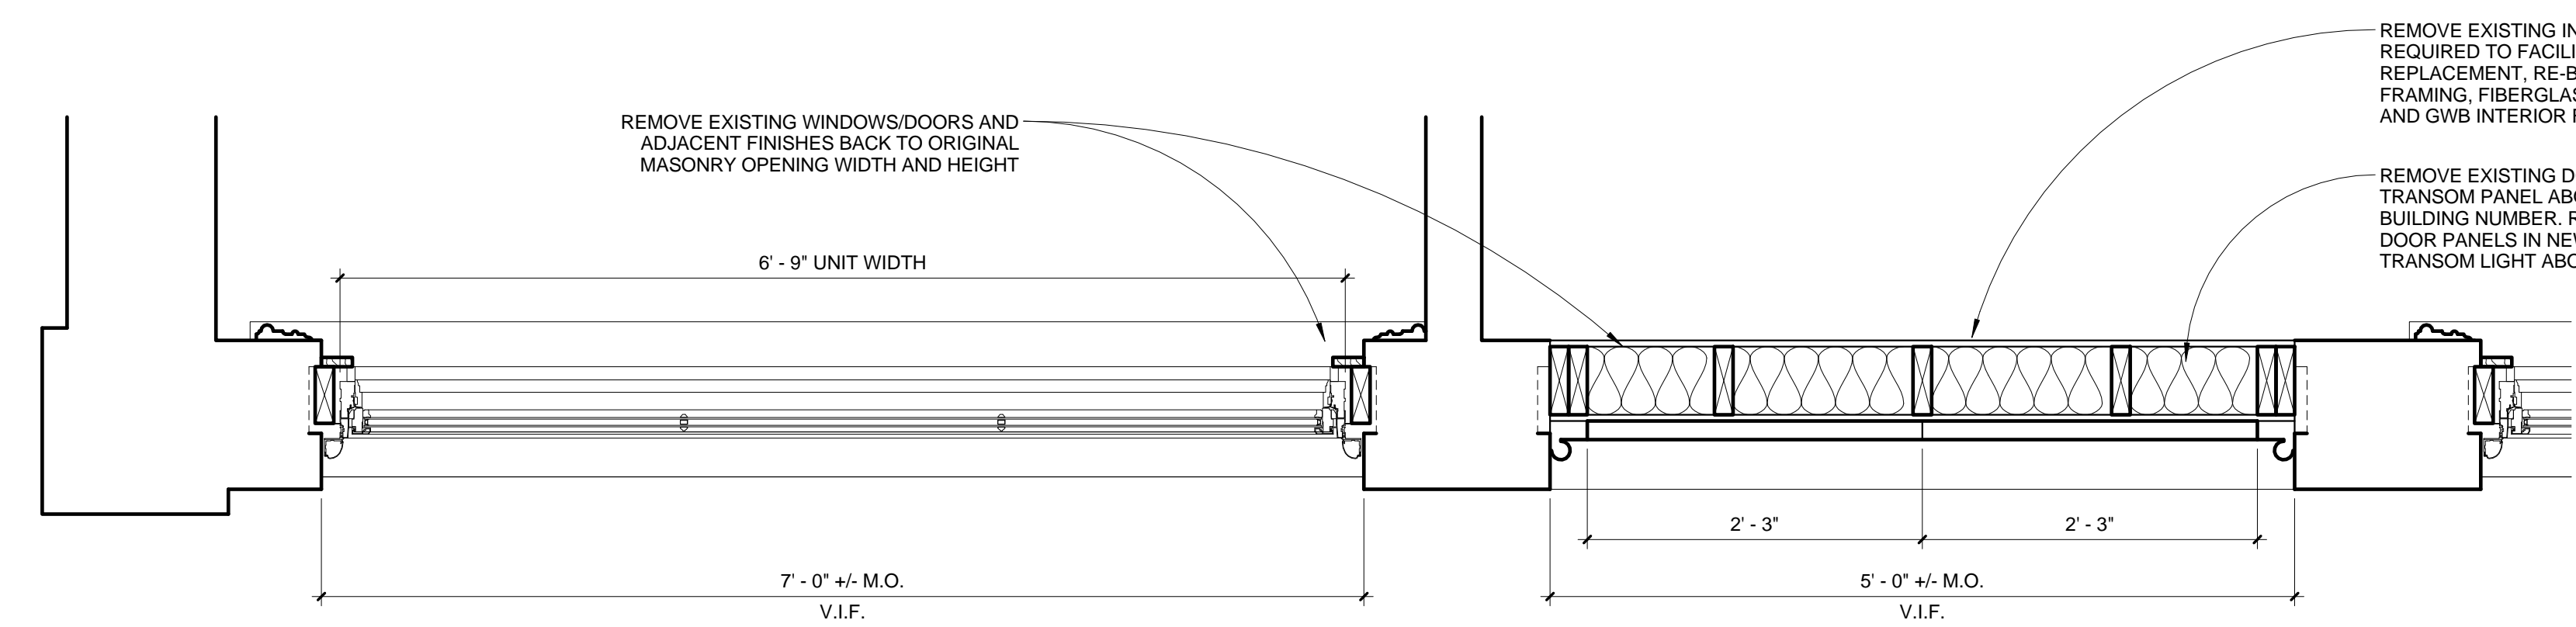
① STOREFRONT  
1" = 1'-0"

ELLIPTICAL TOP TRANSOM WITH SOLID PANEL  
CONTINUOUS BULLNOSE BRICKMOLD TRIM TO MATCH WINDOWS

- **NEW STOREFRONT & ENTRY:** AT (2) 7'-0" +/- WIDE ARCHED OPENINGS REMOVE ALL WINDOWS, WOOD FRAMED & FINISHED WALL AND BRICK INFILL BELOW WINDOW SILLS TO 8" ABOVE GRADE. REPLACE WITH NEW ALUMINUM-CLAD WOOD FIXED WINDOWS TO MATCH ORIGINAL DESIGN: FULL HEIGHT, TRIPARTITE WINDOW WITH paneled wood infill below sill height where ORIGINAL BULKHEAD WINDOWS WERE LOCATED. MODIFY EXISTING CEILING TO SLOPE UP TO ORIGINAL WINDOW HEAD HEIGHT.

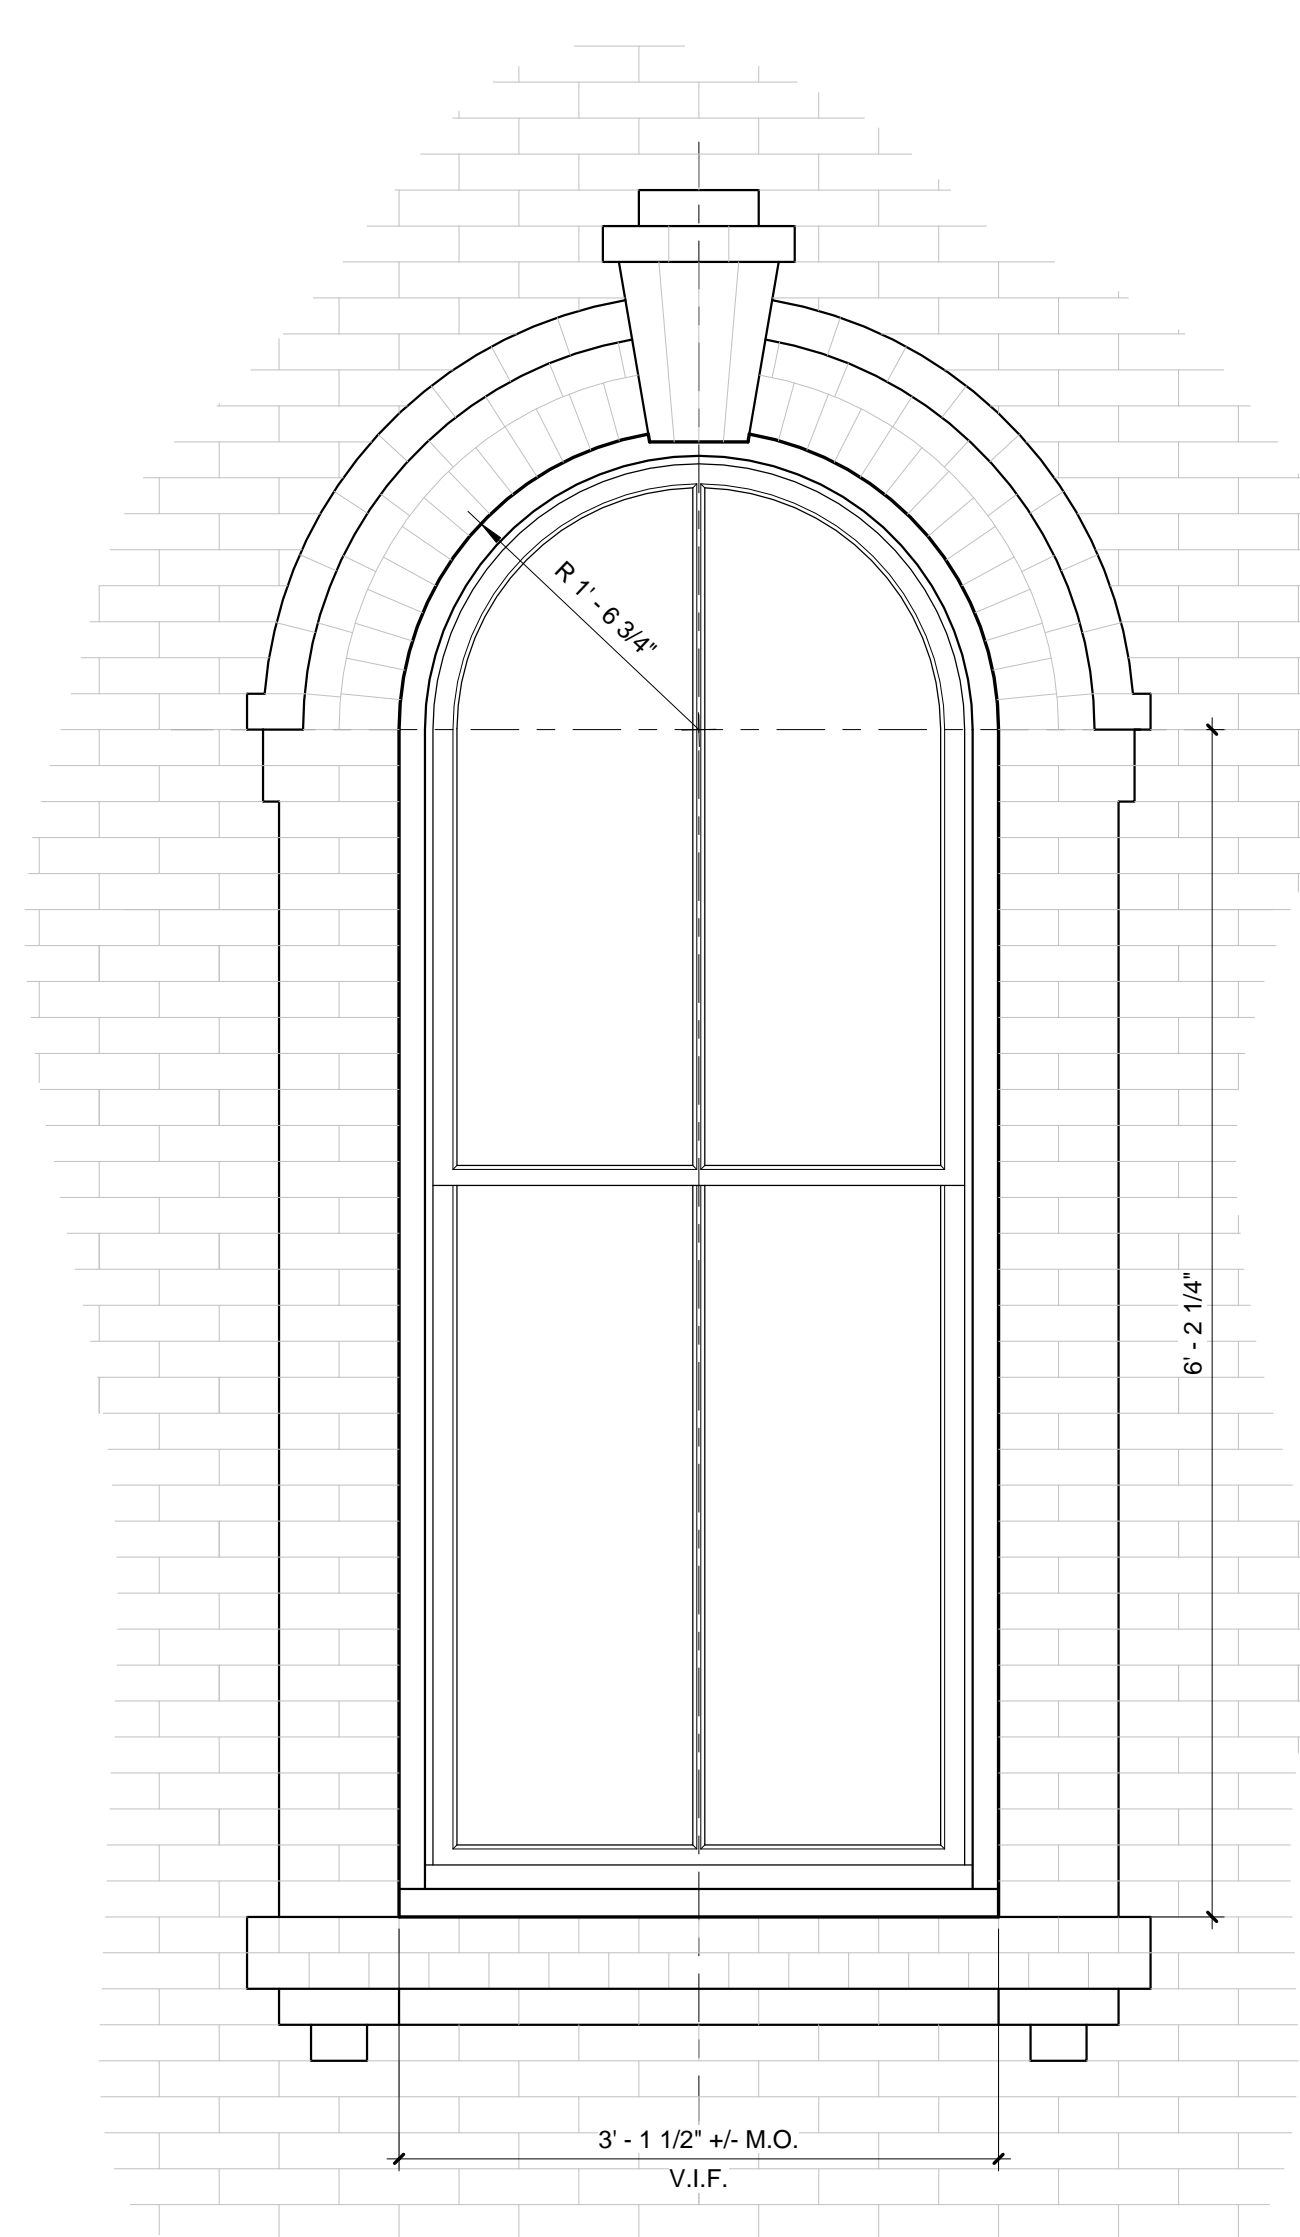
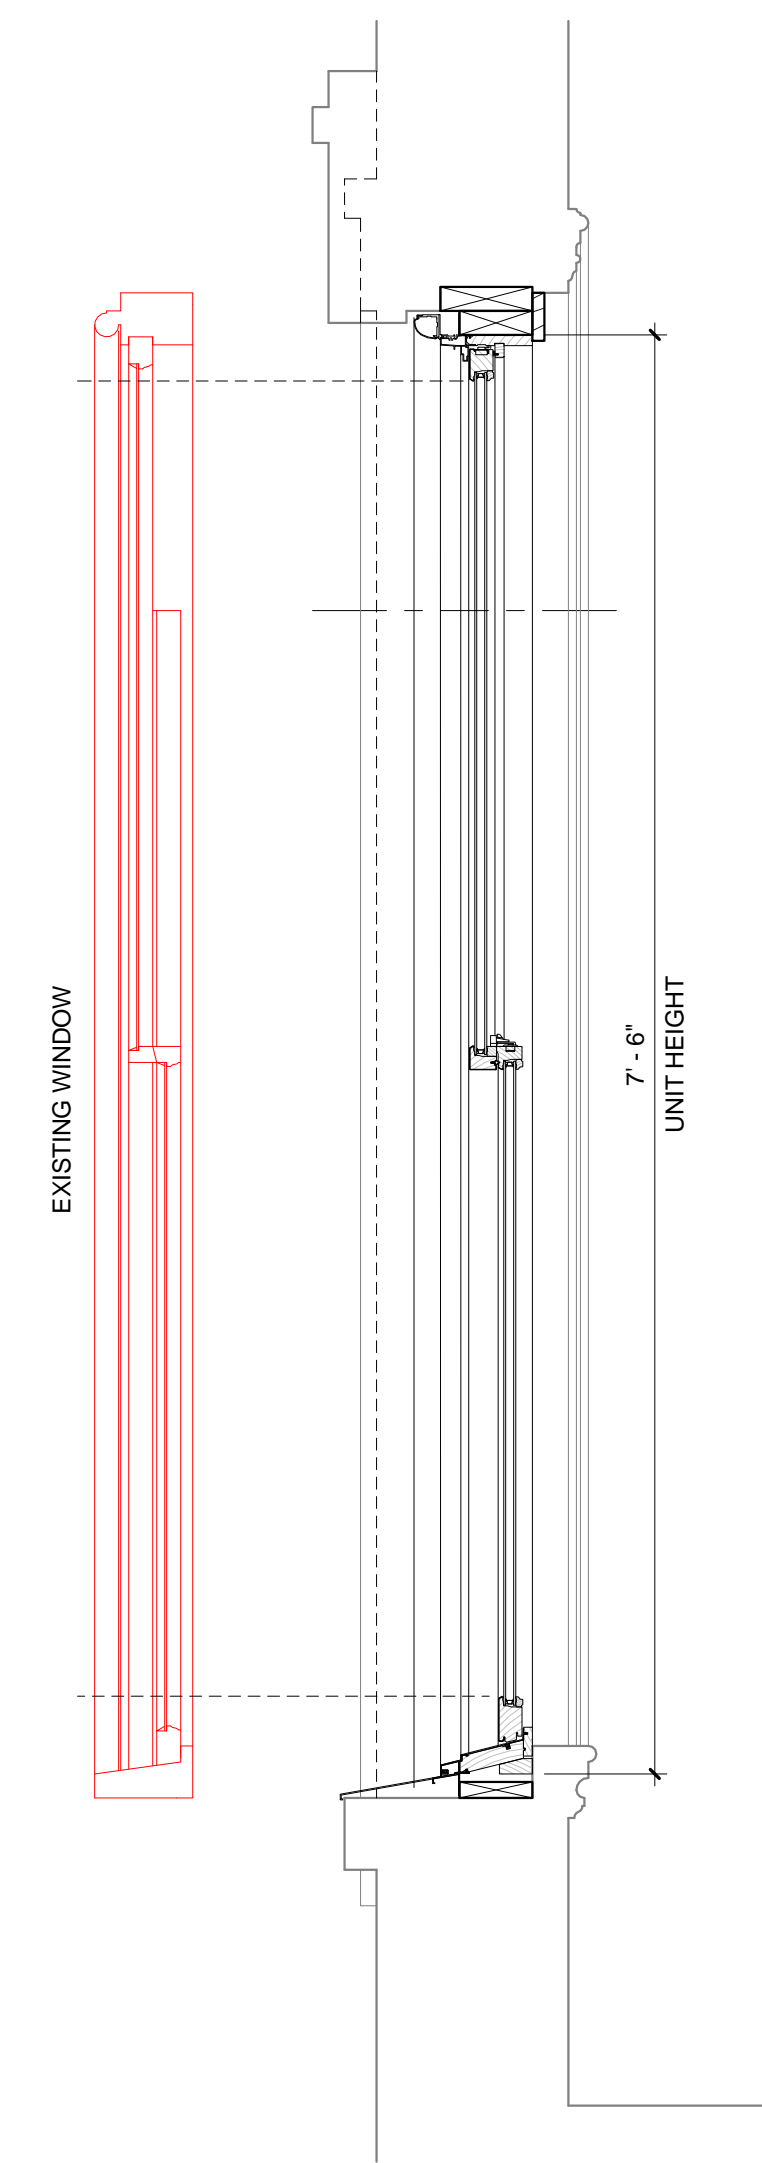
3 ARCH WINDOW DETAILS  
1" = 1'-0"

1. REMOVE EXISTING STORM WINDOWS AND ORIGINAL WOOD WINDOWS INCLUDING FULL FRAME AND WEIGHT POCKETS. REPLACE WITH CUSTOM ALUMINUM-CLAD WOOD ARCH-TOP WINDOWS TO MATCH EXISTING SIGHTLINES AS CLOSELY AS POSSIBLE, SIMULATED DIVIDED LIGHTS AND BRICKMOLD.
2. GC TO VERIFY ALL DIMENSIONS IN THE FIELD AND COORDINATE NEW WINDOW SIZES ACCORDINGLY.

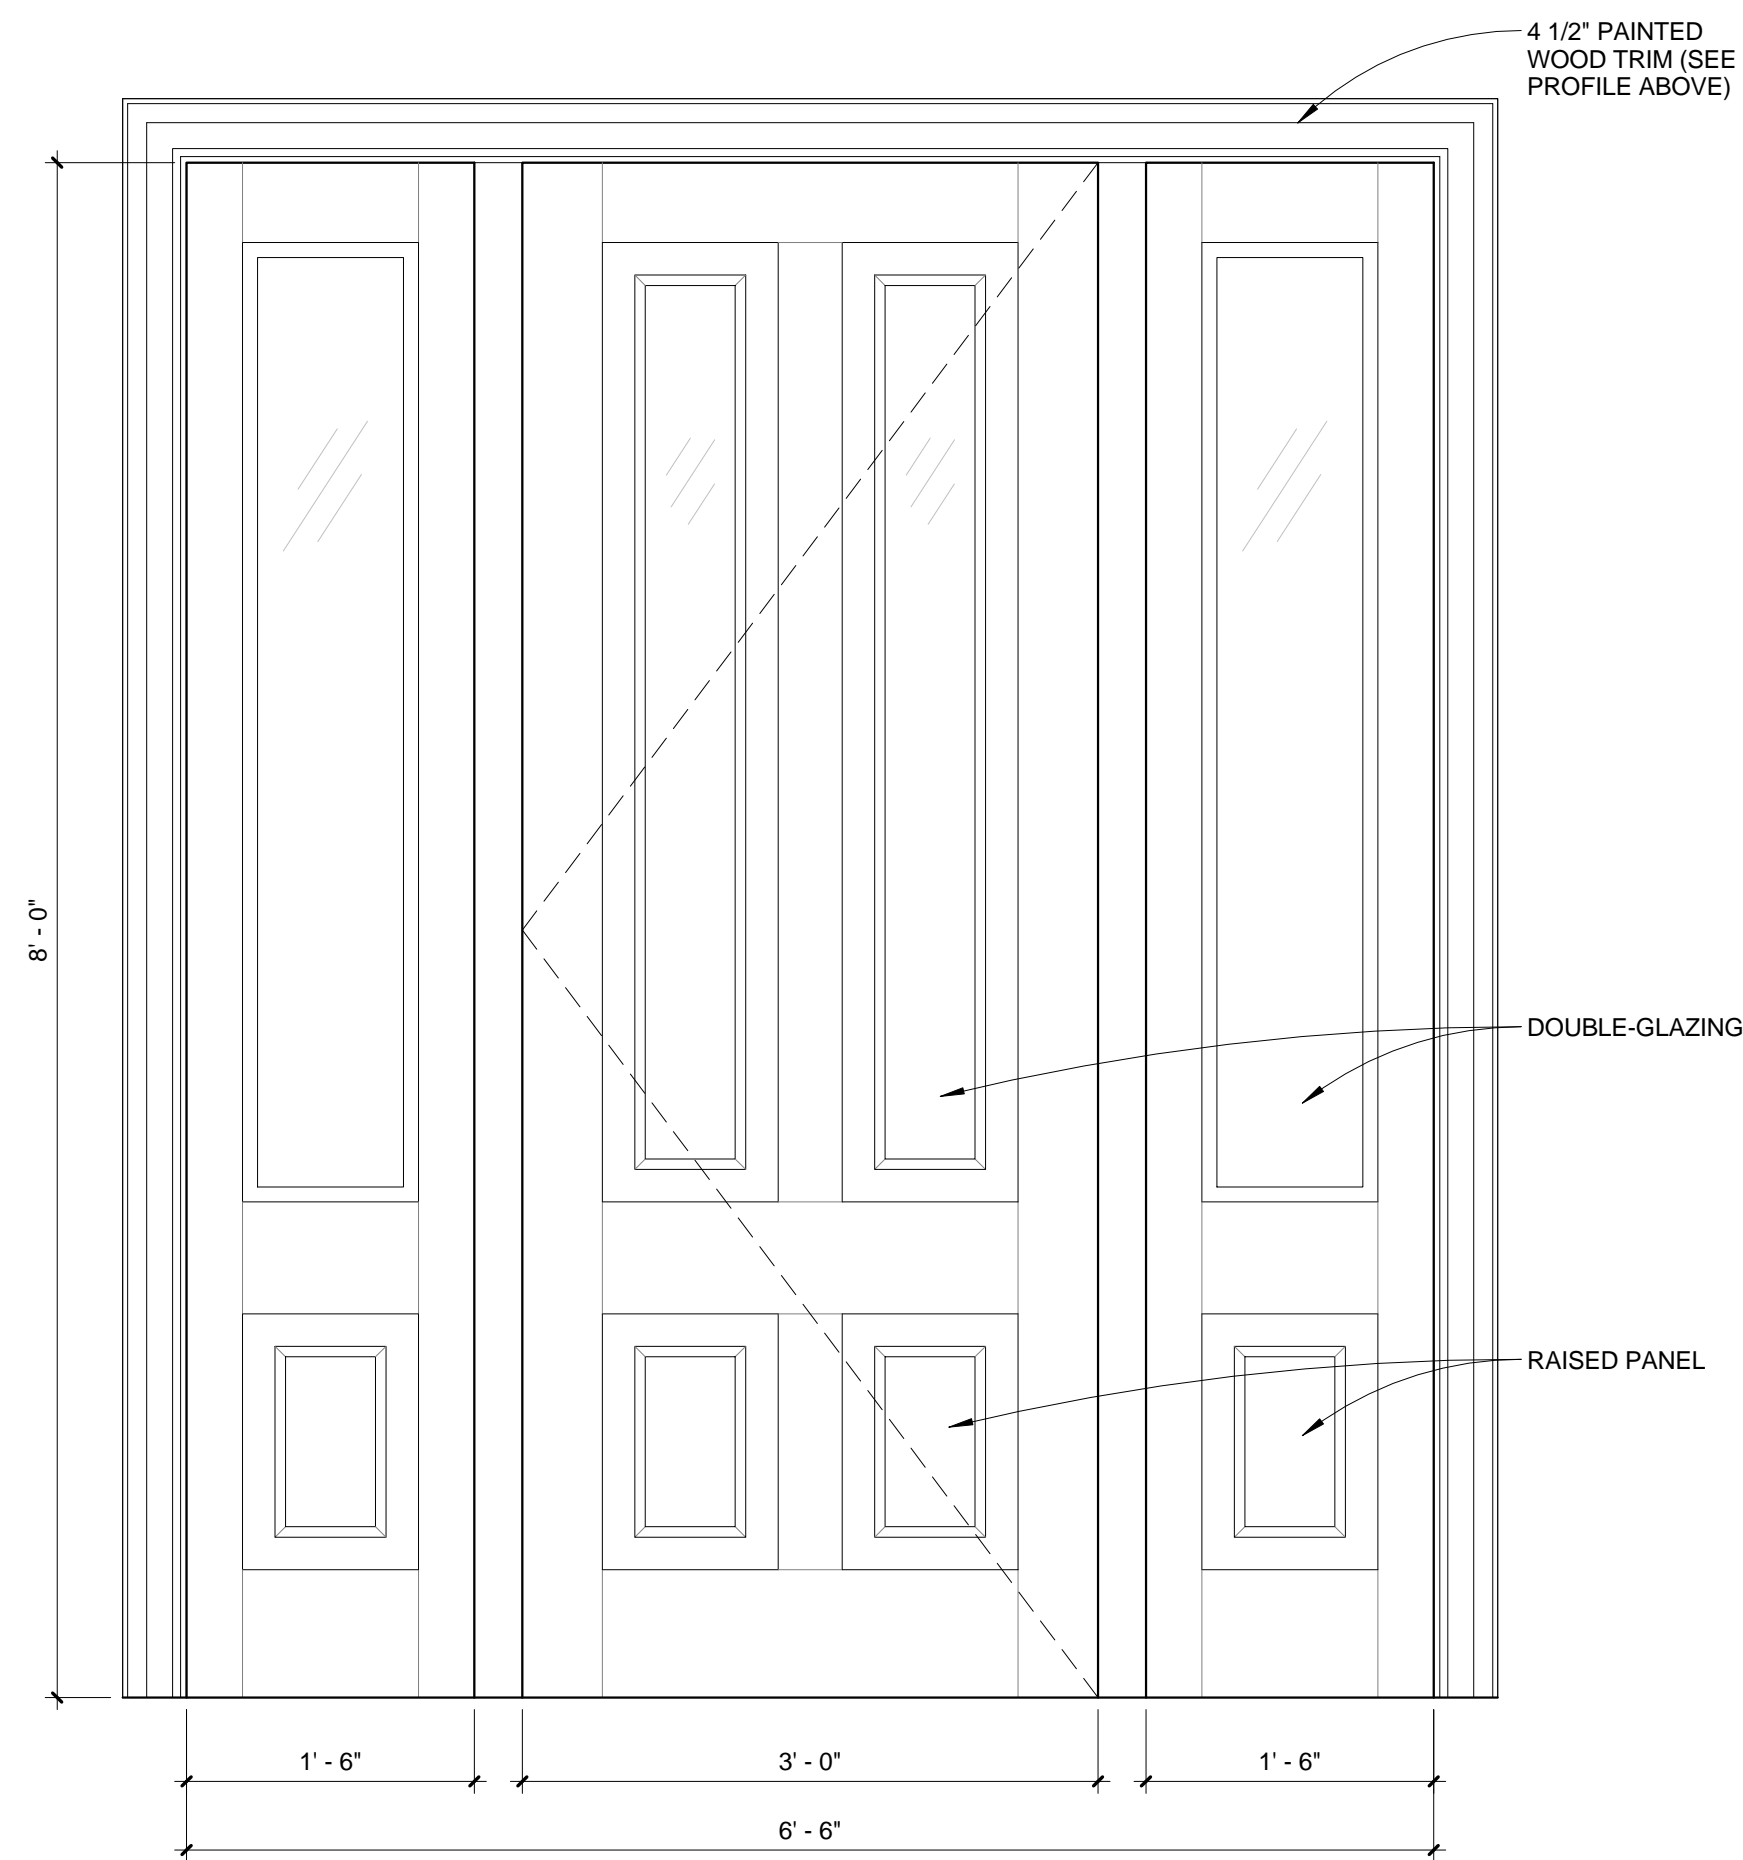
D1

JELD-WEN - CUSTOM CLAD-WOOD GLASS PANEL EXTERIOR DOOR WITH SIDELIGHTS  
MODEL A110  
CUSTOM COLOR PAINT FACTORY FINISH

- REPLACE FULLY-GLAZED DOORS AT CURRENT MAIN ENTRY WITH PART-GLAZED DOORS AND SIDELIGHTS. DOORS TO BE CUSTOM WOOD AS DETAILED IN DRAWINGS. COORDINATE NEW HARDWARE REQUIREMENTS WITH OWNER'S REP.

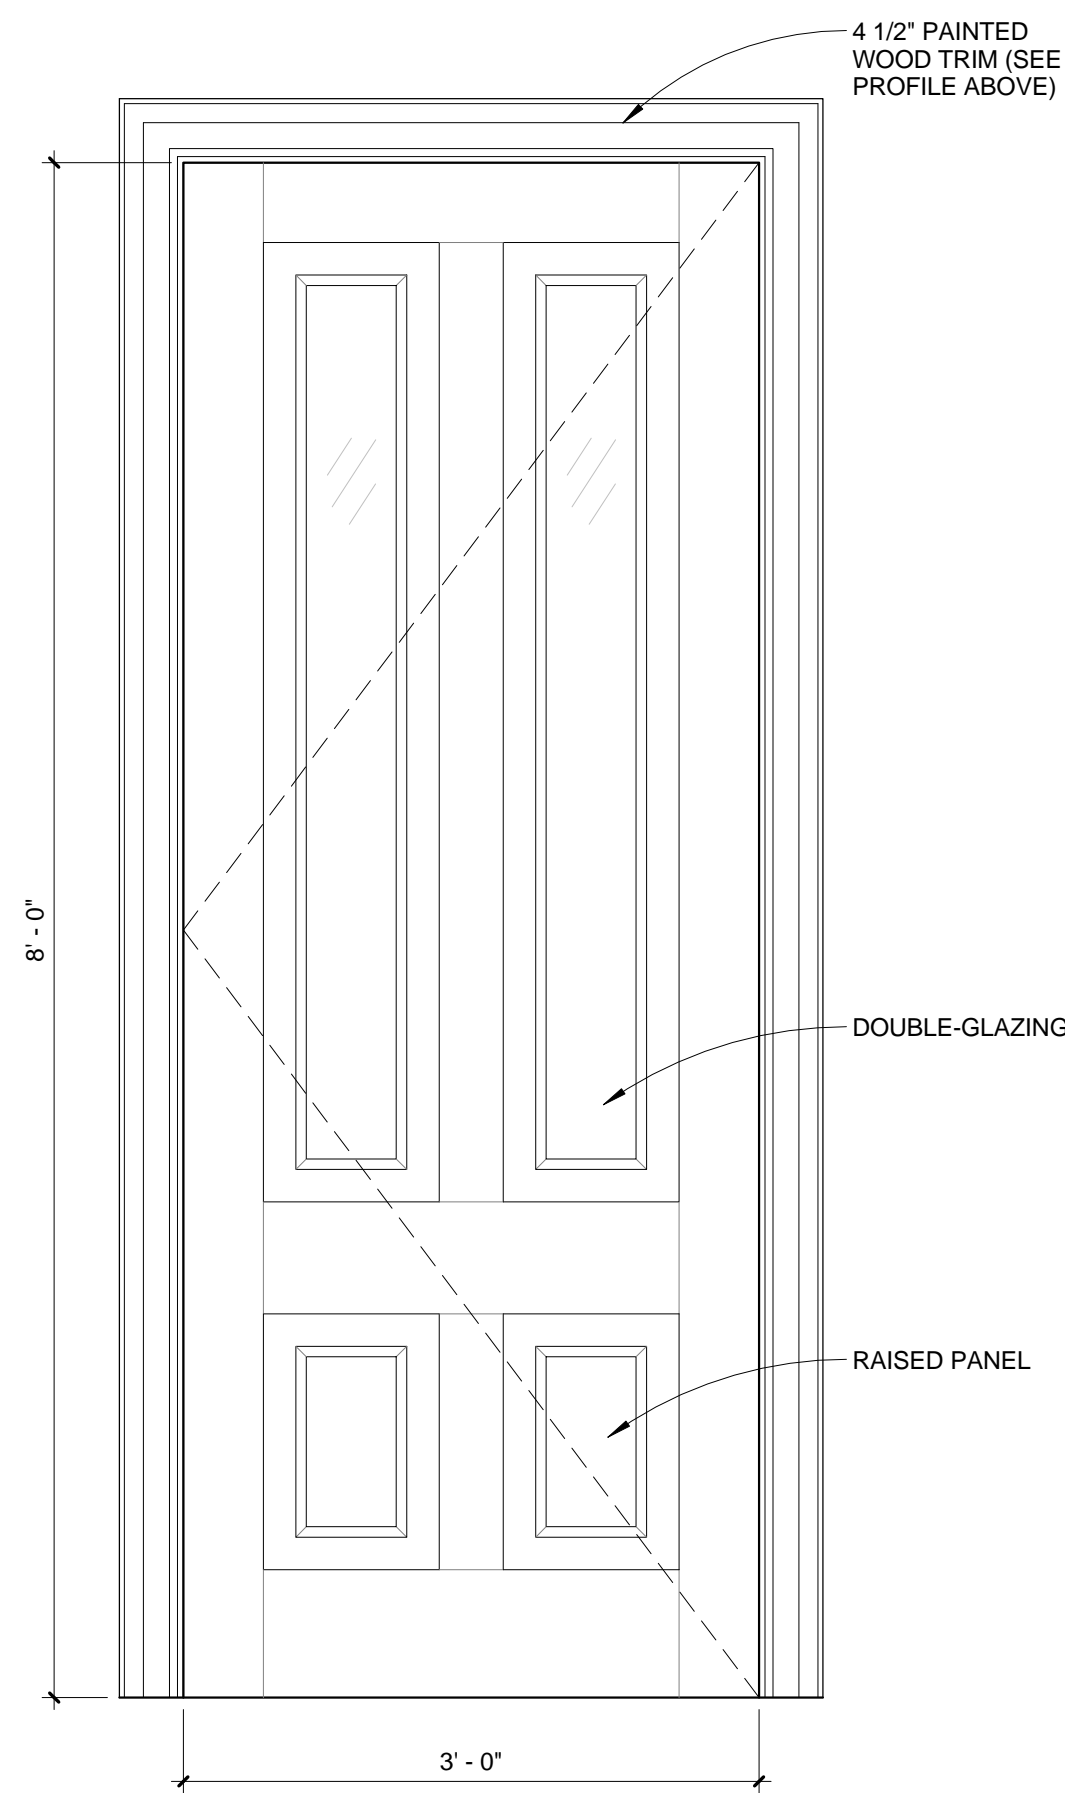
D2

JELD-WEN - CUSTOM CLAD-WOOD GLASS PANEL EXTERIOR DOOR  
MODEL A110  
CUSTOM COLOR PAINT FACTORY FINISH

- REPLACE FULLY-GLAZED DOOR AT STAIR EXIT WITH PART-GLAZED DOOR. DOOR TO BE CUSTOM WOOD AS DETAILED IN DRAWINGS. COORDINATE NEW HARDWARE REQUIREMENTS WITH OWNER'S REP.

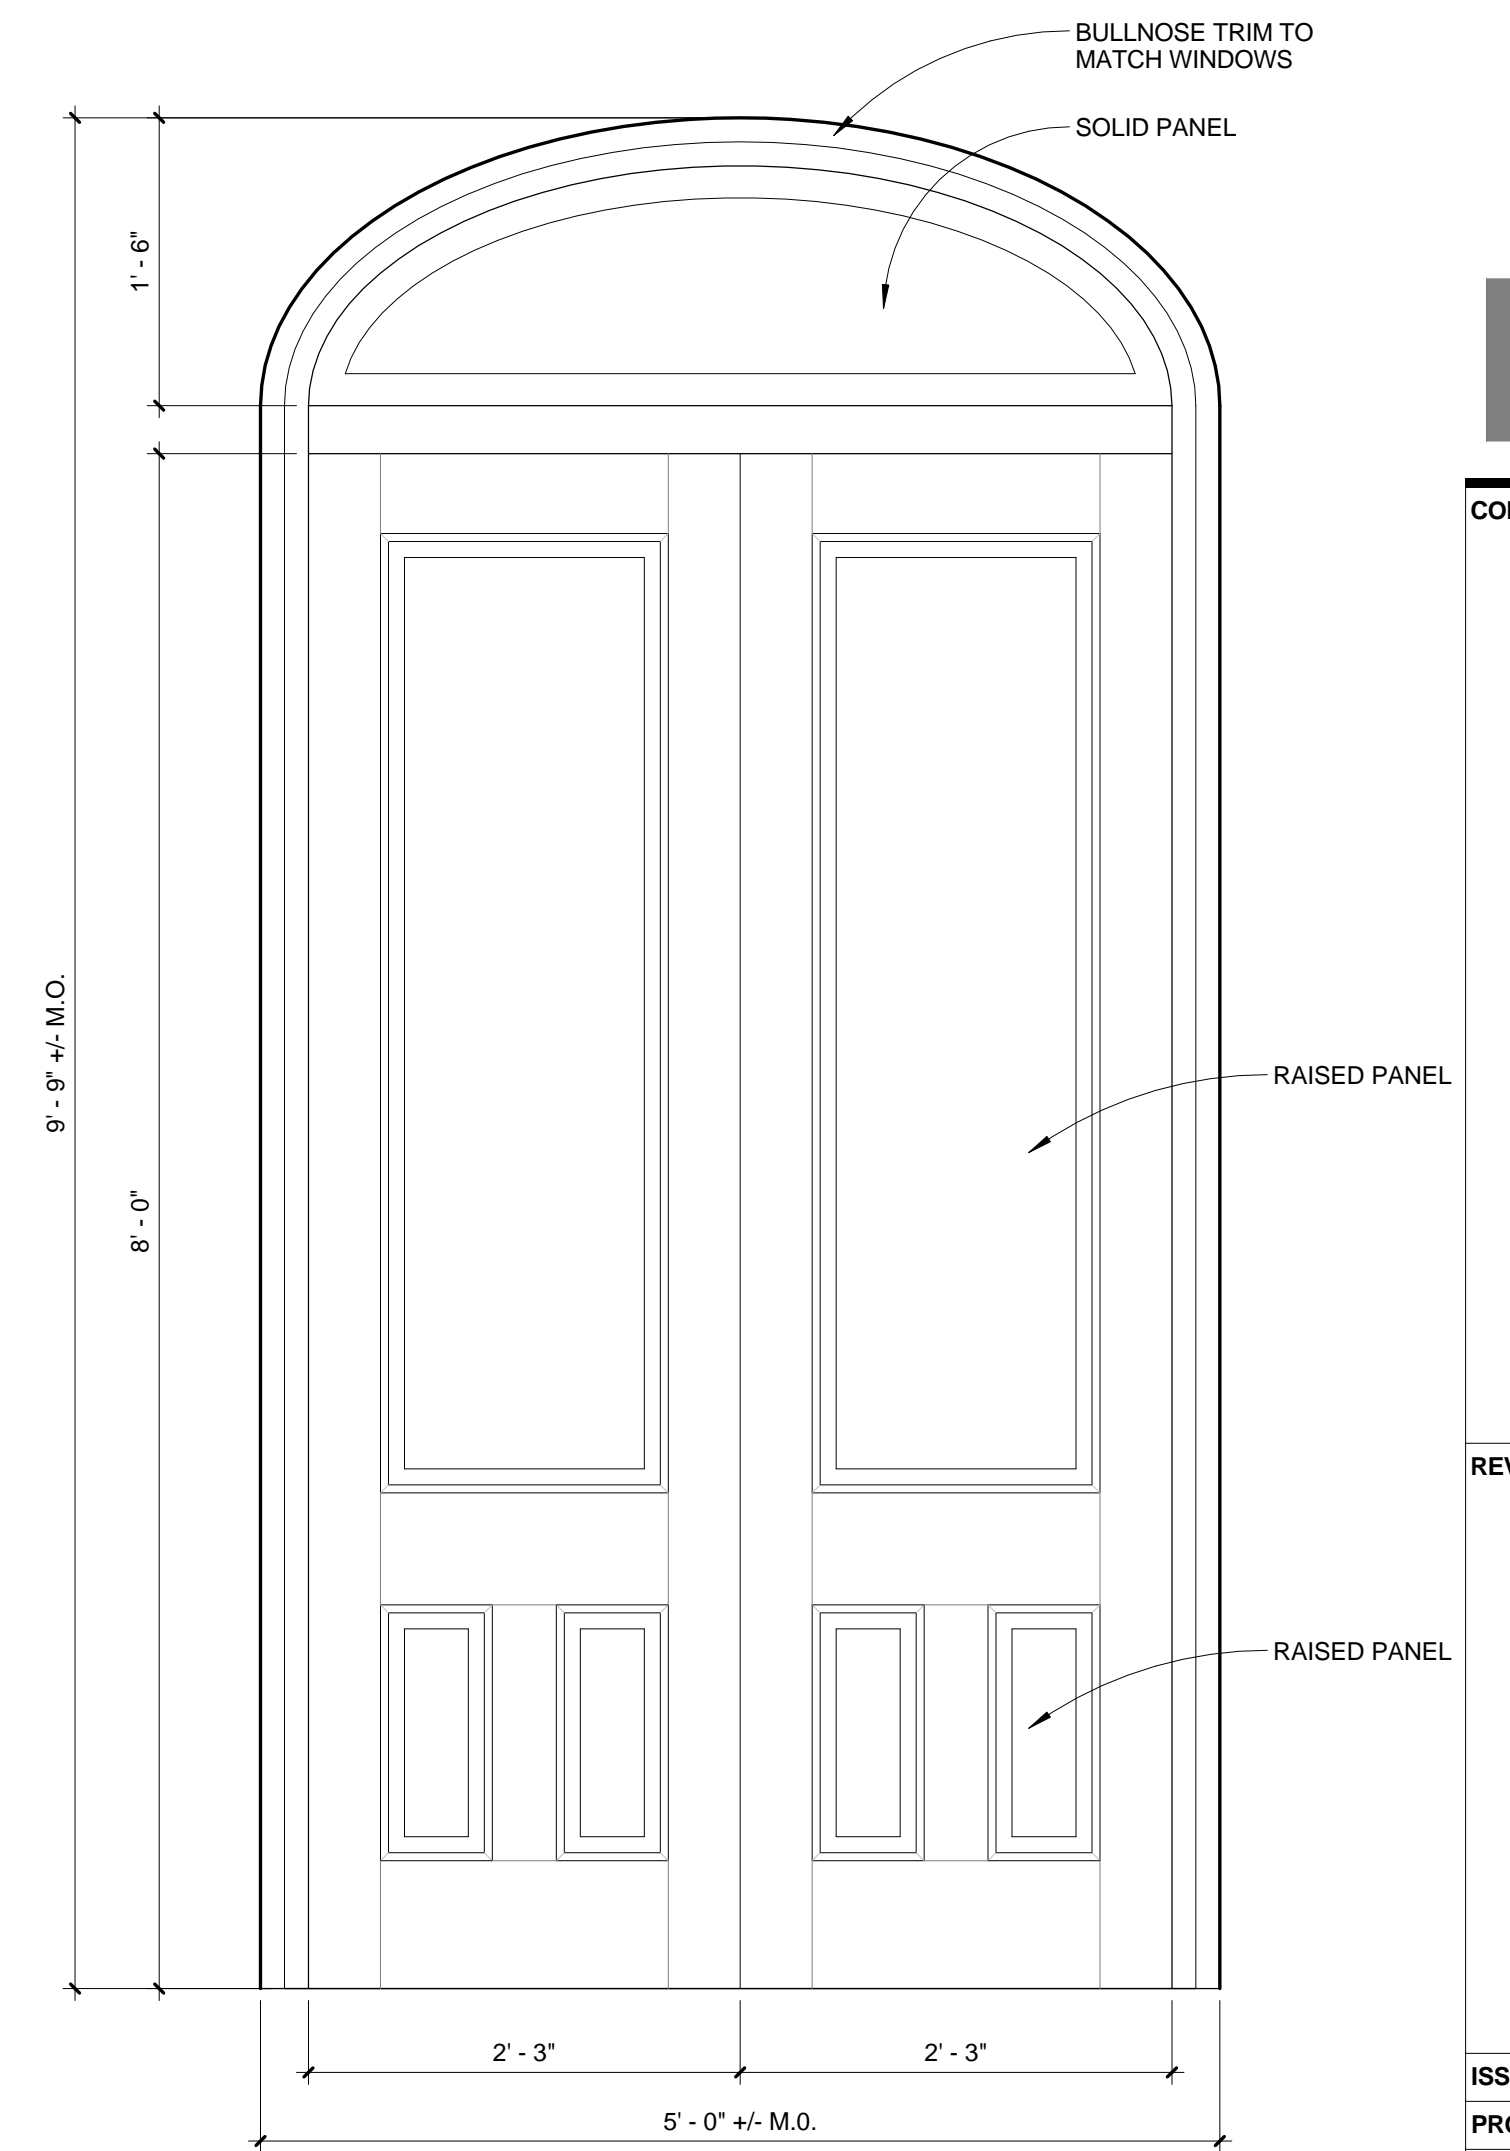
D4

JELD-WEN - CUSTOM CLAD-WOOD EXTERIOR DOOR  
INOPERABLE DOOR PANELS (NO HARDWARE)  
ELLIPTICAL TOP TRANSOM WITH SOLID PANEL (NO GLAZING)  
CUSTOM COLOR PAINT FACTORY FINISH

- REMOVE SINGLE DOOR, SURROUNDING INFILL AND '181' SIGN FROM CENTRAL ARCHED OPENING. REPLACE WITH FIXED DOUBLE DOOR PANELS AND TRANSOM WINDOW ABOVE TO MATCH ORIGINAL LAYOUT. INSULATE BEHIND DOOR PANELS AND FINISH INTERIOR TO BLEND WITH ADJACENT FINISHES.
