GENERAL PLAN NOTES:

FLOOR PLAN KEYNOTES:

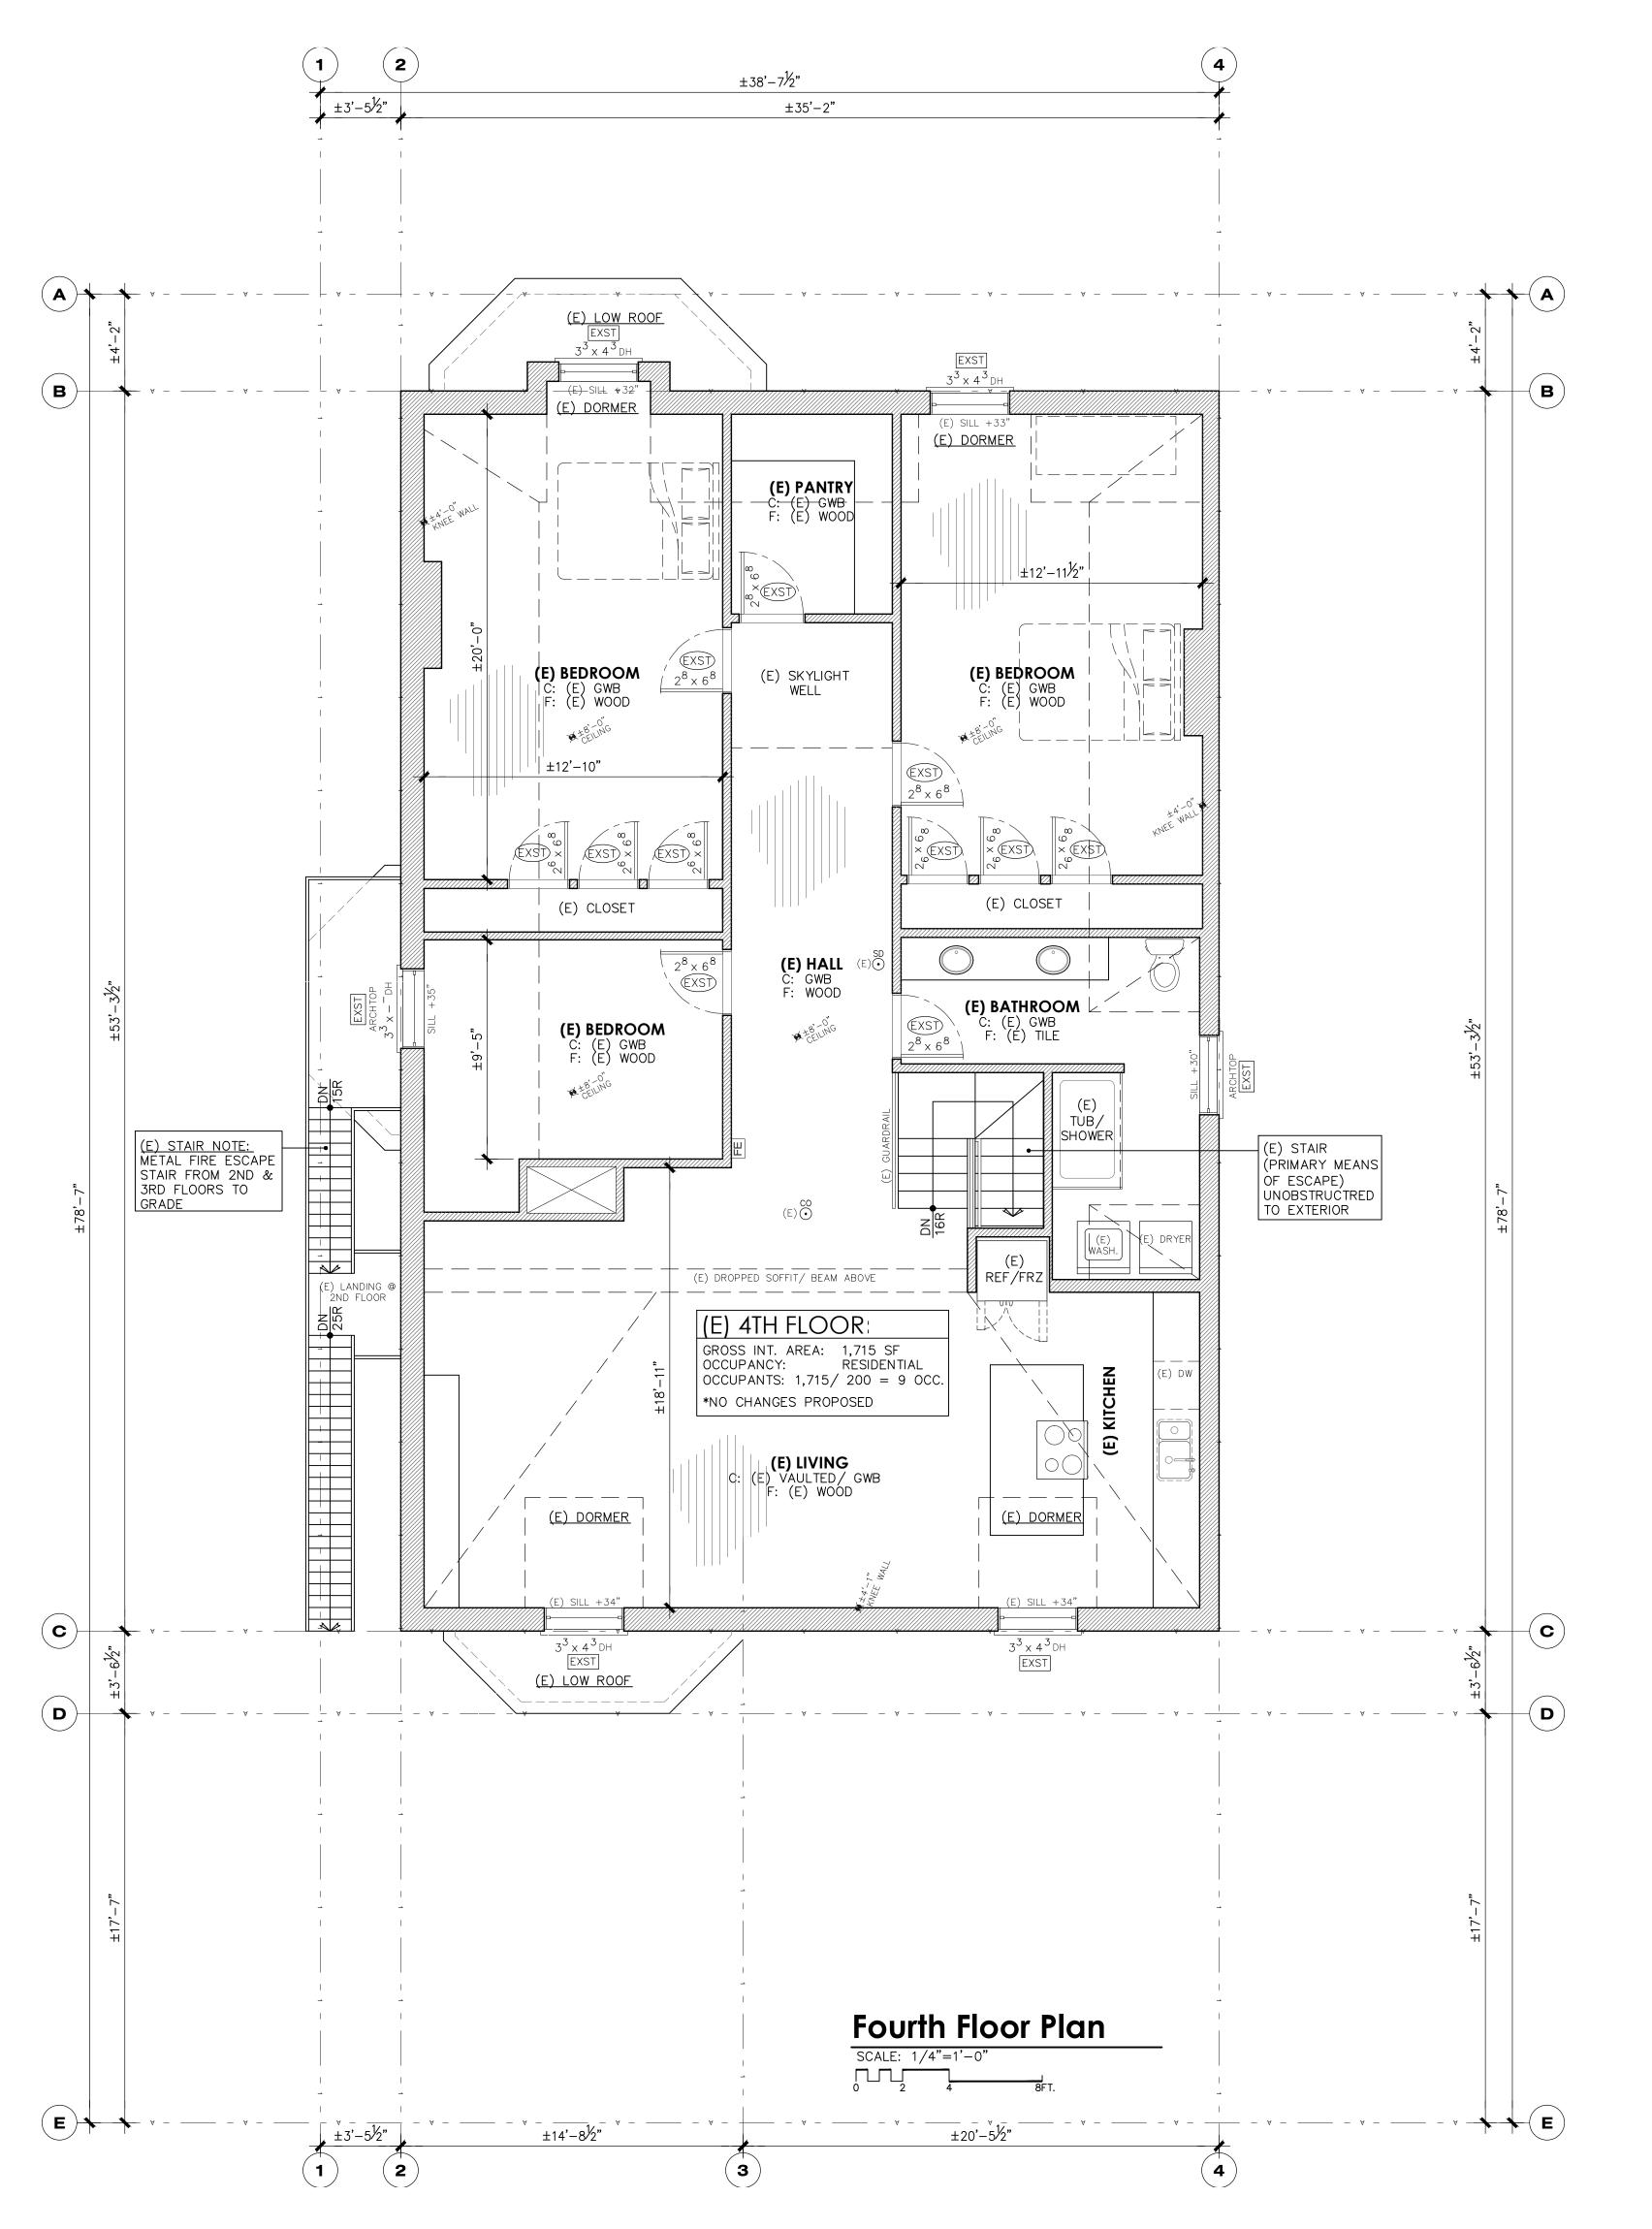
- 01. AN ARCHITECTURAL SITE VISIT TO FIELD MEASURE AND VERIFY EXISTING CONDITIONS OF THE BUILDING WAS CONDUCTED ON AUGUST 1, 2014.
- 02. ALL EFFORTS HAVE BEEN MADE TO PROVIDE A COMPREHENSIVE DOCUMENTATION OF THE EXISTING BUILDING. SOME INTERIOR FINISHES AND ITEMS ARE CONCEALED AND HAVE BEEN A CHALLENGE TO DOCUMENT. IT IS POSSIBLE THAT DEFICIENCIES MAY EXIST WHICH ARE NOT IDENTIFIED IN THESE DRAWINGS.

- 04. CONTRACTOR TO VERIFY ALL EXISTING DIMENSIONS AND CONDITIONS AFTER REVIEWING PROPOSED REVISIONS. NOTIFY ARCHITECT OF ANY DISCREPANCIES.
- 05. ALL CHANGES ARE ANTICIPATED TO BE NON-STRUCTURAL. NOTIFY ARCHITECT/ENGINEER OF ALL STRUCTURAL CONDITIONS IDENTIFIED DURING DEMOLITION FOR DIRECTION / RESOLUTION.

- 5/8" TYPE 'X' DRYWALL (EA. SIDE), 2X4 WOOD STUDS @ 16" O.C. & INSTALL PER U.L. INSTRUCTIONS TO UNDERSIDE OF FRAMING ABOVE. NOTE: PROVIDE (2) LAYERS OF \$" TYPE 'X' DRYWALL ON ONE SIDE, IF OPPOSITE SIDE IS NOT ACCESSIBLE (I.E. NEW KNEE WALL UNDER (E) STAIR) (2x6 WALL STUDS AT "1A" LOCATIONS — GA 3660)
- WALL ASSEMBLY: PATCH/ REPAIR (E) 1/2" LATH & PLASTER (VERIFY) OR ADD \(\frac{8}{2} \) TYPE 'X' DRYWALL, (E) WOOD STUDS/ STRAPPING & INSULATION (UNKNOWN), (E) MASONRY LOAD

- (FP.04) REMOVE (E) TRIM & INFILL (E) OPENING TO MATCH ADJACENT MATERIALS / FINISHES.
- (E) LIGHTED EXIT SIGN TO REMAIN
- (FP.08) REMOVE (E) FINISHES AS REQUIRED FOR NEW DOOR OR RATED WALL INFILL. PATCH & REPAIR AS REQUIRED. ALL

- REUSE / MATCH (E) TRIM
- AT 34" ABOVE NOSING OF TREADS. EXTENSIONS NOT / EMERGENCY LIGHT.
- (FP.19) AT CEILING, TO ACHIEVE FIRE-RATING, OPTION 1: PATCH ANY MISSING AREAS OF EXISTING PLASTER ON UNDERSIDE OF FLOOR JOISTS ABOVE LAY-IN CEILING. OPTION 2: LAY-IN CEILING SYSTEM TO COMPLY WITH DETAIL 4/A7.0.

- (FP.15) ENLARGE (E) CASED OPENING TO BE 32" CLEAR OPENING, FP.16 ADD SLOPED STONE THRESHOLD TO FILL (E) GAP IN FLOOR
- (FP.17) EXISTING STEPS TO REMAIN. INSTALL HANDRAIL EACH SIDE REQUIRED PER IBC 3404.1(2). (GUARDRAIL NOT REQD. AT STAIRS LESS THAN 30" A.F.F. PER NFPA 7.1.8 / IBC 1013.1) (FP.18) REPLACE EXISTING EMERGENCY LIGHT WITH A COMBO EXIT
