BASEMENT FLOOR - STRENGTHENING PLAN

BASEMENT FLOOR FRAMING PLAN
1/8" = 1'-0"

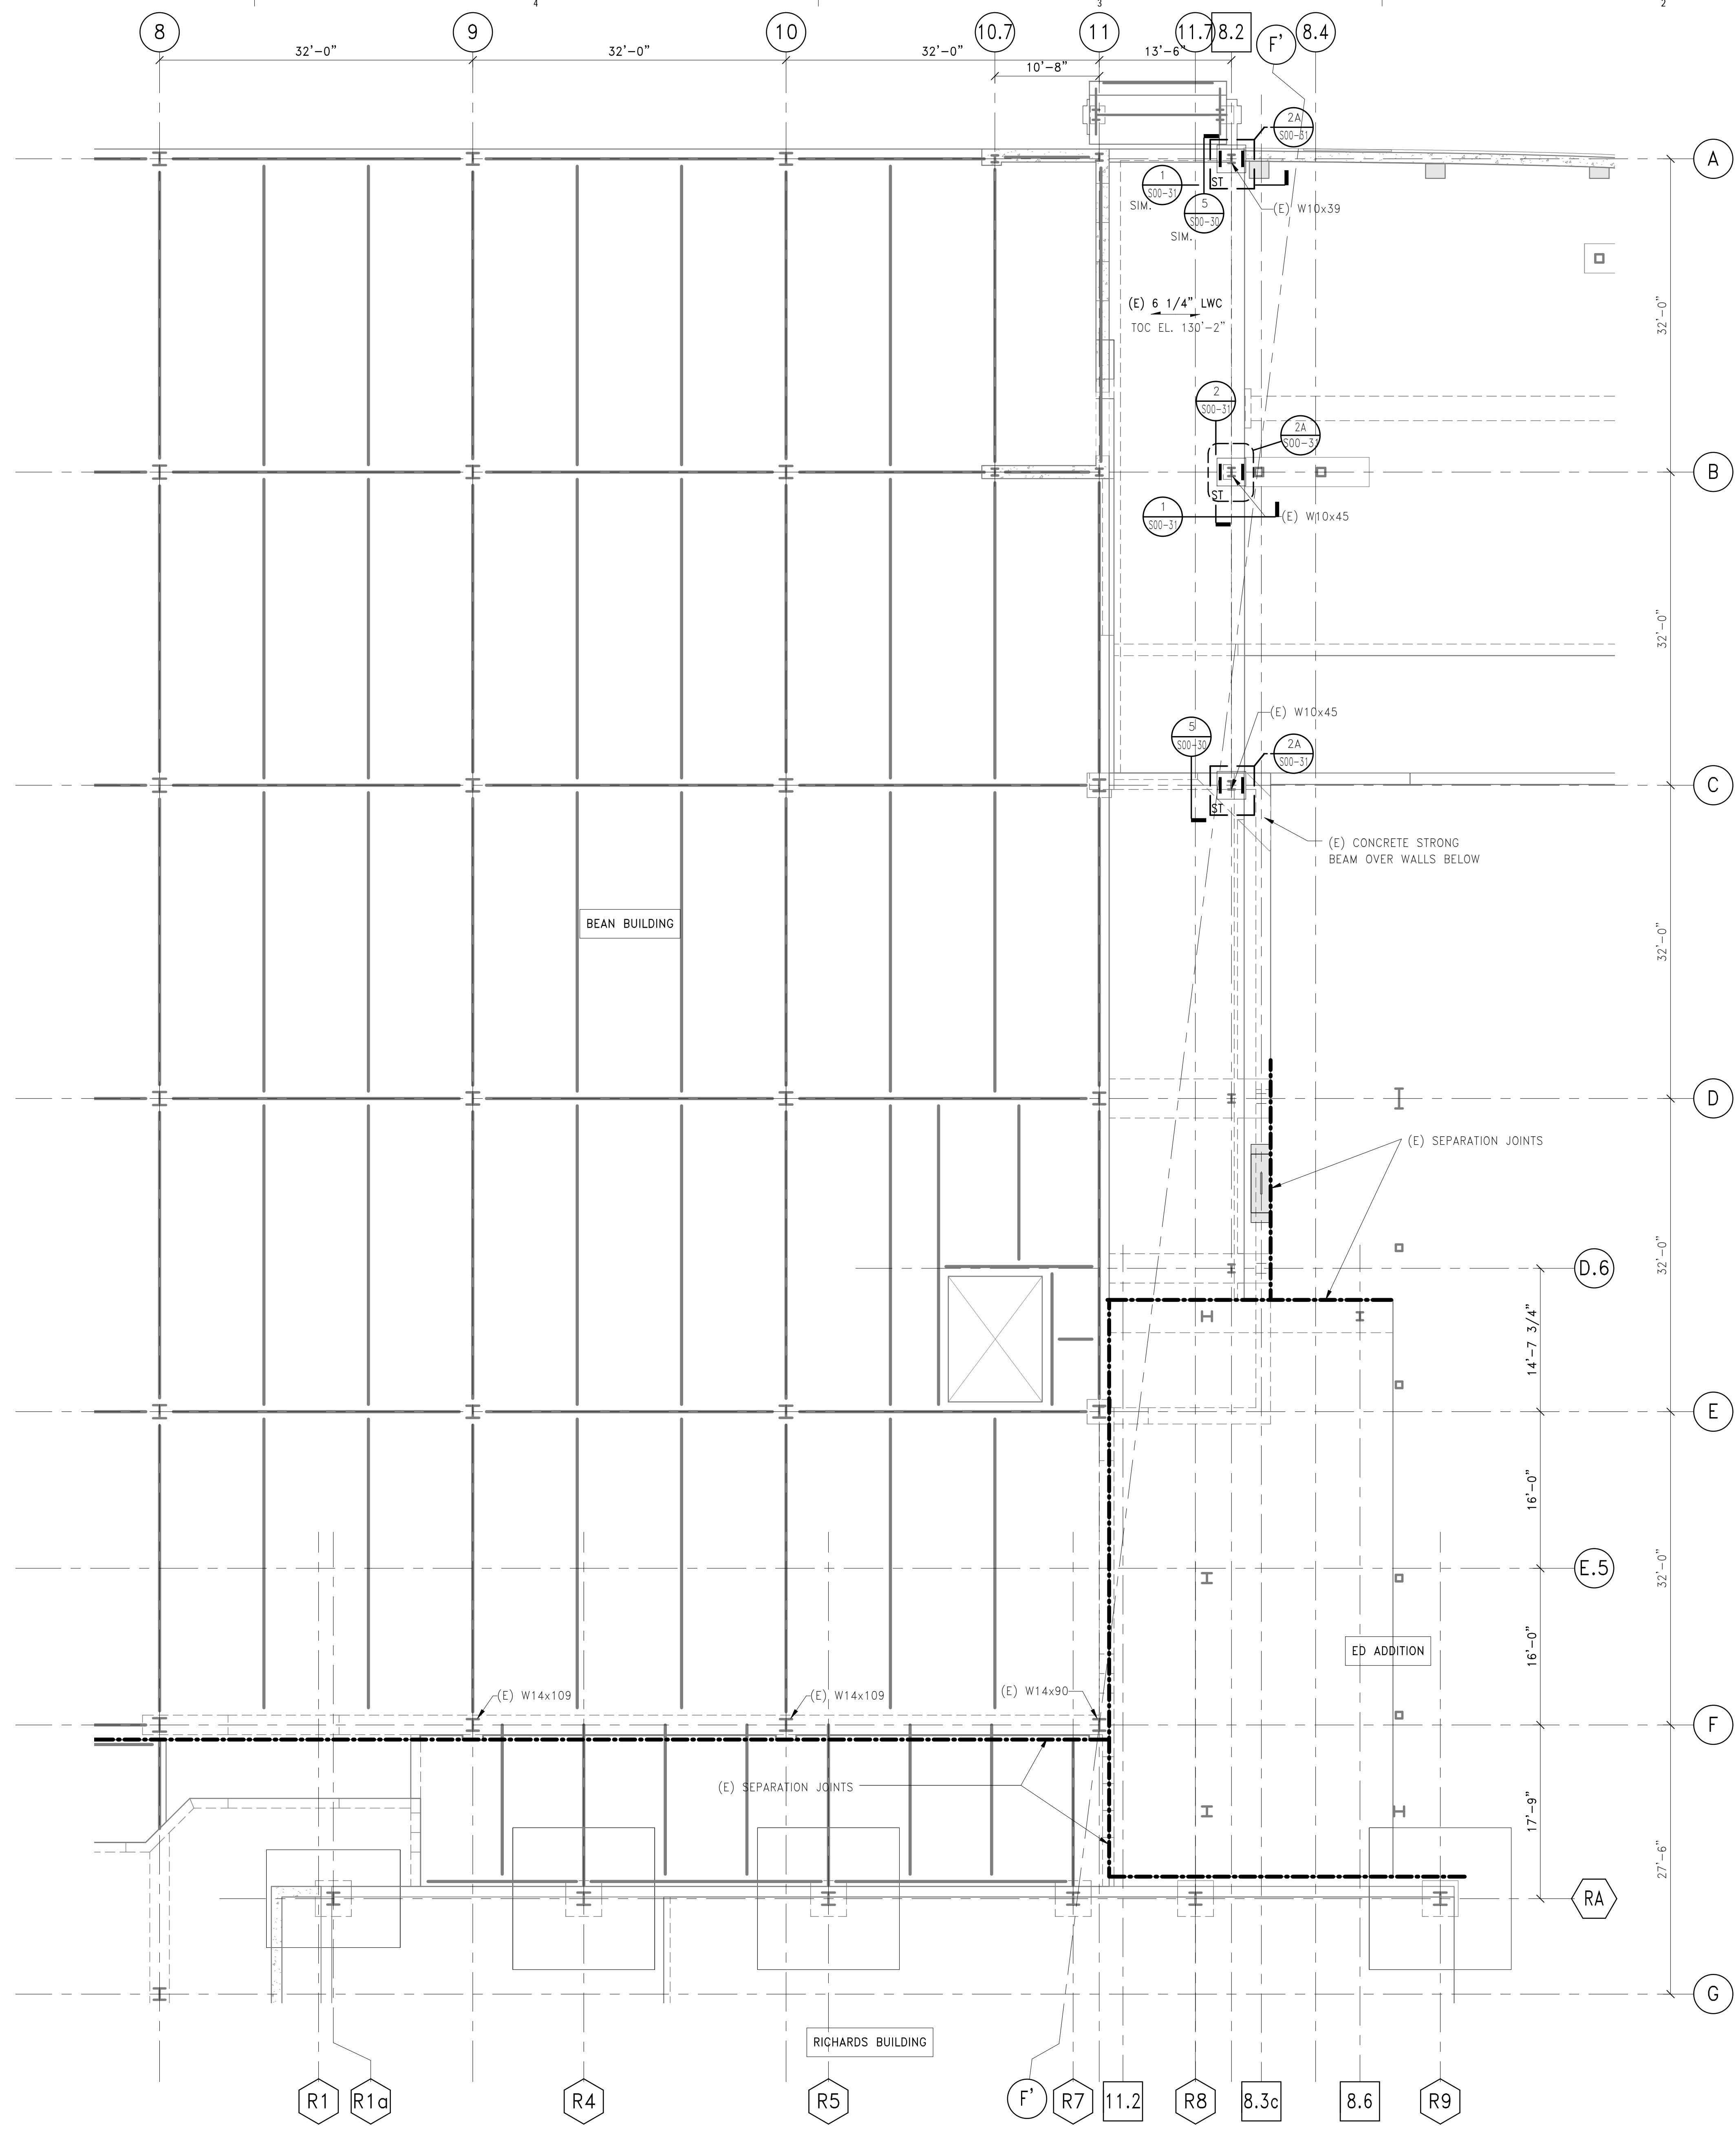
- STRENGTHENING PLAN NOTES:**
1. **II** INDICATES COLUMN STRENGTHENING REQUIRED FROM THIS FLOOR UP TO THE FLOOR ABOVE. SEE TYPICAL DETAIL 1/500-30 FOR COLUMN COVER PLATE REQUIREMENTS.

2. CONTRACTOR REMOVE FIREPROOFING TO VERIFY BEAM SHEAR CONNECTION IS DOUBLE ANGLE CONNECTION (1/4" MIN. THICKNESS) WITH NOTED MINIMUM NUMBER OF 3/4"Ø A325 BOLTS. SUBMIT PHOTOS TO SER TO VERIFY EXISTING CONDITIONS. IF EXISTING CONNECTION DOES NOT HAVE ADEQUATE BOLTS OR ANGLES, NOTIFY SER, AND INSTALL CONNECTION STRENGTHENING PER TYPICAL DETAILS PRIOR TO ERECTING NEW STEEL FRAMING ABOVE.

3. VERIFY EXISTING COLUMN HAS EXISTING CAP PLATE AT ROOF LEVEL. IF NO CAP PLATE, NOTIFY SER, AND INSTALL NEW CAP PLATE PER TYPICAL STRENGTHENING DETAILS.
