# **Structural Special Inspections Report**

## **Florence House**

190 Valley Street

Structural Engineer of Record  
Becker Structural Engineers, Inc.

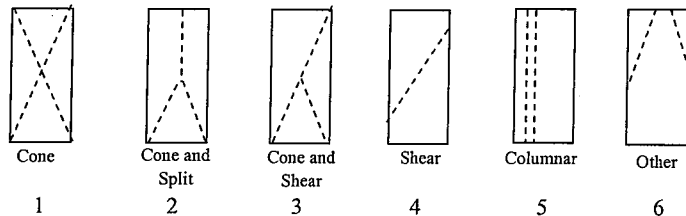
Sample No.	Test Date	Age	Type	Unit Wt.	Area (in <sup>2</sup> )	Load (K)	Strength (psi)
C1a	8-Apr-09	7	2	144.3	28.27	102.7	3630
C1b	29-Apr-09	28	3	144.3	28.27	124.1	4390
C1c	29-Apr-09	28	2	144.9	28.27	123.8	4380
C1d

Average 28 Day (psi): 4385

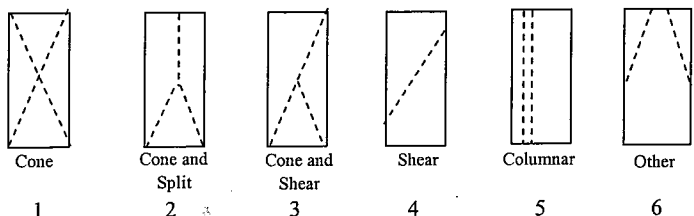
Sample No.	Test Date	Age	Type	Unit Wt.	Area (in <sup>2</sup> )	Load (K)	Strength (psi)
C2a	23-Apr-09	7	6	147.5	28.27	103.7	3670
C2b	14-May-09	28	3	149.1	28.27	127.4	4510
C2c	14-May-09	28	3	148.2	28.27	123.7	4370
C2d

Average 28 Day (psi): 4440

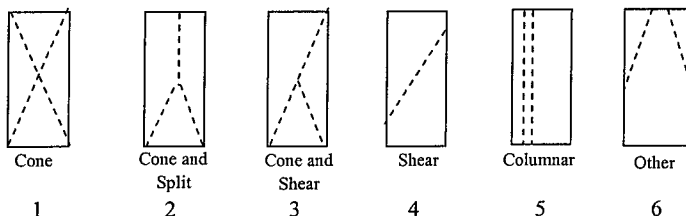
Sample No.	Test Date	Age	Type	Unit Wt.	Area (in <sup>2</sup> )	Load (K)	Strength (psi)
C3a	24-Apr-09	7	2	146.0	28.27	91.5	3240
C3b	15-May-09	28	3	146.8	28.27	109.4	3870
C3c	15-May-09	28	3	147.1	28.32	114.9	4060
C3d

Average 28 Day (psi): 3965

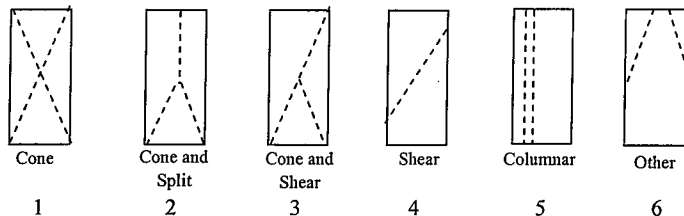
Sample No.	Test Date	Age	Type	Unit Wt.	Area (in <sup>2</sup> )	Load (K)	Strength (psi)
C5a	30-Apr-09	7	2	145.5	28.27	101.1	3570
C5b	21-May-09	28	6	147.5	27.91	126.0	4510
C5c	21-May-09	28	3	147.7	27.97	121.1	4330
C5d

Average 28 Day (psi): 4420

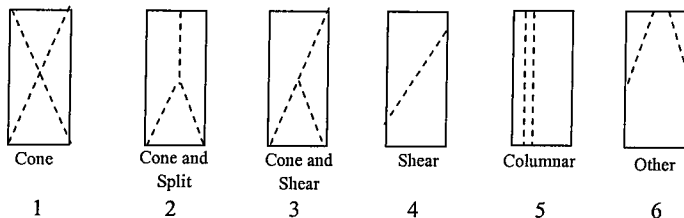
Sample No.	Test Date	Age	Type	Unit Wt.	Area (in <sup>2</sup> )	Load (K)	Strength (psi)
C6a	8-May-09	7	2	143.9	28.27	97.2	3440
C6b	29-May-09	28	6	145.3	28.18	120.9	4290
C6c	29-May-09	28	3	143.3	28.46	117.7	4140
C6d

Average 28 Day (psi):                      4215

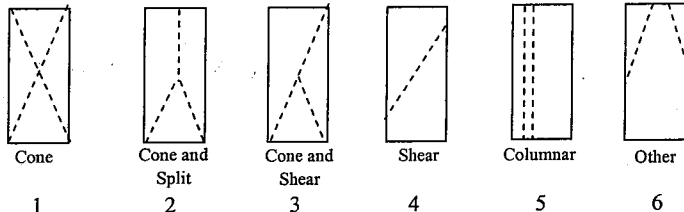
Sample No.	Test Date	Age	Type	Unit Wt.	Area (in <sup>2</sup> )	Load (K)	Strength (psi)
C15a	3-Jun-09	7	3	143.1	28.27	100.4	3550
C15b	24-Jun-09	28	3	138.3	28.27	126.7	4480
C15c	24-Jun-09	28	3	143.7	28.27	124.8	4420
C15d

Average 28 Day (psi): 4450

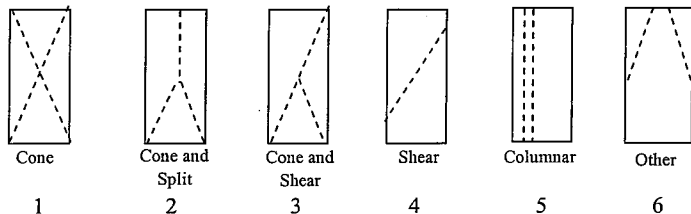
Sample No.	Test Date	Age	Type	Unit Wt.	Area (in <sup>2</sup> )	Load (K)	Strength (psi)
C18a	25-Jun-09	7	4	147.4	28.27	101.7	3600
C18b	16-Jul-09	28	6	146.9	28.27	116.2	4110
C18c	16-Jul-09	28	6	146.9	28.27	111.4	3940
C18d

Average 28 Day (psi):                    4025

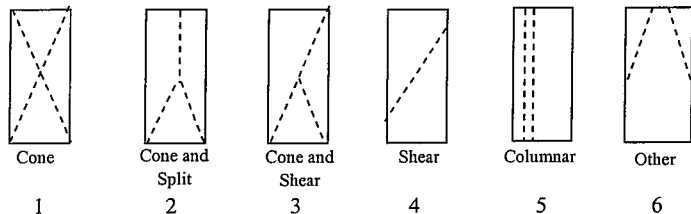
Sample No.	Test Date	Age	Type	Unit Wt.	Area (in <sup>2</sup> )	Load (K)	Strength (psi)
C19a	13-Jul-09	7	6	147.7	28.27	68.7	2430
C19b	3-Aug-09	28	6	148.3	28.27	90.9	3210
C19c	3-Aug-09	28	6	148.0	28.27	89.2	3150
C19d

Average 28 Day (psi): 3180

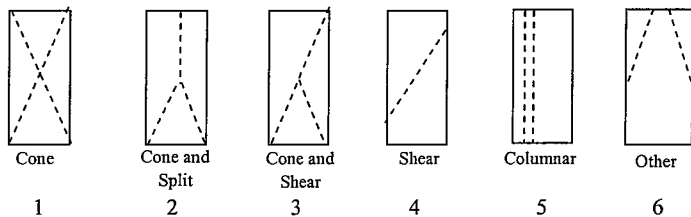
Sample No.	Test Date	Age	Type	Unit Wt.	Area (in <sup>2</sup> )	Load (K)	Strength (psi)
C20a	13-Jul-09	7	6	147.5	28.27	70.8	2510
C20b	3-Aug-09	28	6	149.3	28.27	90.0	3180
C20c	3-Aug-09	28	6	150.0	28.27	88.0	3110
C20d

Average 28 Day (psi):                      3145

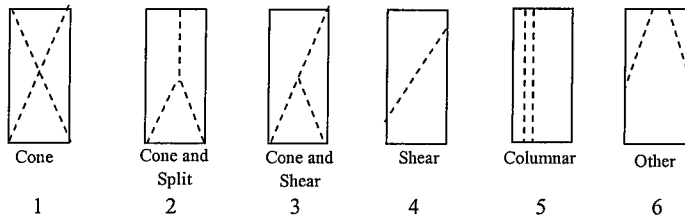
Sample No.	Test Date	Age	Type	Unit Wt.	Area (in <sup>2</sup> )	Load (K)	Strength (psi)
C25a	13-Aug-09	7	6	148.7	28.27	88.9	3140
C25b	3-Sep-09	28	6	146.4	28.27	101.5	3590
C25c	3-Sep-09	28	3	147.8	28.27	100.3	3550
C25d

Average 28 Day (psi): 3570

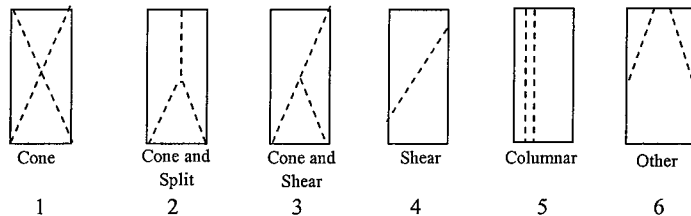
Sample No.	Test Date	Age	Type	Unit Wt.	Area (in <sup>2</sup> )	Load (K)	Strength (psi)
C26a	4-Sep-09	7	2	145.4	28.27	76.0	2690
C26b	25-Sep-09	28	4	146.5	28.27	95.5	3380
C26c	25-Sep-09	28	4	146.4	28.27	109.8	3880
C26d

Average 28 Day (psi): 3630

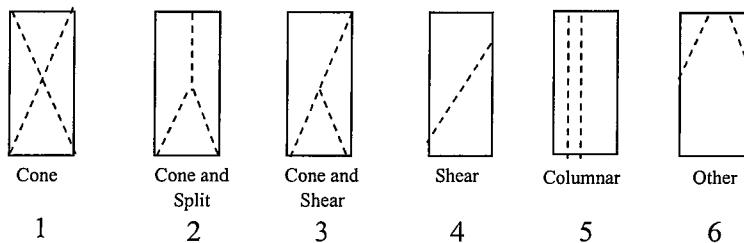
Sample No.	Test Date	Age	Type	Wt. (lb.)	Unit Wt.	Area (in <sup>2</sup> )	Load (K)	Strength (psi)
G3a	27-Aug-09	7	6	4.84	116.2	12.07	25.0	2070
G3b	17-Sep-09	28	6	4.58	115.7	11.59	24.5	2110
G3c	17-Sep-09	28	6	4.62	114.6	11.73	29.5	2510
G3d	15-Oct-09	56	3	4.73	113.9	12.04	35.5	2950

Average 28 Day (psi): 2310

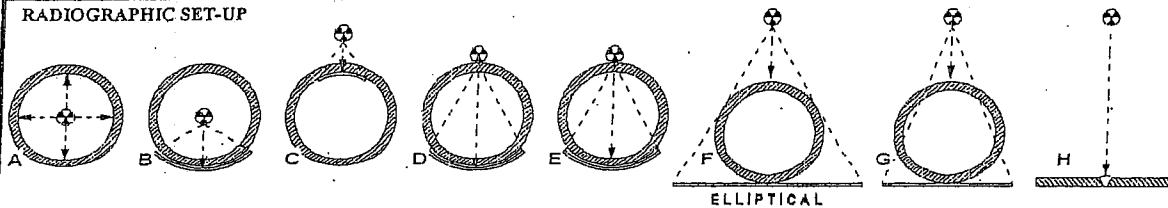
**RADIOGRAPHIC SET-UP**

MATERIAL: TYPE **CS/SS** THICKNESS: **1.250"-3/8"** ACCEPTANCE STANDARD: **AWSD1.1**

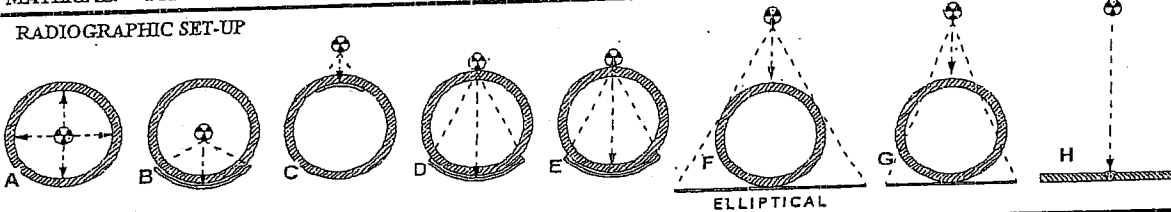
**RADIOGRAPHIC SET-UP**

CUSTOMER'S NAME: <b>PRECISION WELDING</b>		P.O. NO.: <b>N/A</b>	PAGE <b>1</b> OF <b>1</b>	
RADIOGRAPHY REPORT NO.: <b>QAL-02-843</b>		PROCEDURE NO.: <b>0913</b>	QUANTITY: <b>1</b>	
PART NO.: <b>TEST COUPON</b>		JOB NO.: <b>N/A</b>		
SOURCE: TYPE <b>Iridium 192</b>	SIZE: <b>.107 X .118</b>	CURIES: <b>30</b>	KV: <b>N/A</b>	MA: <b>N/A</b> SFD: <b>20"</b>
FILM: TYPE <b>II</b>	SPEED: <b>100</b>	SINGLE <input checked="" type="checkbox"/>	DOUBLE <input type="checkbox"/>	SIZE: <b>4 1/2 x 10</b> SCREENS: <b>0.010"</b>
IQL: SIZE <b>ASTM "B" WIRE</b>		GROUP: <b>I</b>	SENSITIVITY: <b>.020</b>	SHIM: <b>N/A</b>
MATERIAL: TYPE <b>C/S</b>		THICKNESS: <b>1"</b>	ACCEPTANCE STANDARD: <b>ASME SECTION IX</b>

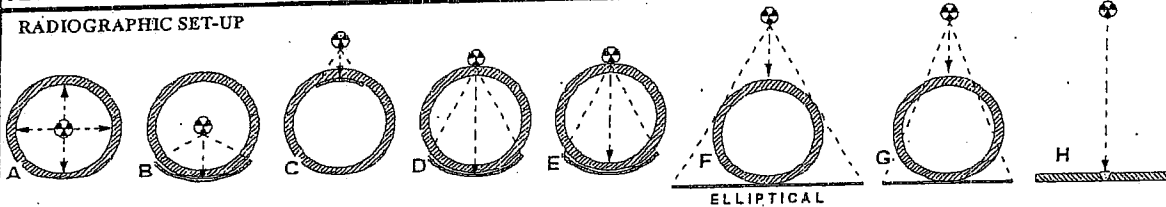
**RADIOGRAPHIC SET-UP**

CUSTOMER'S NAME: PRECISION WELDING	P.O. NO.:	PAGE 1 OF 1
RADIOGRAPHY REPORT NO.: QAL-08-0082	PROCEDURE NO.: AWS D1.1	QUANTITY: 2
PART NO.: SEE BELOW	JOB NO.: 2258/ 9877	
SOURCE: TYPE Iridium 192      SIZE: .118	CURIES: 75      KV:      MA:      SFD: 12"	
FILM: TYPE II      SPEED: 100	SINGLE <input checked="" type="checkbox"/> DOUBLE <input type="checkbox"/>	FRONT <input checked="" type="checkbox"/> BACK <input checked="" type="checkbox"/>
	SIZE: 4 1/2 x 10      SCREENS: 0.005"	FILM SIDE <input type="checkbox"/> SOURCE SIDE <input checked="" type="checkbox"/>
IQI: SIZE B      GROUP: 1	SENSITIVITY: .025	SHIM:      SOURCE SIDE <input checked="" type="checkbox"/>
MATERIAL: TYPE CS/SS      THICKNESS: 1" +1/4" BB	ACCEPTANCE STANDARD: AWS D1.1

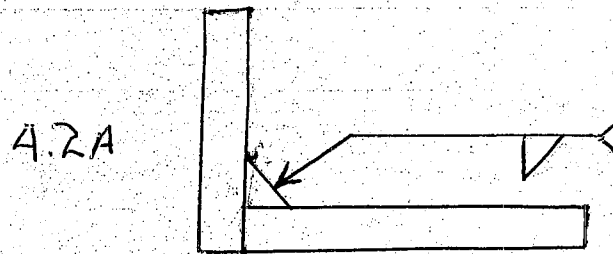
Sketch of Joint Details

**BASE METAL (1.2)**  
 Material specification type and grade:  
 Sheet steel A36 to A36  
 Support steel \_\_\_\_\_  
 Thickness Range:  
 Sheet Steel 1/8 - 3/16  
 Support Steel 1/8 - 3/16  
 Thickness 10 gauge  
 Base Metal Preparation \_\_\_\_\_
